# **Memorial Union, University of Wisconsin-Madison: historic structure report.**

Uihlein/Wilson et al.

Historic Structure Report

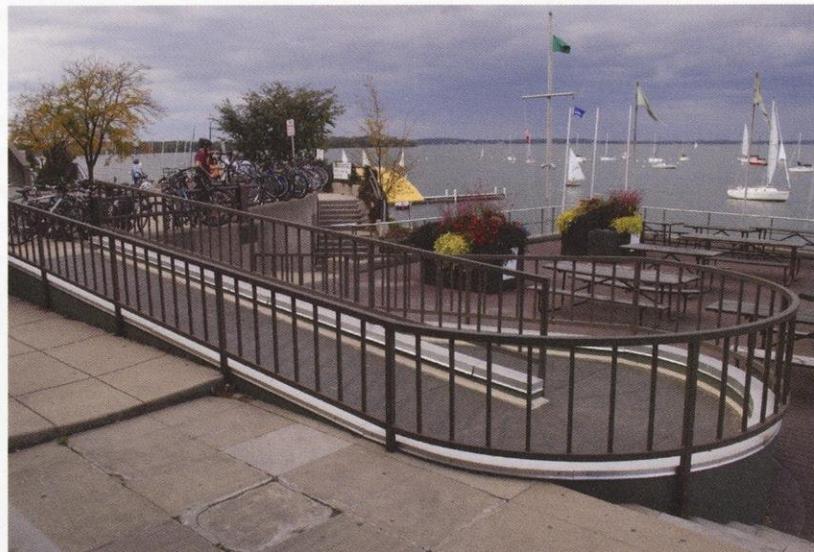
Image, top: View of the east area of the upper Terrace and the temporary accessible ramp.

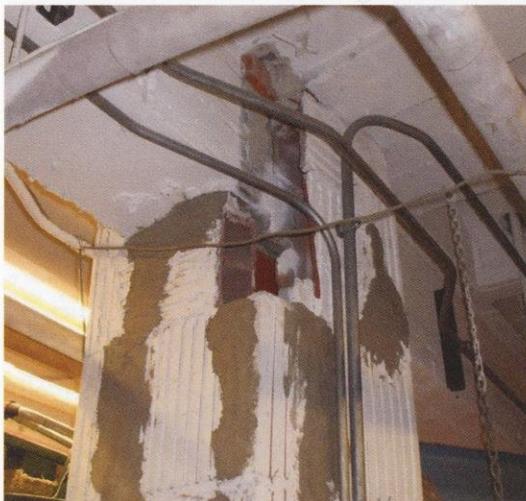
Image, bottom: Typical damaged or removed clay tile fireproofing around the pan-joist longitudinal bar.

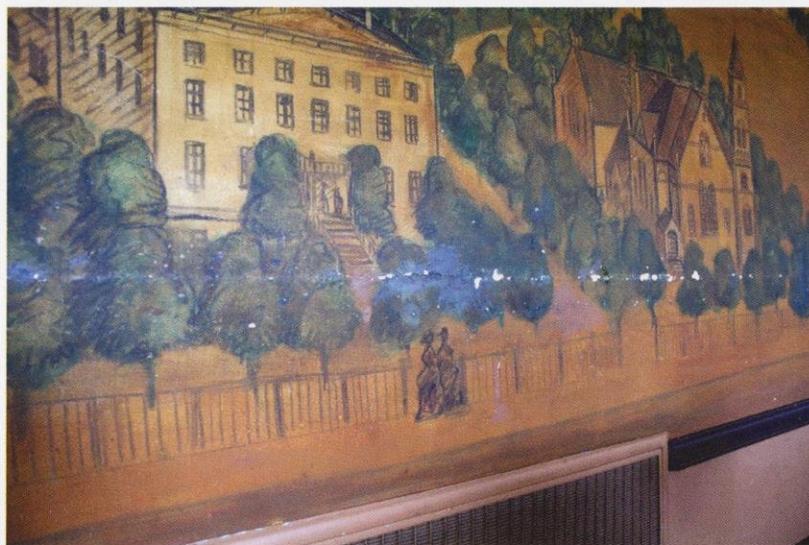
■ Image, left: Old Madison Room mural with repeated impact damage at the chair rail level.

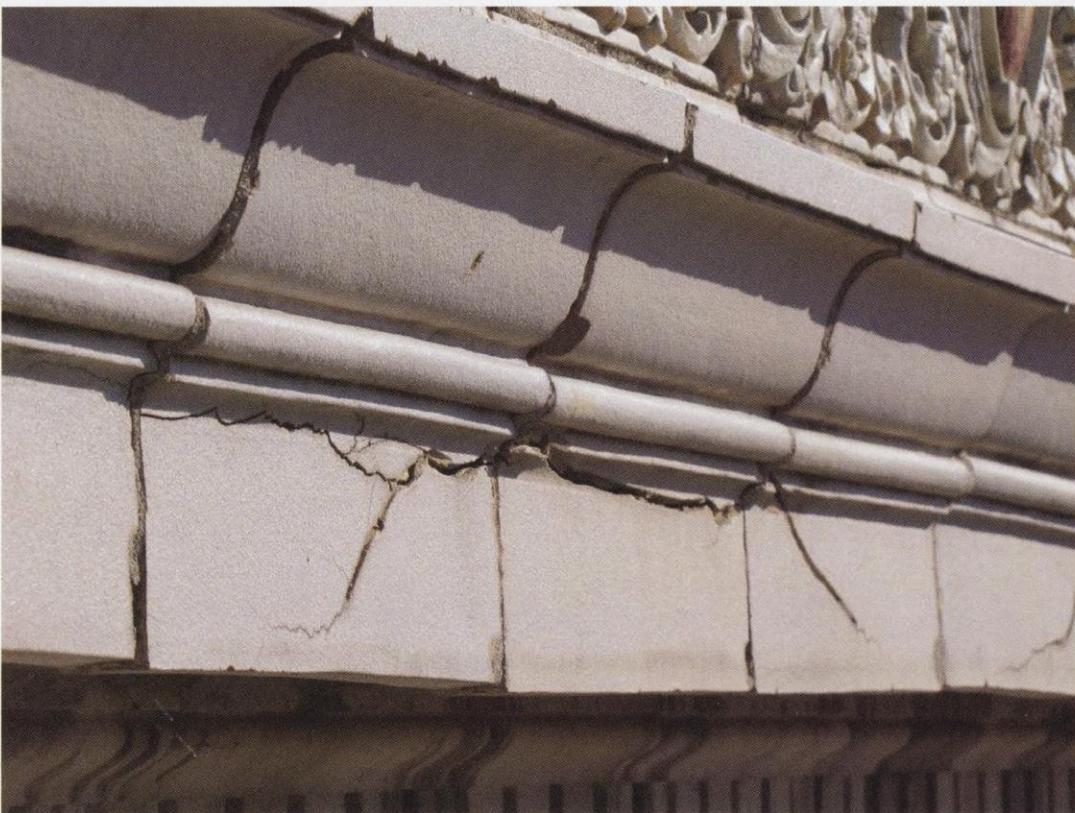
Image, left: Typical Cheneau deterioration above Great Hall.
