Plover Area Nitrate Study 1986

Fred Bailey Water Supply Manager Wisconsin Rapids Area North Central District Wis. Department of Natural Resources

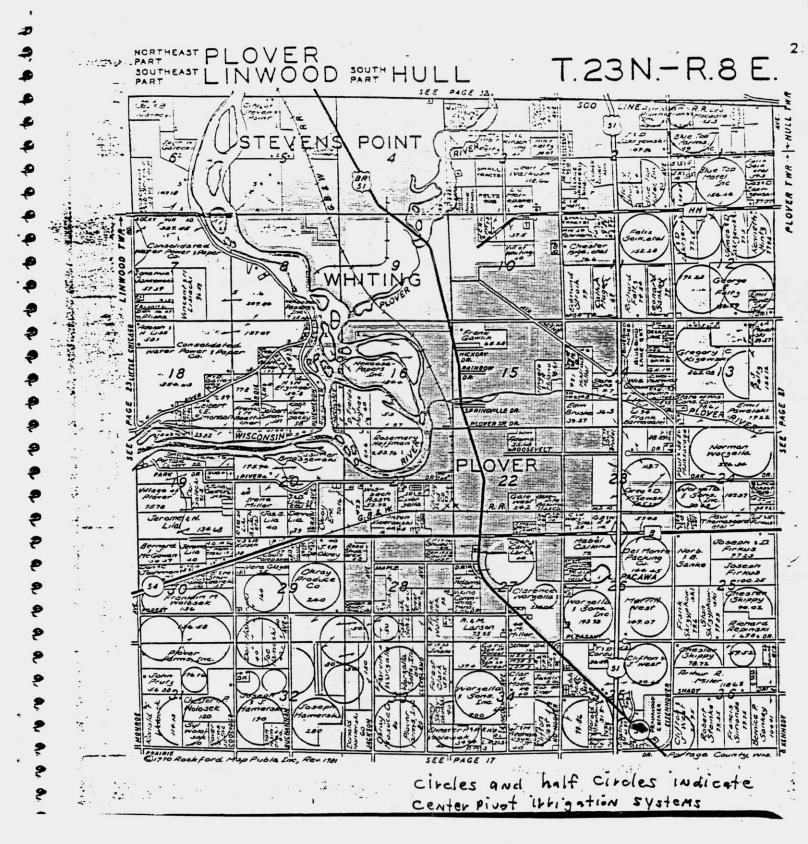
Map NO. 3

there is a lot of irrigated agriculture on the east side of Highway 54. The enclosed maps indicate the groundwater gradient and also show the center pivot irrigation systems present on some of these nearby farmfields (See maps 2 and 3). The plainfield sand present is quite suitable for growing potatoes and snap beans.
