Proceedings of The 13th Annual Conference on Wetlands Restoration and Creation

PROCEEDINGS OF THE THIRTEENTH ANNUAL
CONFERENCE ON WETLANDS
RESTORATION AND
CREATION

Sponsored by
Hillsborough Community College
Environmental Studies Center

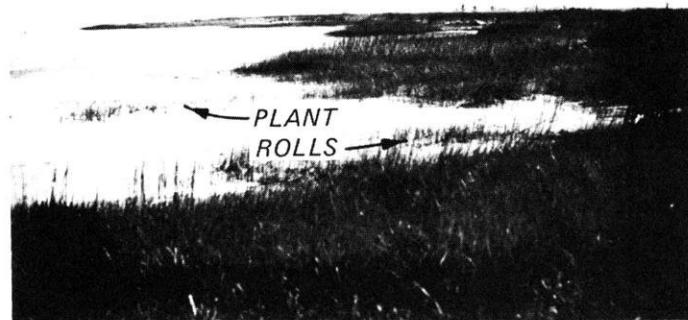
Figure 3. Successfully established smooth cordgrass marsh at Gaillard Island showing plant rolls extending out into the water.

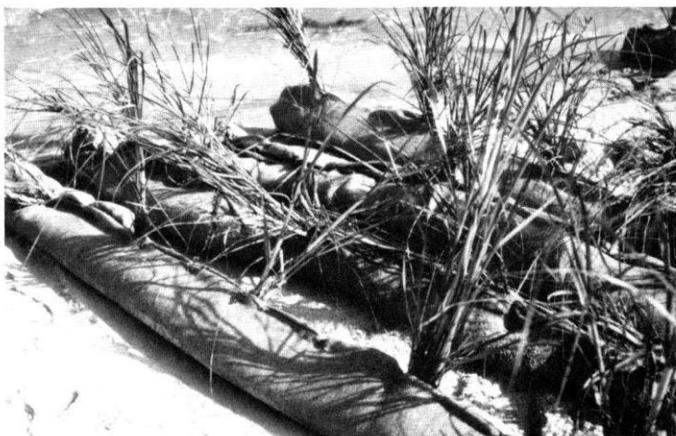
Figure 8. Plant rolls constructed on site ready for installation.

Treatment 4. A plant roll was constructed by laying a 3.7-m length of 0.9-m-wide burlap on the ground. Sandy soil was placed on the strip of burlap and six clumps of plants were spaced at 0.5-m intervals on the burlap. Then, the sides of the burlap were brought together around the plants and fastened with hog-rings. This created a 3-m-long roll of plants and soil (Figure 8). The plant rolls were placed parallel to the shoreline and buried in the plots by the use of a jet pump (Allen, Webb, & Shirley 1984).

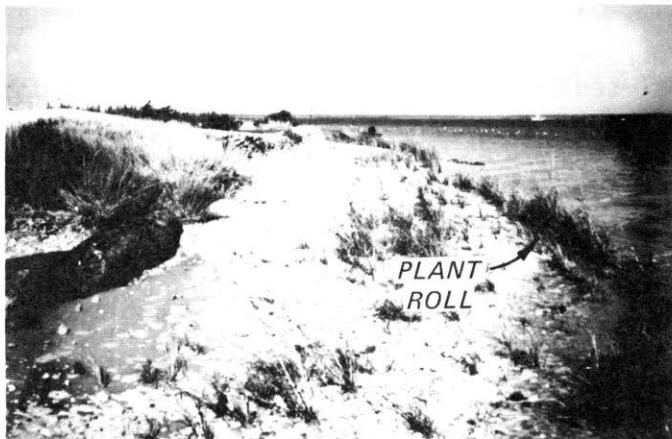
Figure 9. Coffee Island marsh development site 2-1/2 months after planting, showing plant rolls seaward of what were originally single-stemmed transplants.

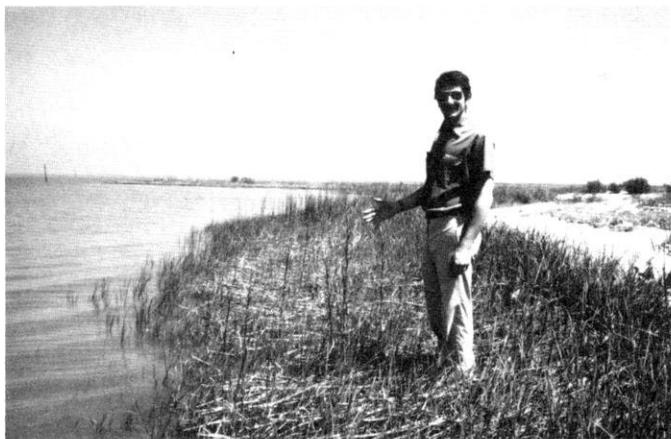
Figure 10. Coffee Island marsh development site 1-1/2 years after planting with smooth cordgrass.

The demonstrational planting at Coffee Island gave very noteworthy findings, although from a nonexperimental perspective. Periodic inspection revealed that the plant rolls placed end-to-end and seaward of single-stemmed transplants satisfactorily stabilized the eroding dredged material face. This is evident from comparisons of a photo made just 2-1/2 months after planting (Figure 9) to one made 1-1/2 years later (Figure 10). Upon inspection of the site at the time of the latter photo, the marsh fringe showed signs of accreting sediment and protecting the island from further erosion.

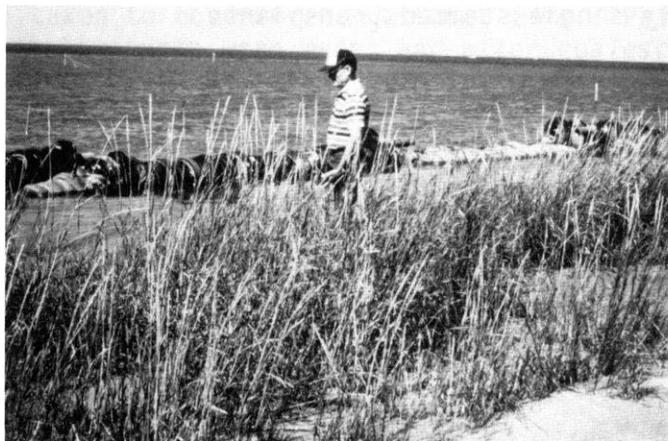
Figure 11. Smooth cordgrass behind fixed tire-pole breakwater at Bolivar Peninsula site.

because the fixed breakwater sustained some damage. Part of the upper tier of tires, two tire-pole sections, broke loose from the brackets and anchors holding them together. The FTB also was more effective because it did not cause quite as much sediment build-up and smothering of transplants as the fixed breakwater. On July 24-25, 1985, the fixed breakwater damage was partially repaired by cabling the loose ends of the broken sections to the intact portions of the breakwater.

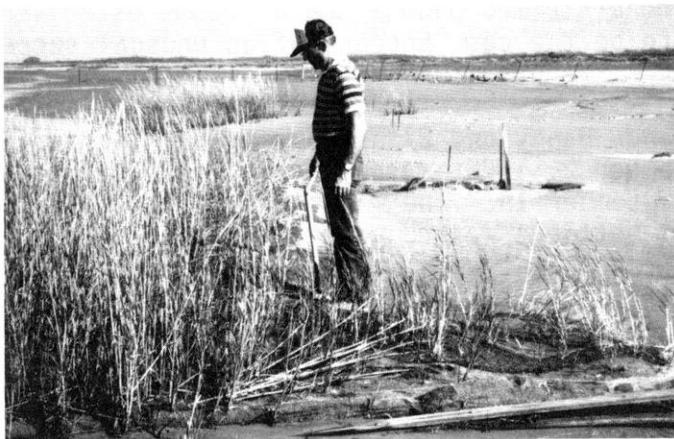
Figure 12. Smooth cordgrass in fabric mat at Bolivar Peninsula 15 months after planting.

Treatment 5. A biodegradable fabric mat, trade-name Paratex, consisting of 0.1 kg/m^2 natural fibers was laid like carpet on the shore. Then, single-stemmed transplants were inserted into slits cut through the material. The edges of the mat were nailed between 5- by 15-cm boards that were then placed on their edge and buried in the sediment (Allen, Webb, & Shirley 1984).

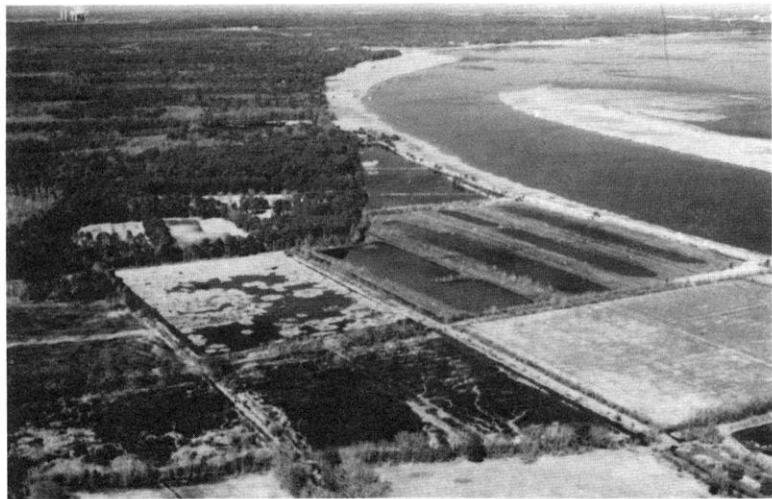
Figure 3. Impoundment being managed for duck hunting. Water is kept brackish (<15 ppt) which stimulates the growth of Scirpus spp., Eleocharis sp., and Ruppia maritima.

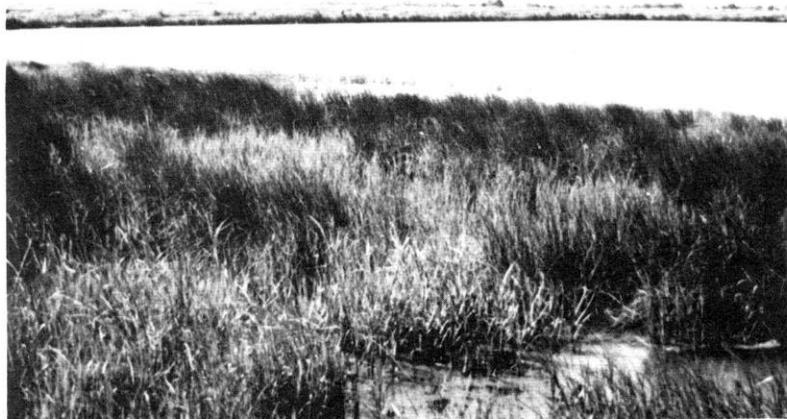
Figure 4. Beginning formation of hard, acidic "cat clays" during drying of a coastal impoundment.

The restoration of tidal flushing to impoundments creates problems, however. Workers have seen problems with acid sulfate soils, called "cat clays" by the Dutch, in many areas of the world (Hart 1959; Dost 1973; Moorman 1973; Saenger et al. 1983). Toxic runoff, fertilizer inefficiency, hyperacidity, high aluminum concentration, and generally low productivity are associated with flushing these soils (Saenger, et al. 1983). In South Carolina, Czyscinski (1975) studied cat clays and found similar problems due to the oxidation of iron sulfides to pyrite, as summarized in the following reaction:

Czyscinski determined that marsh muds growing Spartina alterniflora, Juncus roemerianus, and ecologically similar species which had sulfur contents greater than 0.75 percent were very likely to result in cat-clay formation upon drying and reemersion (Fig. 4). The primary methods he found of avoiding this problem were to prevent drying for over four months and provide adequate tidal flushing following restoration.

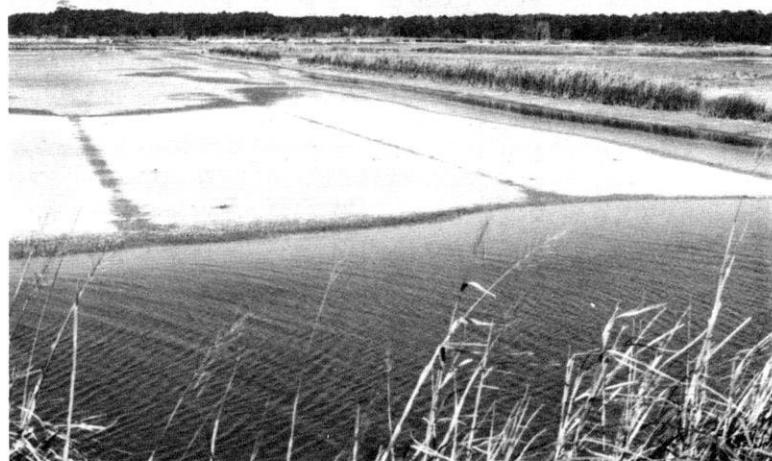
Figure 5. Successful planting of marsh species as a result of proper elevation selection.

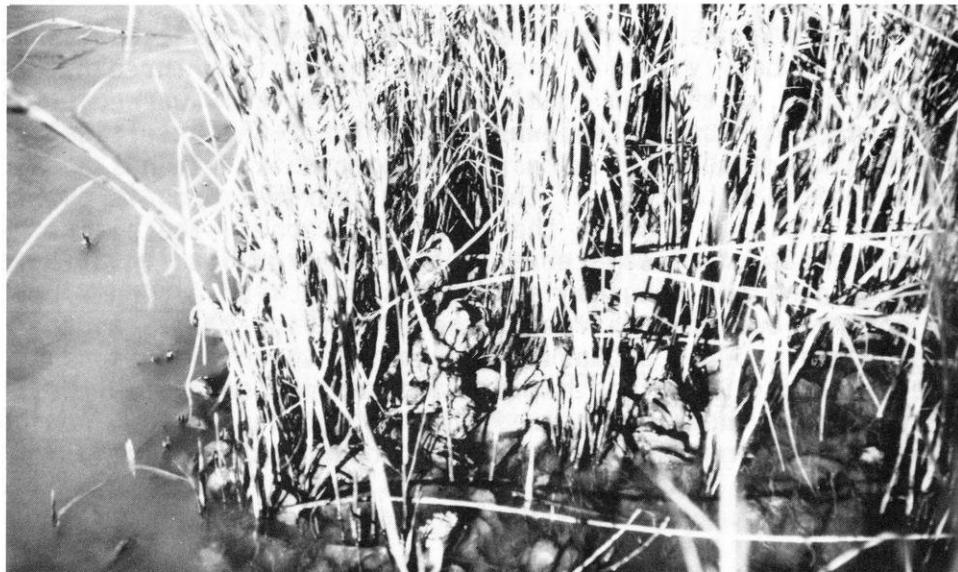
Figure 1. The salt marsh at the original Bolivar Peninsula site, 8 years after planting, showing colonization of systems in the intertidal zone.

The site has been heavily colonized by invertebrates such as fiddler crabs and receives much use by small fish during high tide. Oysters have densely colonized the sandbag dike area (Fig. 1). Moderate to heavy wildlife use occurs, primarily by seabirds, wading

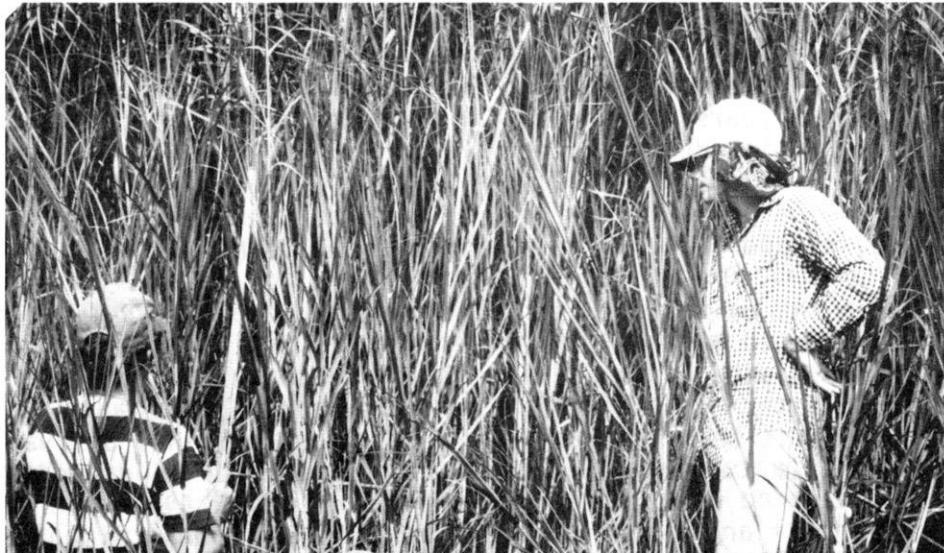
Figure 2. The salt marsh at the Buttermilk Sound site, 6 years after planting.

The Buttermilk Sound site differs from its reference marshes by possessing greater plant diversity at lower elevations. This is probably due to planting species in zones lower than they would naturally colonize. Aboveground biomass is similar to the reference marshes, but belowground biomass is less. Wildlife use of the site is more diverse and greater than that of the reference marshes. This is probably the result of the greater habitat diversity found on the Buttermilk Sound island site.

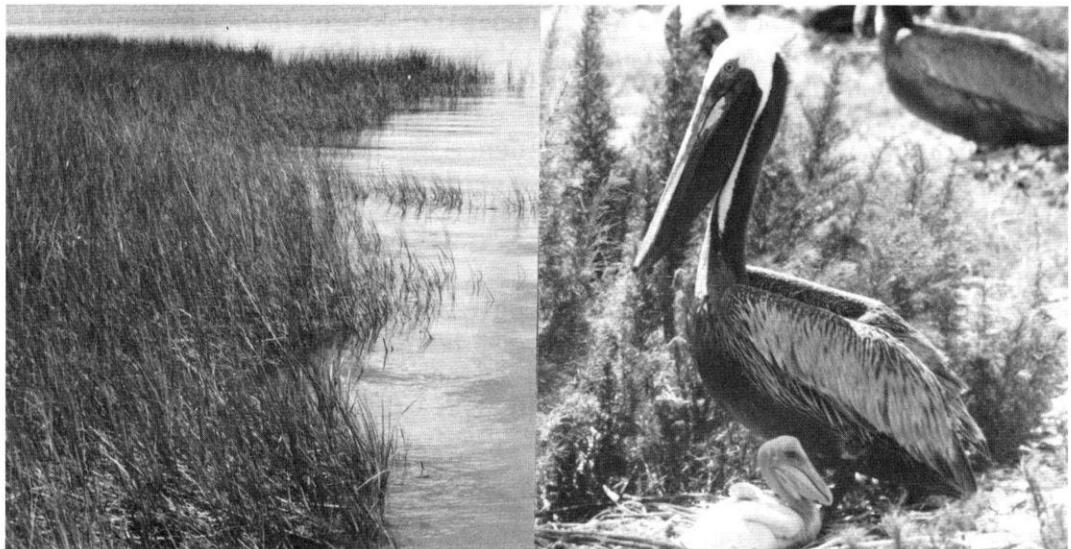
Figure 3. (a) The salt marsh at Gaillard Island at 4 years after planting. (b) The brown pelican colony on Gaillard Island.

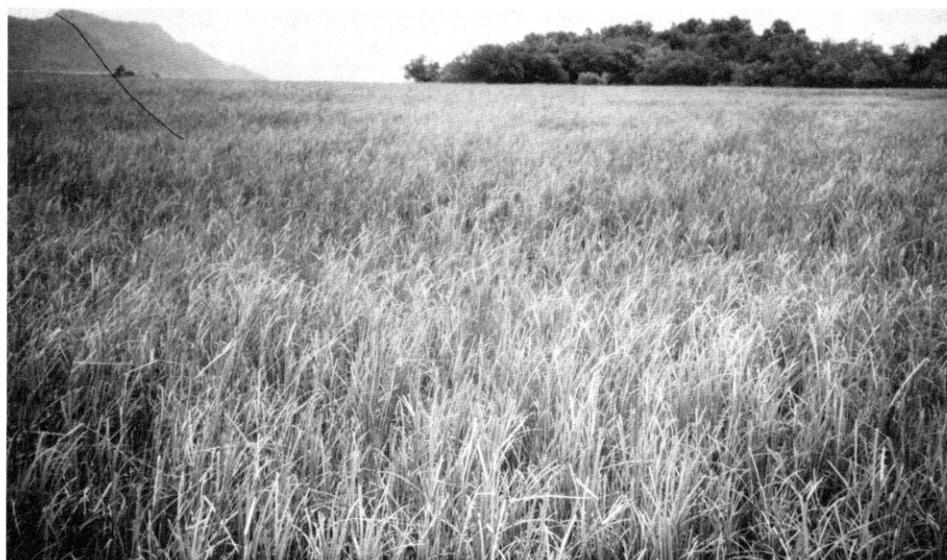
Figure 4. The fresh water intertidal marsh at Miller Sands, where large areas of natural marsh have colonized around the original planted area.

Miller Sands Island, a 100+ ha long-term disposal site for the Portland District, is a horseshoe shaped island in the fresh water intertidal region of the Columbia River (Fig. 4). Dredged material is placed hydraulically on the island annually, and was placed in the intertidal zone during 1975. The intertidal area was graded and planted with eight marsh species. Large-scale plantings of Deschampsia caespitosa and Carex obnupta were generally successful, especially at middle and higher elevations in the intertidal zone. Upland plantings of Ammophila arenaria were established in 1977 on the sand spit surrounding the marsh to retard sand erosion, and are well established. A. arenaria now grows over large areas of the entire sand spit, which has been enlarged due to increased dredging of Mt. St. Helen's ash and

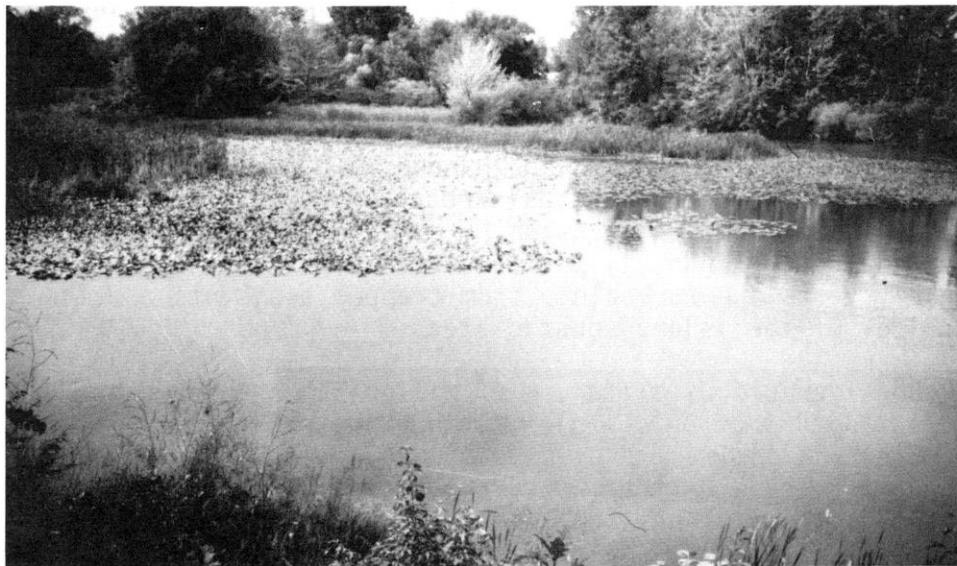
Figure 5. The fresh water marsh at Pointe Mouillee in western Lake Erie, where marsh is being allowed to colonize naturally behind the containment dikes.

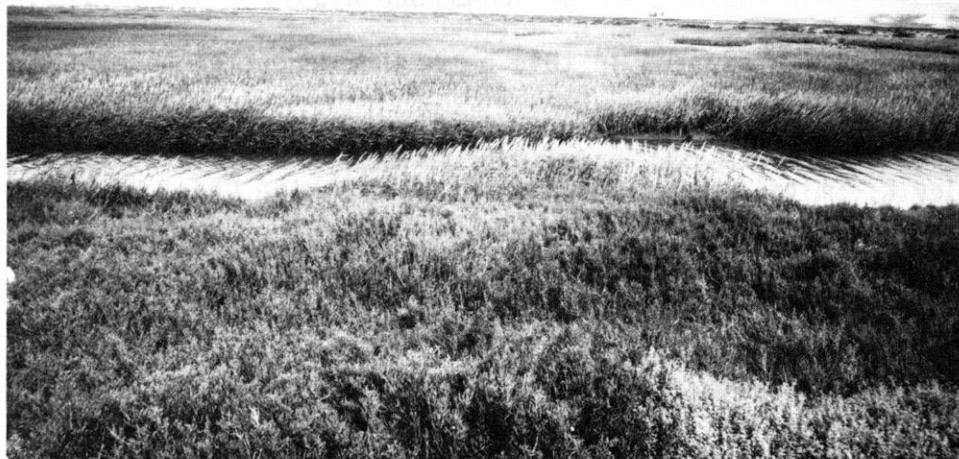
Figure 6. The salt marsh at Salt Pone #3 in south San Francisco Bay, where the original 3-ha plantings now cover the entire 40-ha site.

This wetland site was established on a portion of a 40-ha salt water evaporation pond in south San Francisco Bay that was partially filled in 1974 with hydraulically dredged clay material. Plantings of Spartina foliosa and Salicornia pacifica were established during 1976-77. S. foliosa sprigging was successful in the lower two-thirds of the intertidal zone. Planting in the upper one-third was not necessary because this area was rapidly invaded and dominated by naturally occurring Salicornia spp. (Fig. 6).

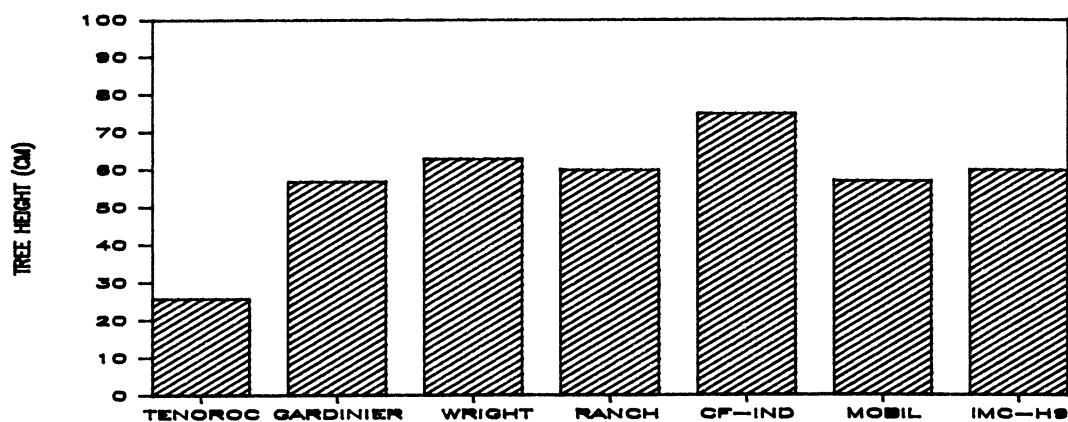
Figure 2. Comparison of baldcypress (*Taxodium distichum*) bareroot seedlings planted in seven clay settling ponds.

The remaining sites had from 55 to 77 percent survival of bald-cypress bareroot seedlings after one year. Average water table depth below the surface didn't appear to have a detrimental affect on tree survival. Seventy-seven percent of the trees were alive at Alderman Ford Ranch where the water table is the lowest. The sand/clay mix used by CF Industries may enhance tree growth. Some of the tallest trees (average 75 cm) were found there with 68 percent survival. The Mobil pasture pond where seedlings are growing in sand tailings had a high survival (79%) and an average height of 57 cm. Poorer survival (56%) and growth (avg. 32 cm) at Tenoroc may be attributed to heavy grazing by wildlife. The older sites, O. H. Wright and A. F. Ranch, 25 and 35 years since deactivated respectively, didn't have any better growth and survival than younger sites. This is especially true when the post

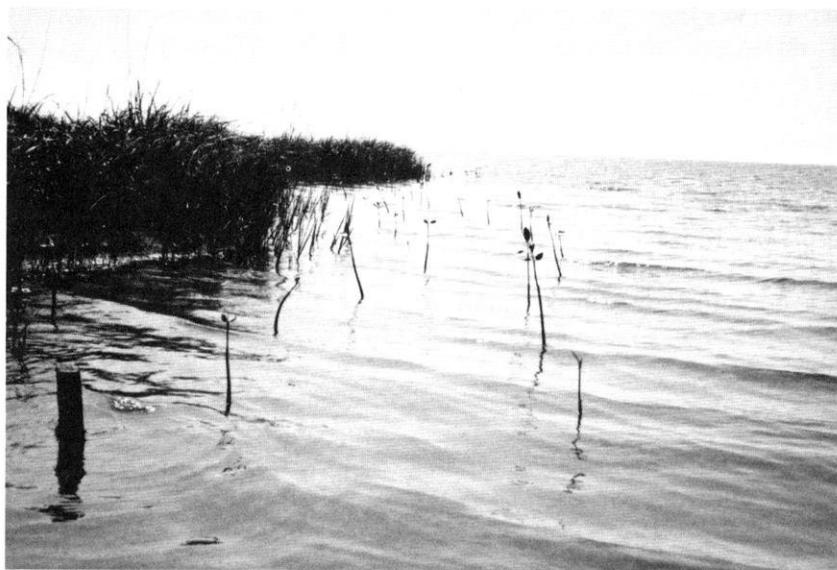
Figure 2. Rhizophora plantings on South Padre Island in February 1983.

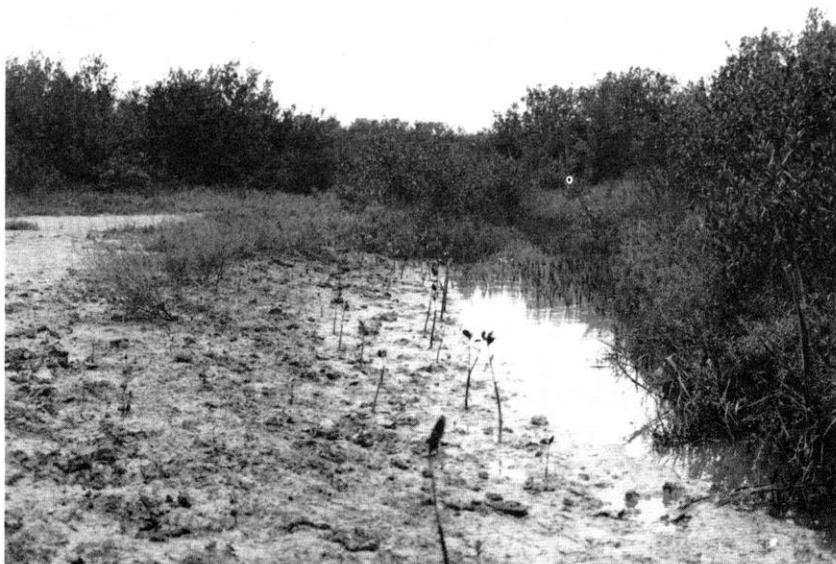
Figure 3. Rhizophora plantings at the mouth of the Rio Grande in April 1983.

centers in the soft silty-clay sediments characteristic of this site at an elevation of approximately MLW to MWL (mean water level). The planting area was generally surrounded by black mangroves 1 to 5 meters in height. The sediments and water were relatively warm at this time of year (estimate 20° to 25°C).
