Measured drawings of some colonial and Georgian houses. Volumes 1 & 2 1916

Donald Millar

Measured Drawings
of
Some Colonial
and
Georgian Houses

by
Donald Millar

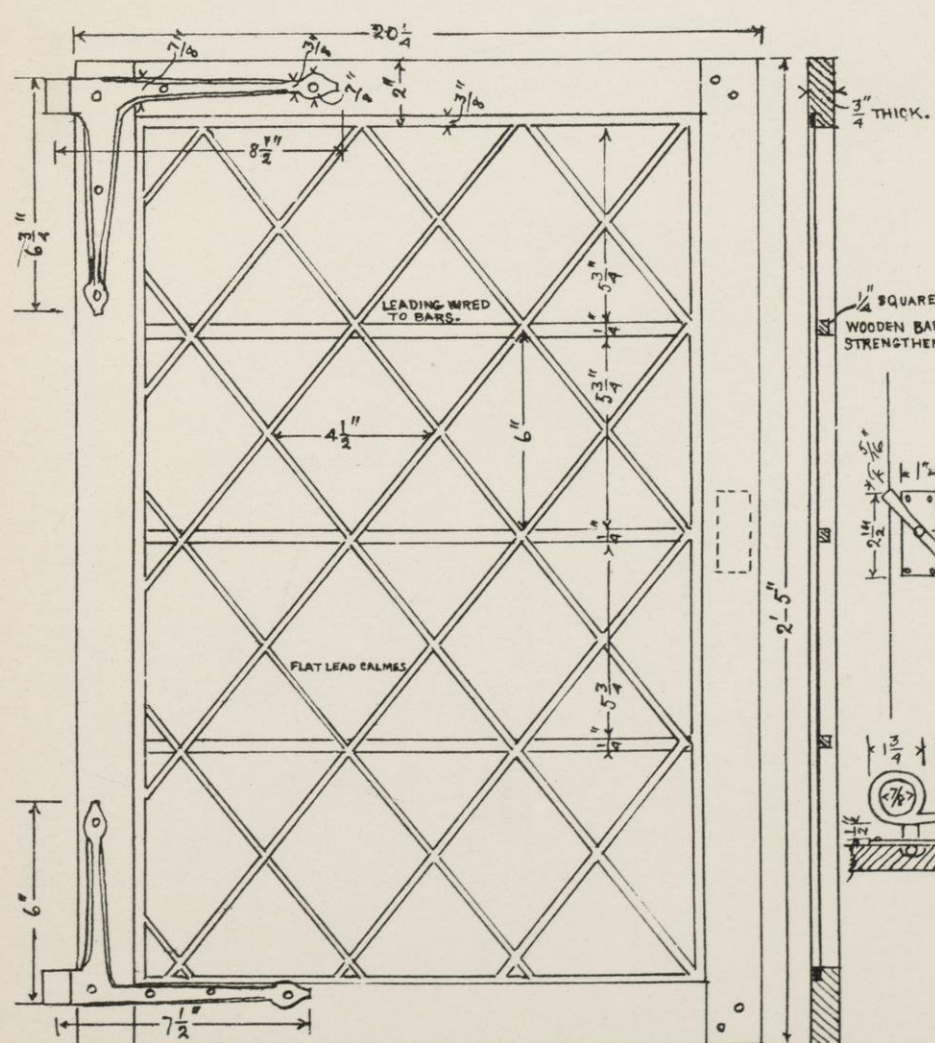
WINDOW CASEMENT - FROM BUFFUM HOUSE, SALEM, MASS. 1642-1661. NOW PRESERVED IN THE MUSEUM OF THE ESSEX INSTITUTE.

The stairway in the Curwin house in Salem is shown. This is evidently the original stair built in 1636, and is not unlike that in the Capen House. The old door shows some wainscot molding of unusual pattern. The casement from the Buffum House has its original hinge and latch. This latch is the only example which has been preserved, and has been duplicated in the restoration of the Capen House. There is evidence of the use of hooks for fastening doors and casements. The homely casement from the Fairbanks House (1636) at Dedham shows how glass was cut that not a fragment should be lost. Most early casements were very small. The one shown with rectangular glazing is unusually large. The earliest double hung sash were glazed with diamond panes set in lead, sash bars being a later invention.

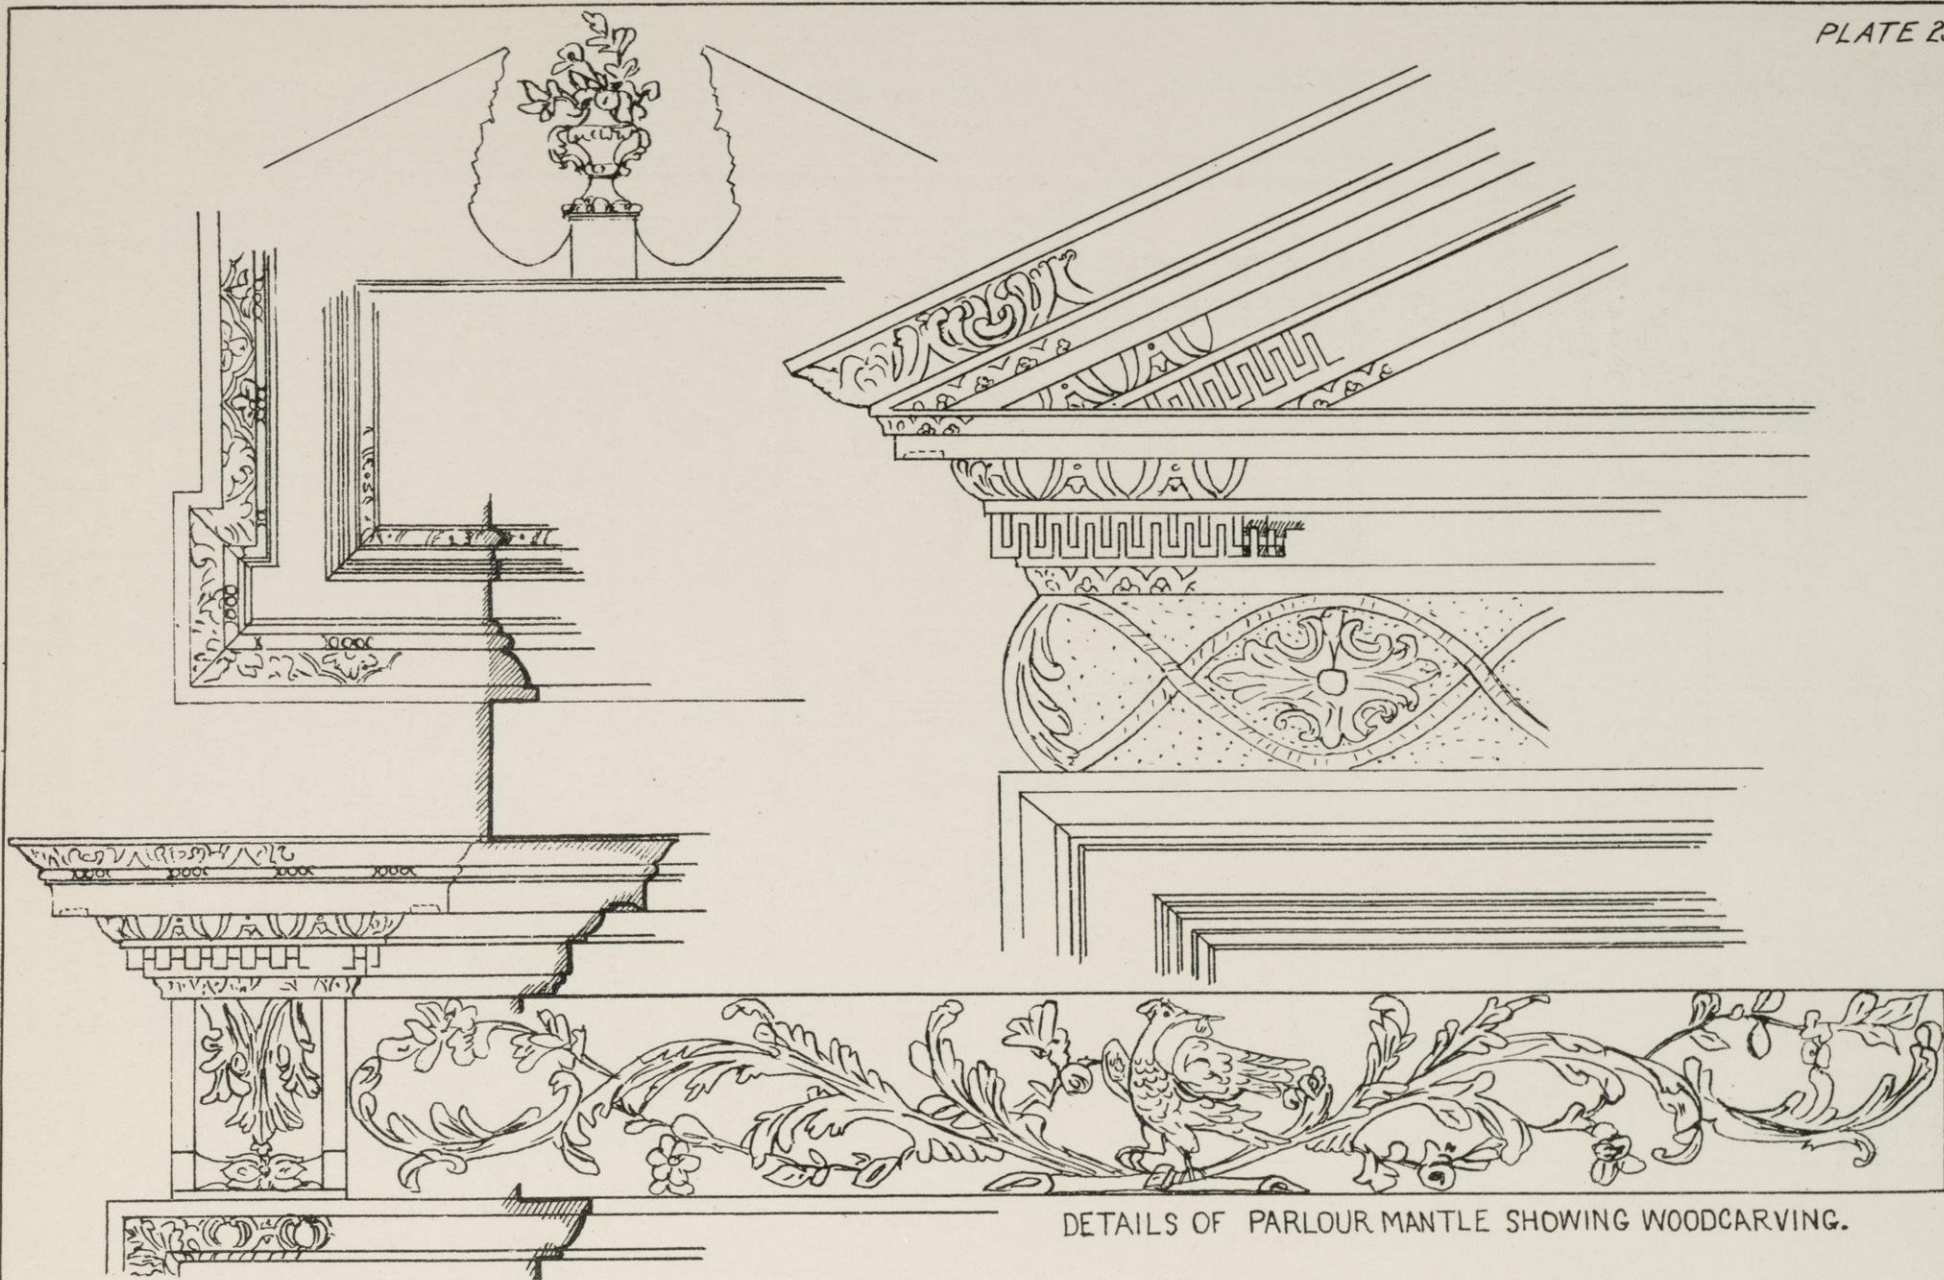
DETAILS OF PARLOUR MANTLE SHOWING WOODCARVING.

The old trim of the Parlor was removed in 1913 and the room panelled in excellent woodwork under the direction of Mr. Isham, but the old trim was of greater importance, and is here shown. The carving of the over-mantle is hard to trace, as it is not incised deeply, but the panel under the mantle shelf is carved in wood in high relief.

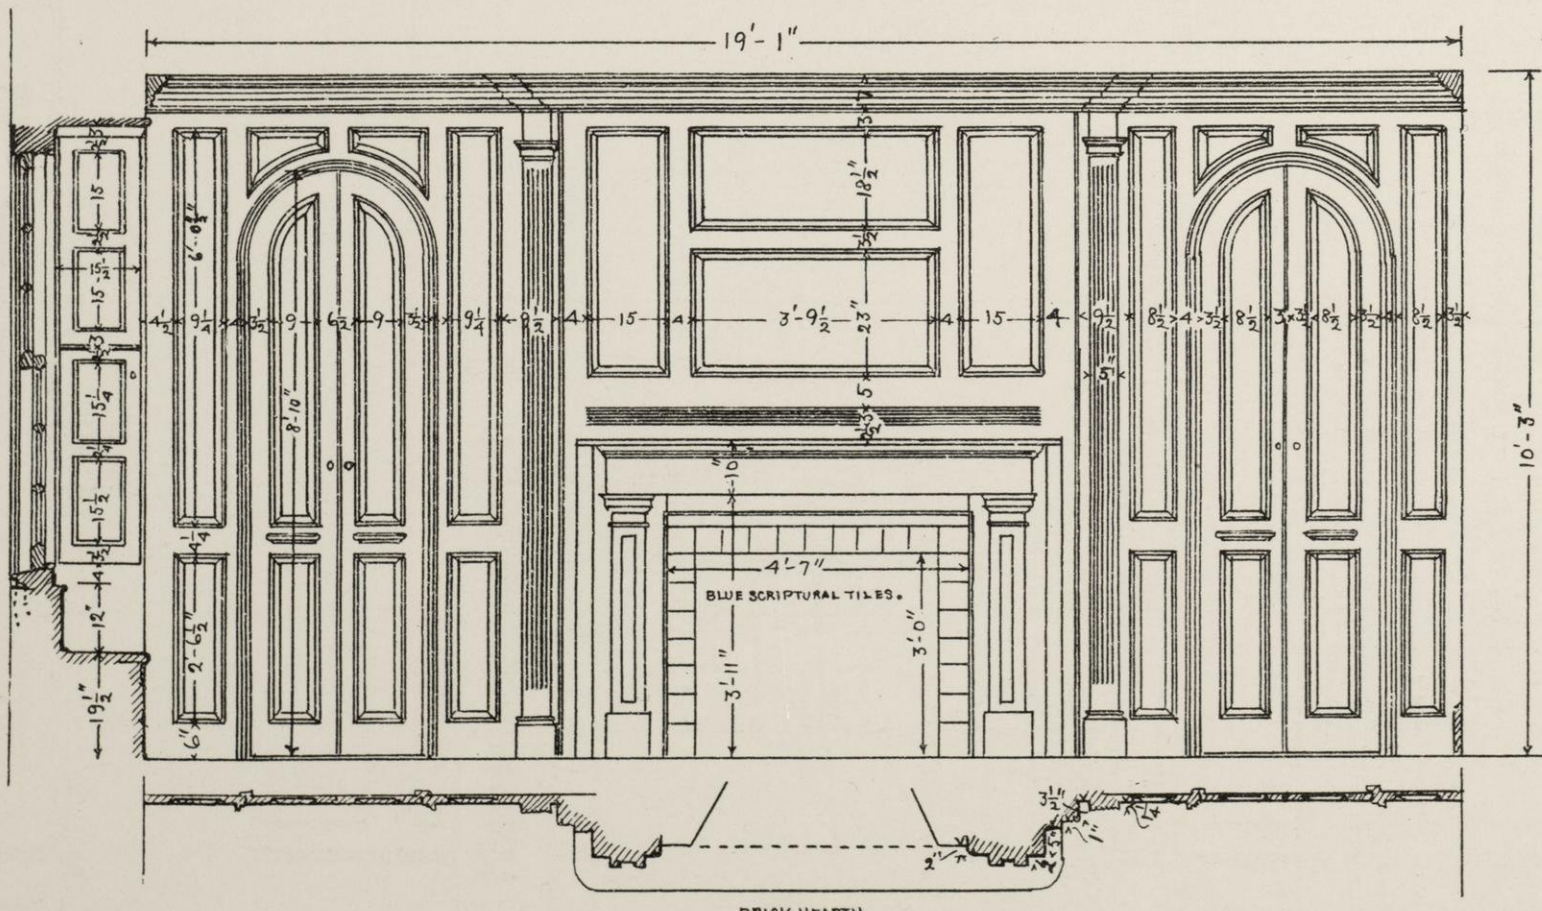
NORTH SIDE OF WEST ROOM.

THIS MANTLE DOES NOT APPEAR TO BE AS OLD AS THE PANNELLING BEHIND IT - AND IS PROBABLY A LATER ADDITION.

THIS WAS THE STATE BEDCHAMBER. GENL WASHINGTON SLEPT HERE IN NOVEMBER, 1783. DOORS TO THE CLOSETS HAVE BEEN ALTERED - BUT ARE HERE SHOWN AS ORIGINALLY BUILT.

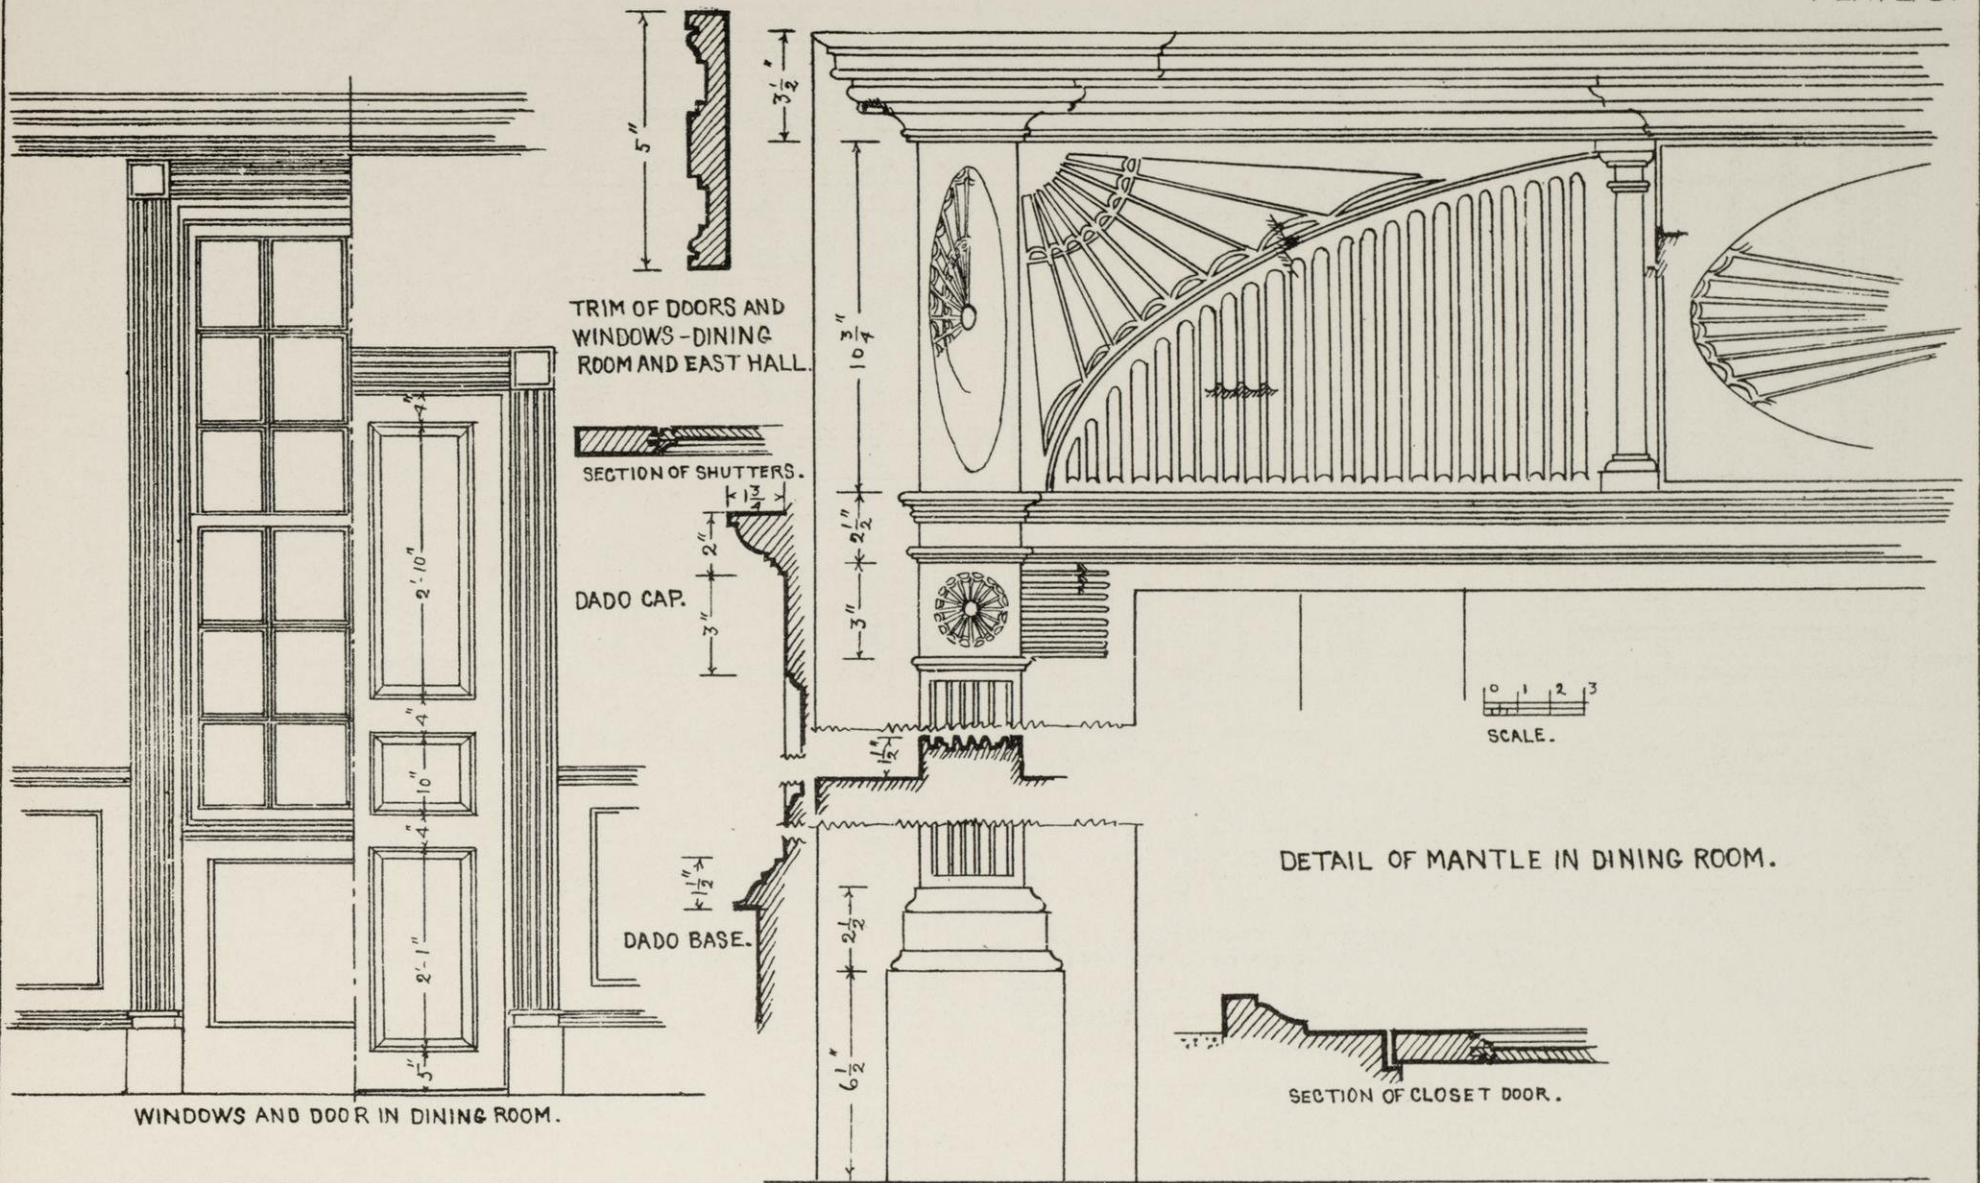
THE SHUTTER BOXES ARE PANELLLED AS IN CHAMBER ABOVE.

THIS PLASTER CORNICE IS A POOR ONE PROBABLY DATING FROM THE LAST CENTURY.

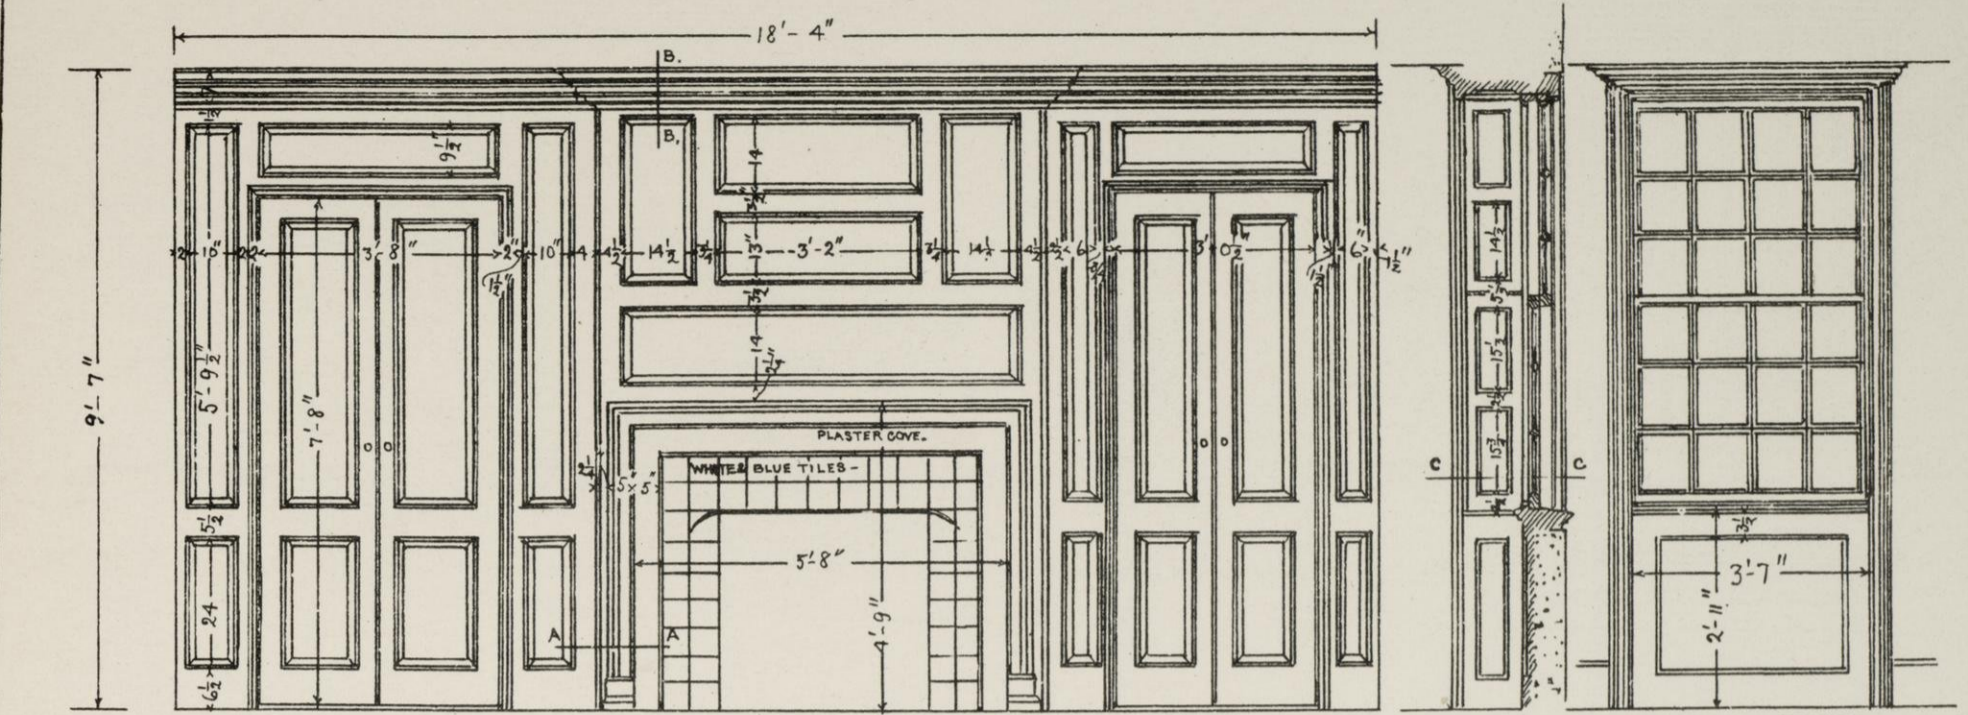
NORTH SIDE OF NORTH CHAMBER.

NOTE. DOORS AT PRESENT HERE ARE POOR MODERN ONES. OLD DOORS WERE AS SHOWN.

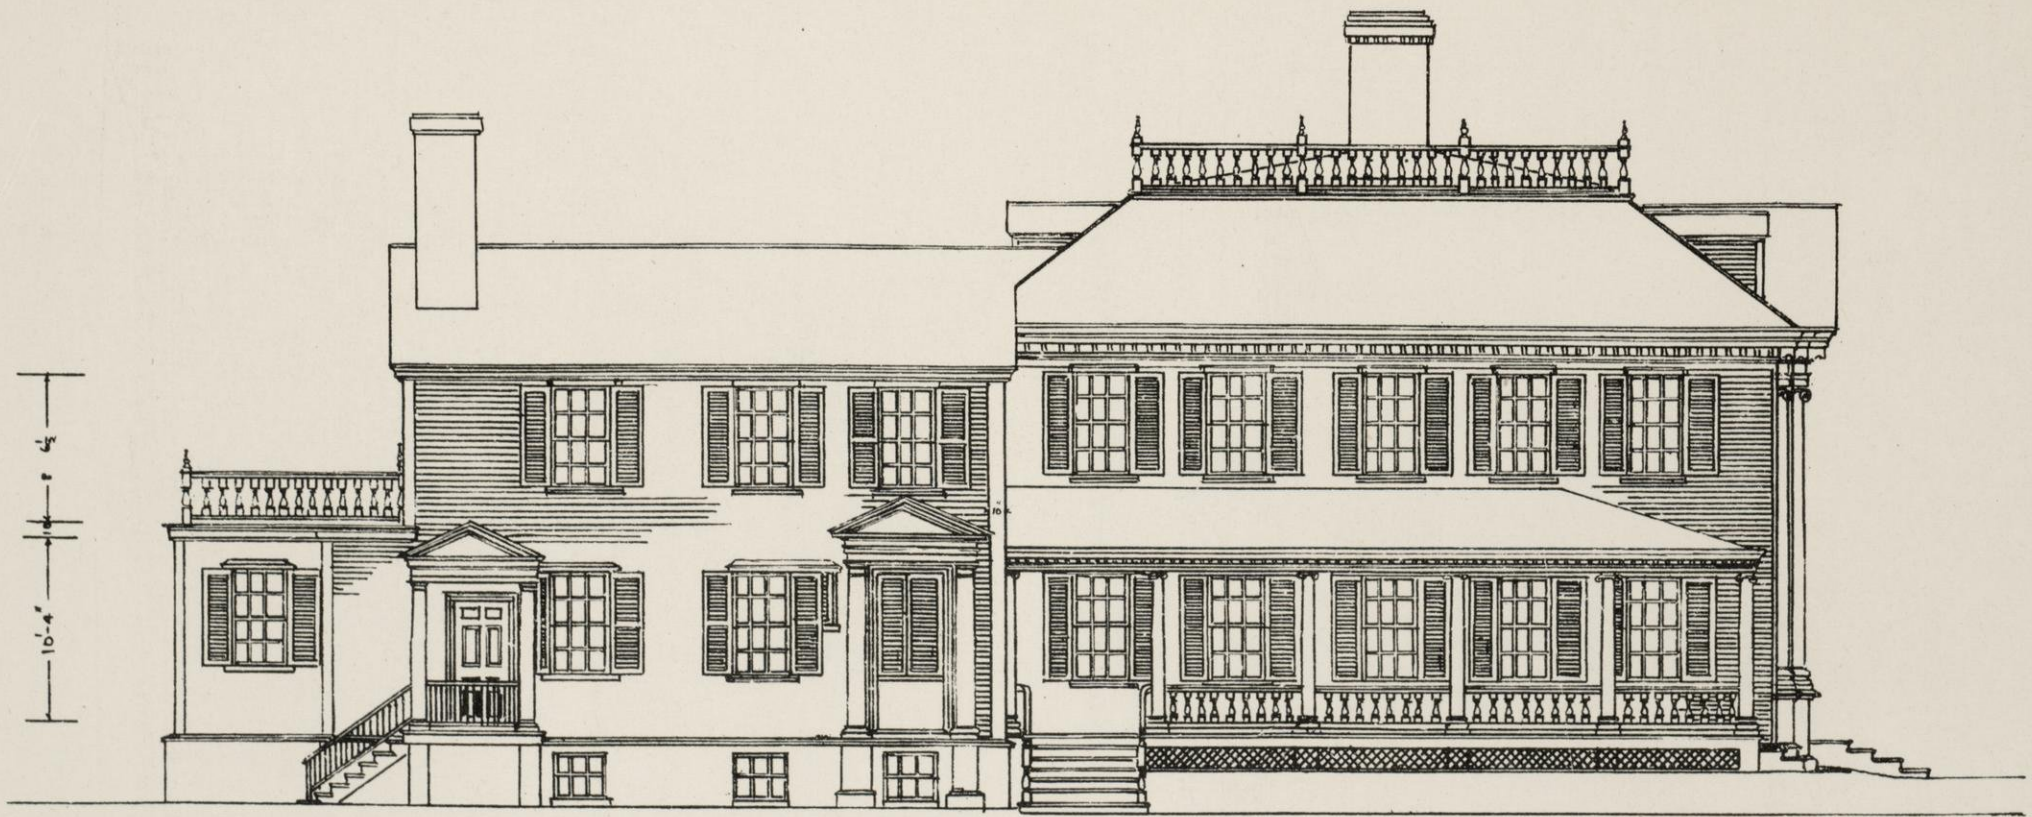
WEST ELEVATION.

BUILT BY JOHN VASSALL IN 1759-
GEN: WASHINGTON'S HEADQUARTERS, 1775-76.
ENLARGED BY DR. ANDREW CRAIGIE IN 1793.
ACQUIRED BY HENRY WADSWORTH LONGFELLOW IN 1843.

John Vassall built the house in 1759. At the beginning of the Revolution it became Gen. Washington's headquarters, 1775-6. After the war the confiscated estate was purchased by Dr. Andrew Craigie, who in 1793 enlarged the house by the addition of the wing to the north, and the verandas, and altered the northeast parlour, the old dining-room. The present dining-room was the Vassalls' kitchen.

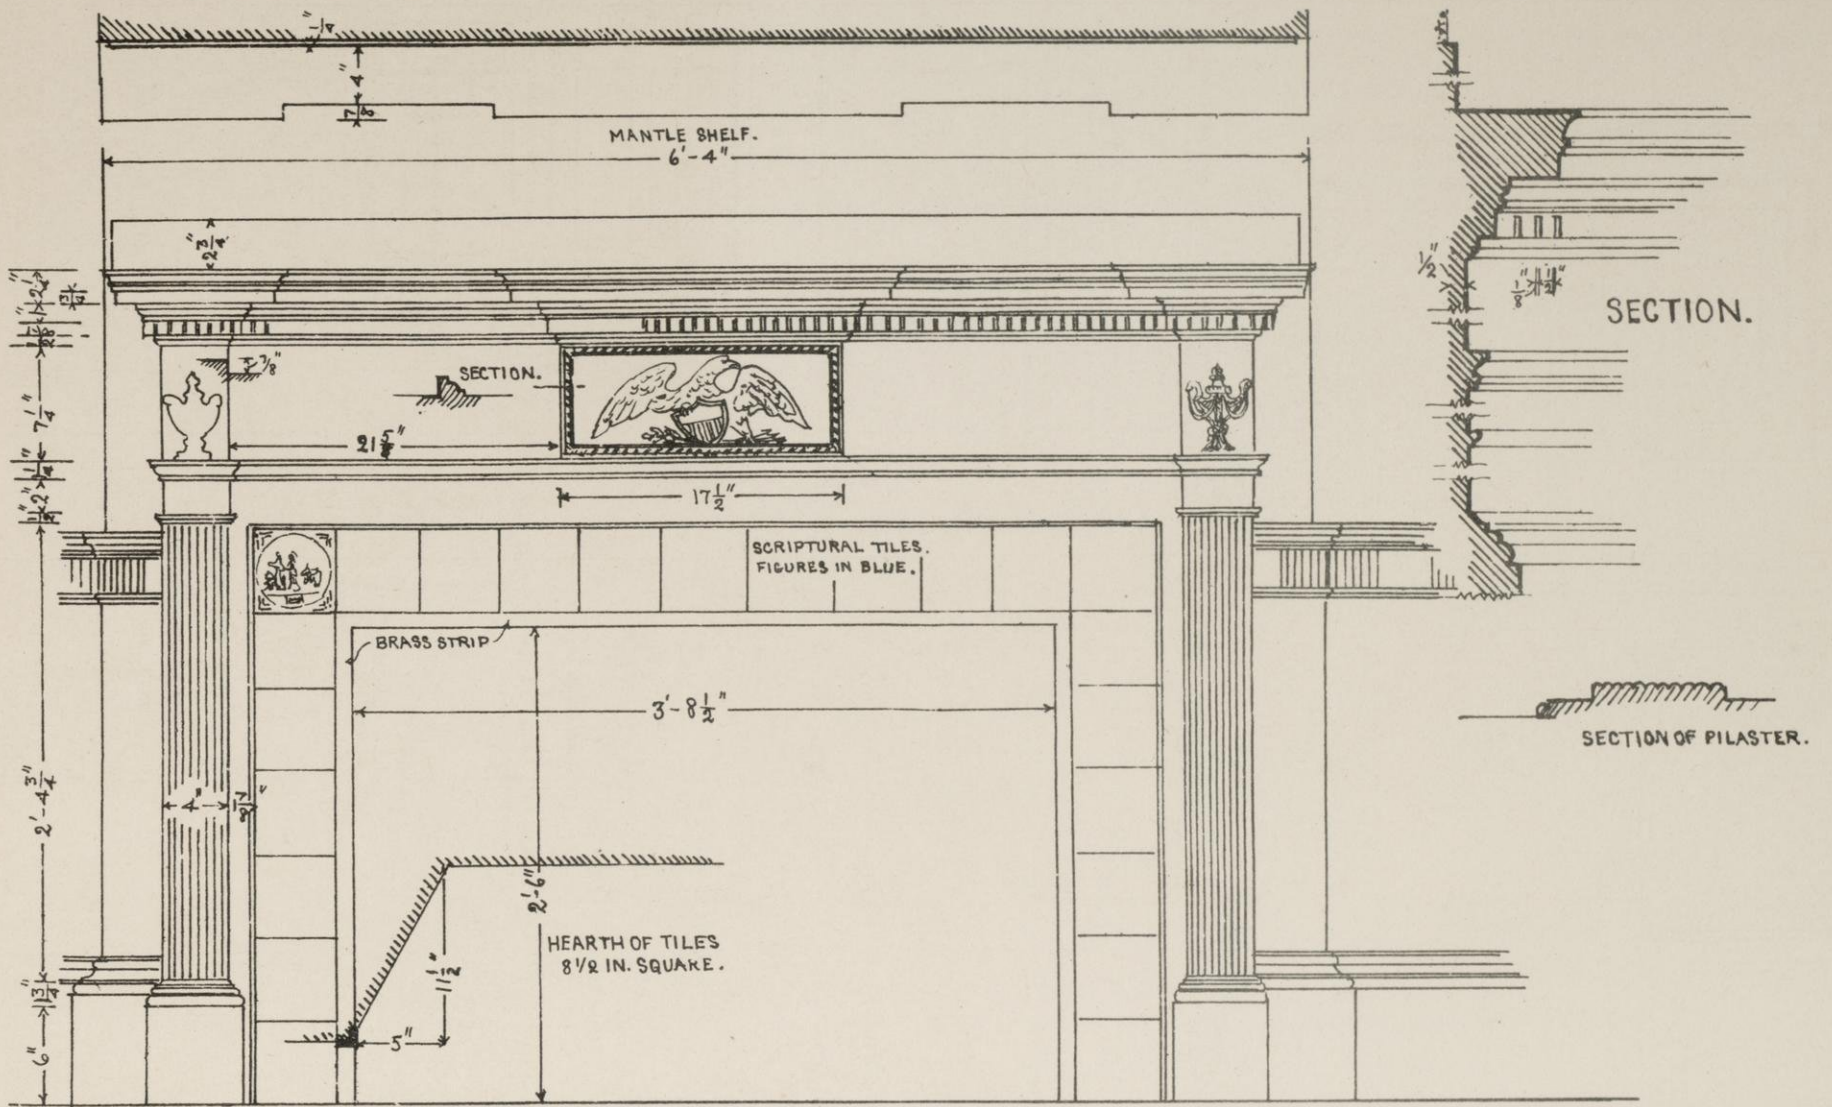
MANTLE BY SAMUEL M^C INTYRE - 1800.
FORMERLY IN THE OLD REGISTRY OF DEEDS BUILDING, SALEM, MASS. NOW IN THE ESSEX INSTITUTE.

A very handsome mantle by Samuel McIntyre, the noted Salem architect and wood-carver, is shown. It formerly was in the old Registry of Deeds Building. The eagle is carved in high relief.

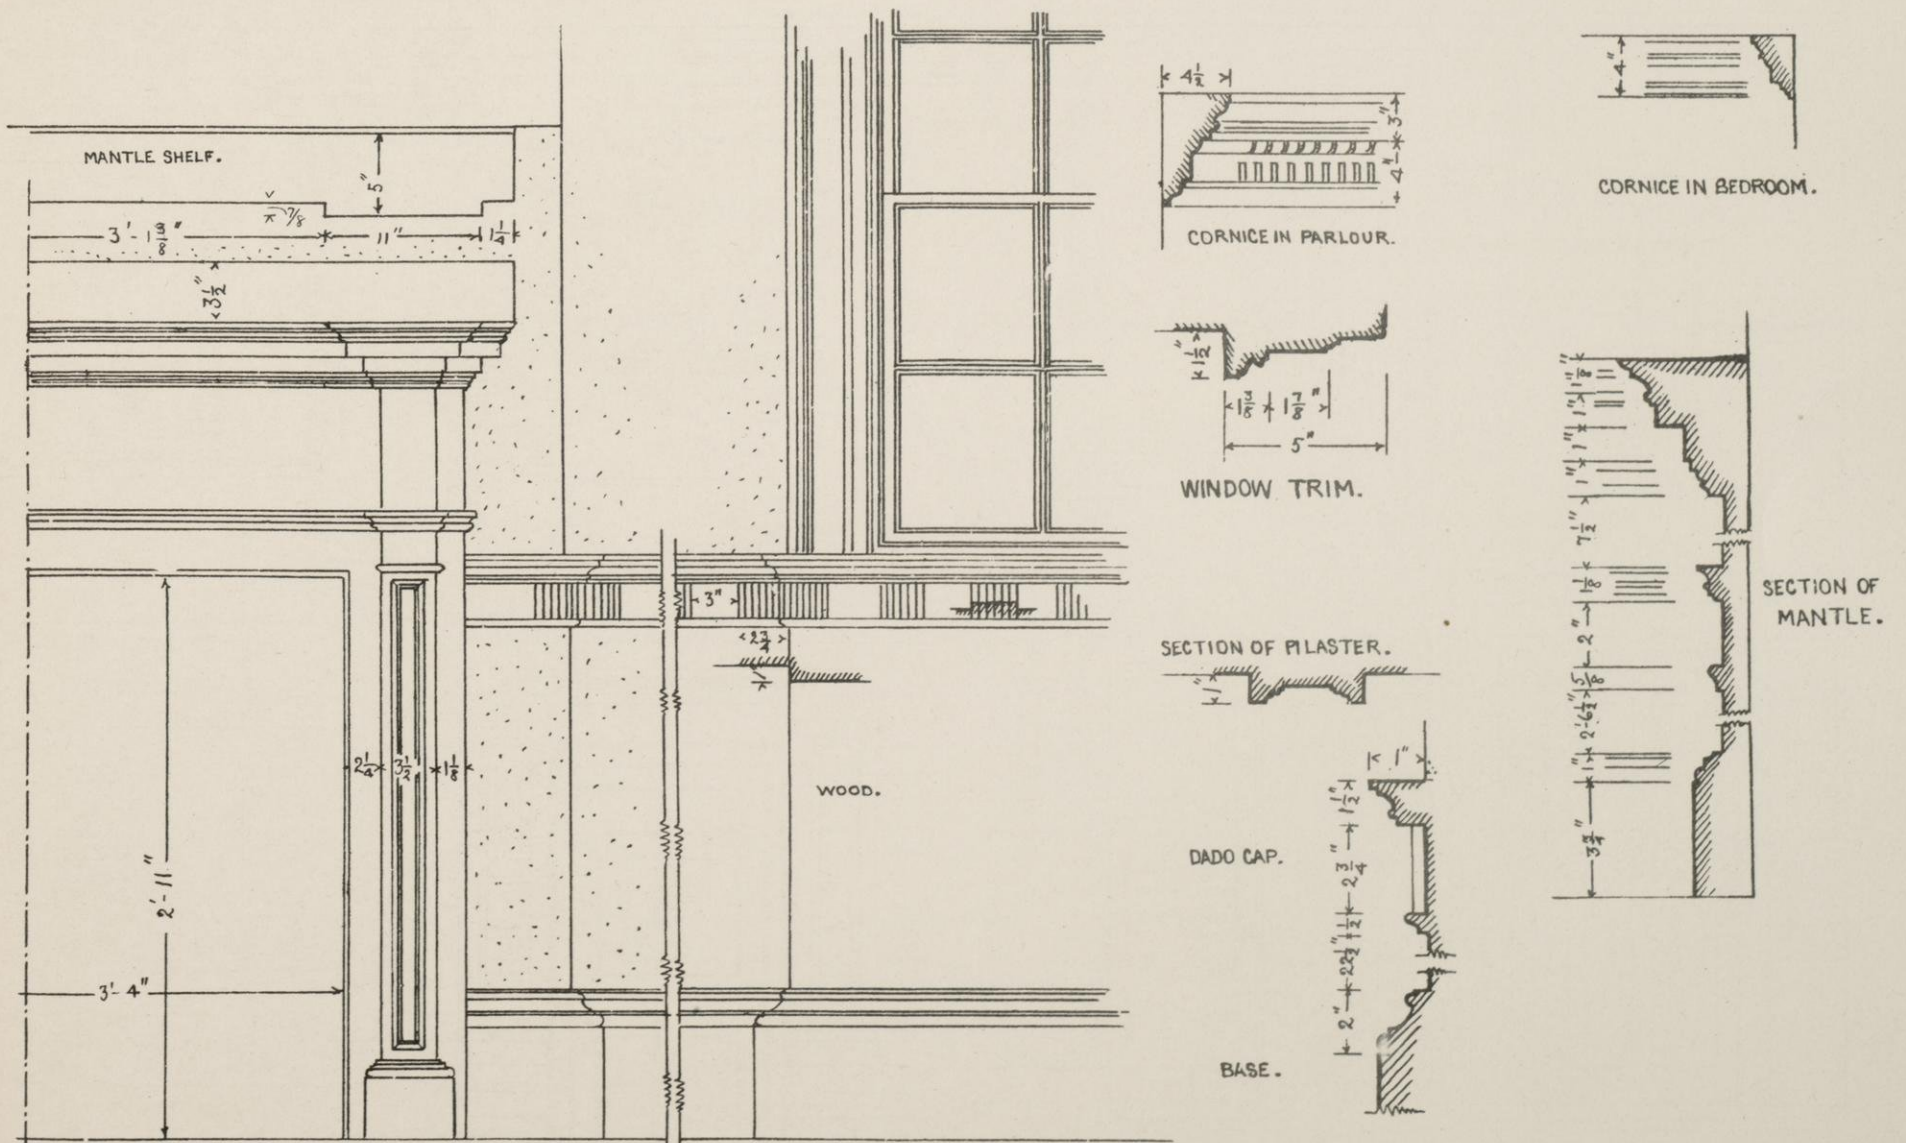
MANTLE IN "1800 BEDROOM"- ESSEX INSTITUTE. - WINDOW TRIM AND DADO IN PARLOUR.

The bedroom mantle in the specimen "bedroom of 1800" in the Essex Institute is a copy of an old mantle—the dado and trim represent the fashion of 1800.

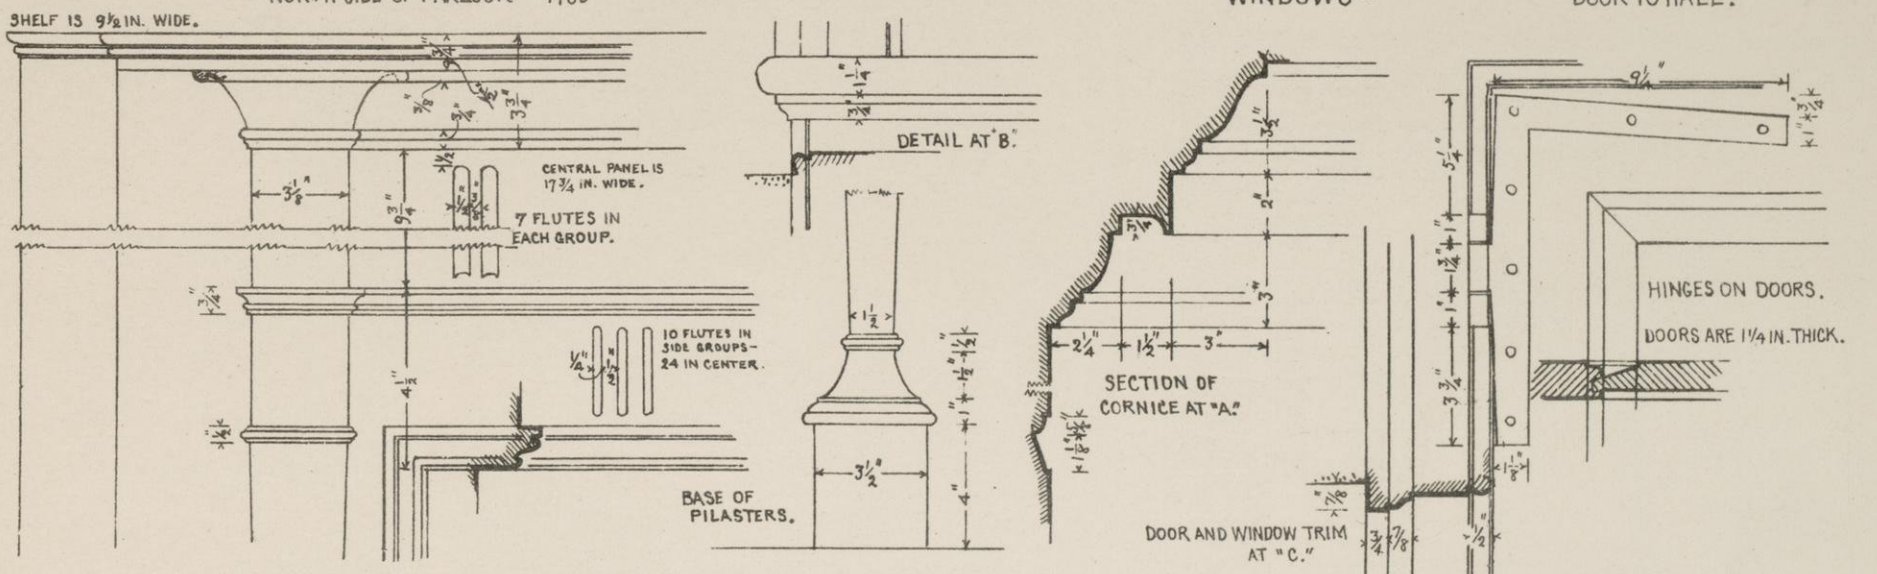
SHELF IS 9 1/2 IN. WIDE.

HINGES ON DOORS.
DOORS ARE 1 1/4 IN. THICK.

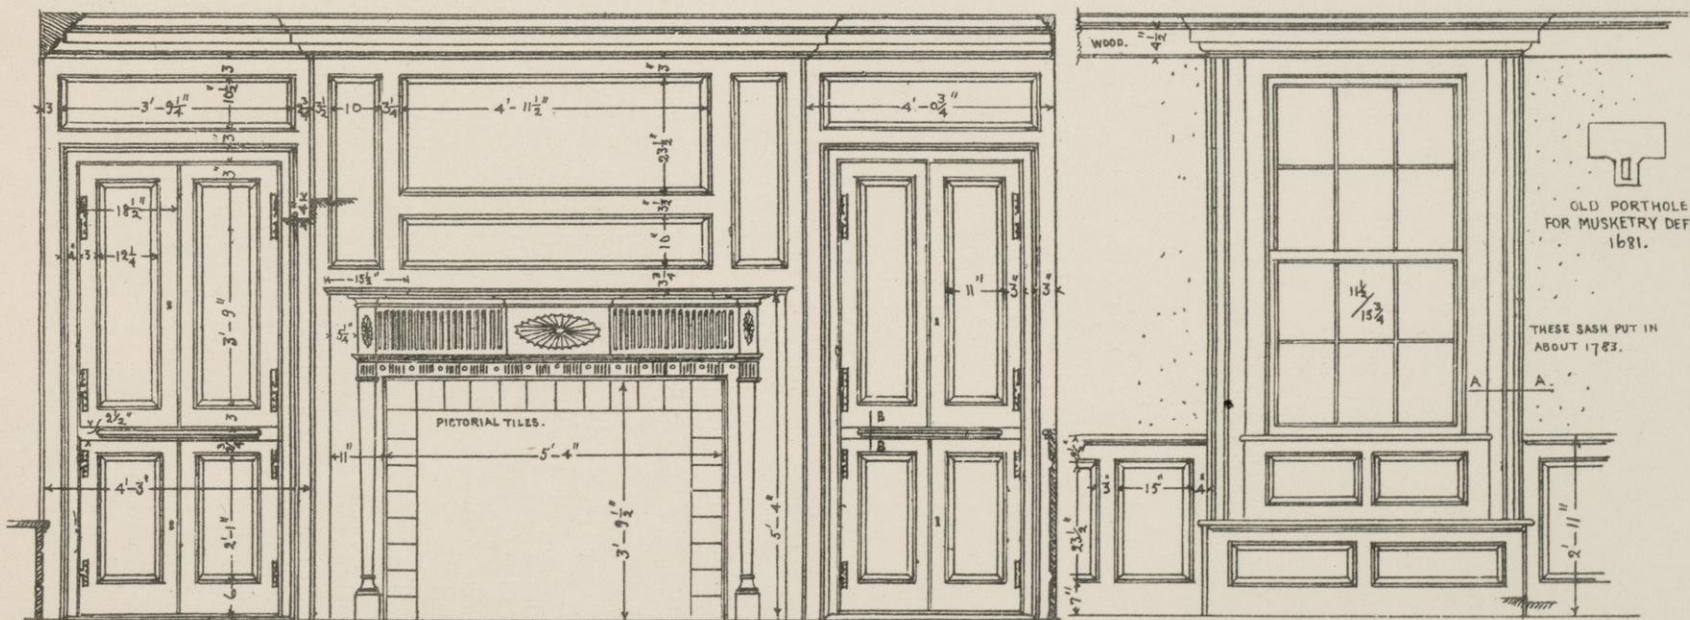
NORTH SIDE OF DINING ROOM. - 1783 -

OLD PORTHOLE FOR MUSKETRY DEFENCE.
1681.

THESE SASH PUT IN ABOUT 1783.
