**Proceedings of
The 22nd Annual Conference
on Ecosystems Restoration
and Creation**

May, 1995

Sponsored by
Hillsborough Community College
Institute of Florida Studies

Frederick J. Webb Jr.
and
Patrick J. Cannizzaro
Editors

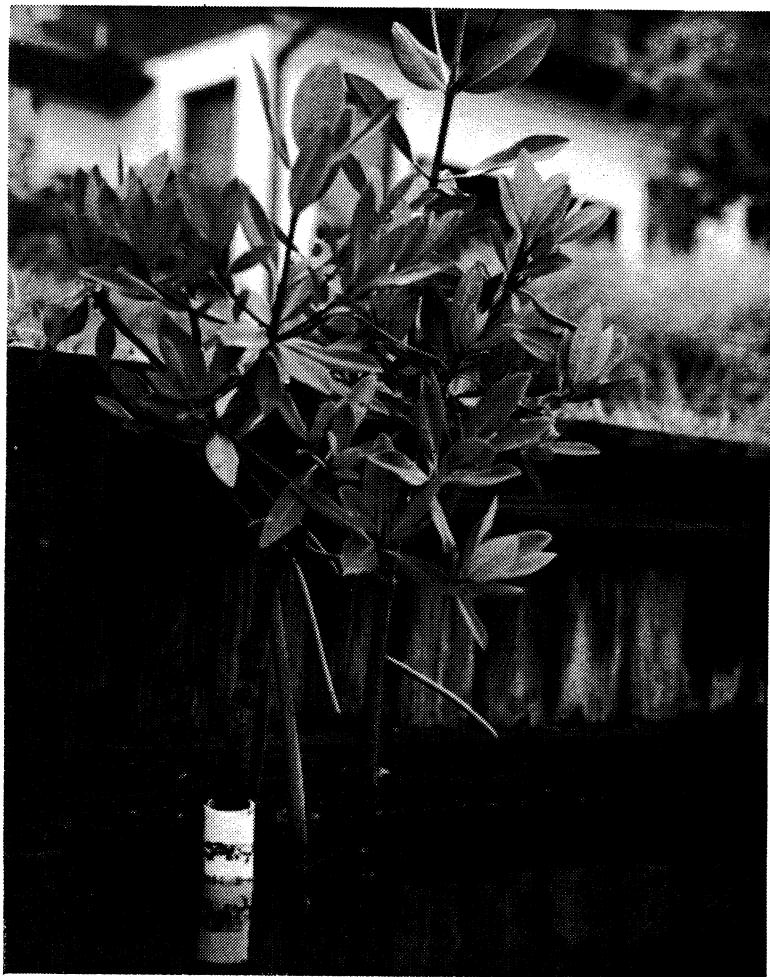
Figure 2. Planting along sea walls.

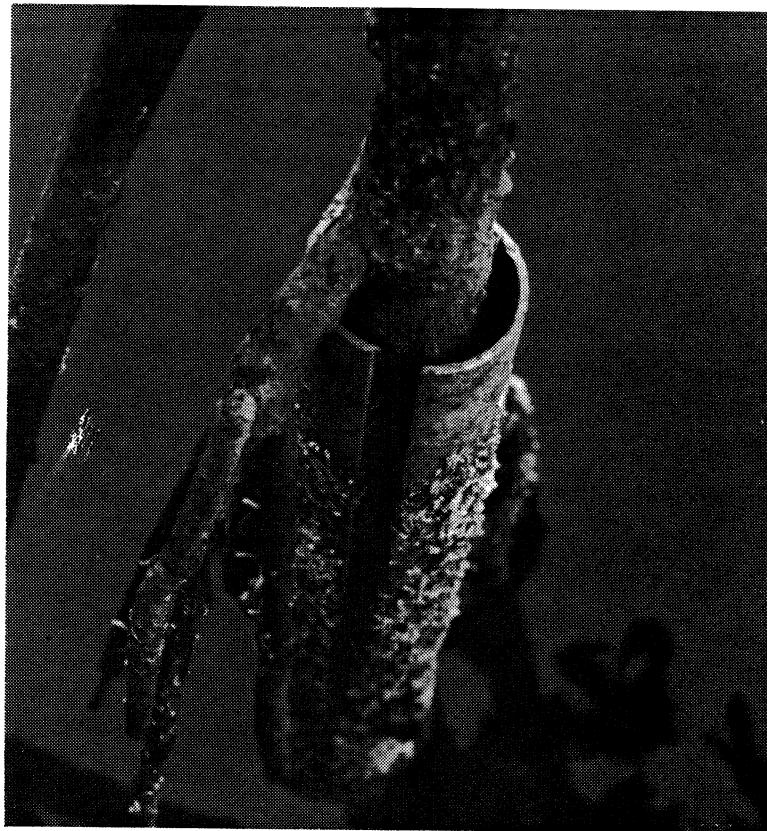
Figure 5. Mangrove becoming independent from encasement.

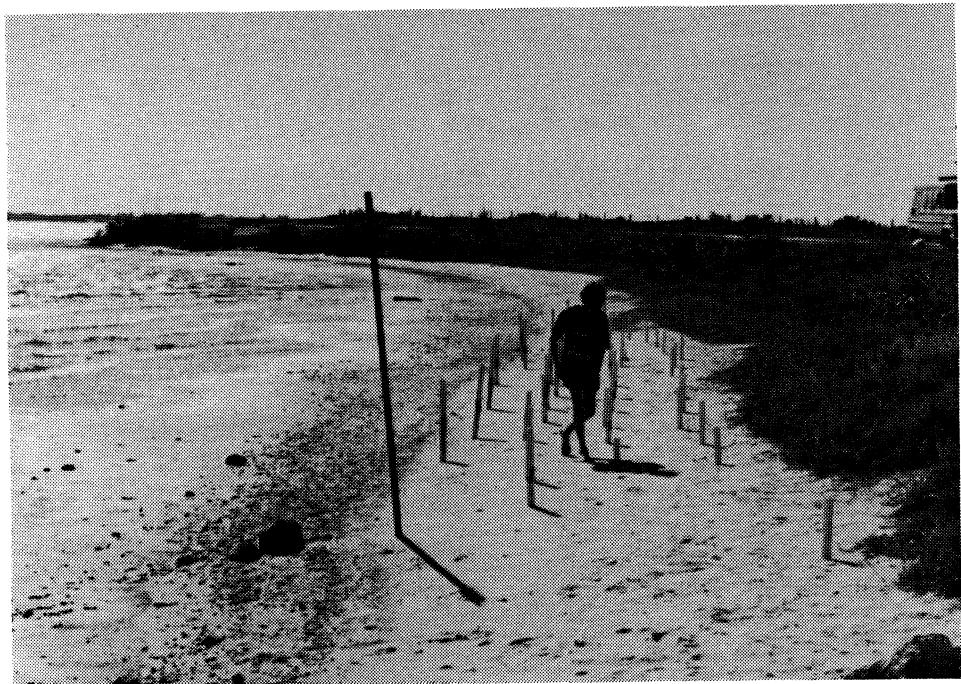
Figure 8. Encased plantings at low tide.
