Wisconsin Groundwater Management Practice Monitoring Project No. 36

Downward Movement of Water Below
Barnyard Grass Filter Strips -
Case Studies

Agreement Number: NRH 95405
Date: November 15, 1988

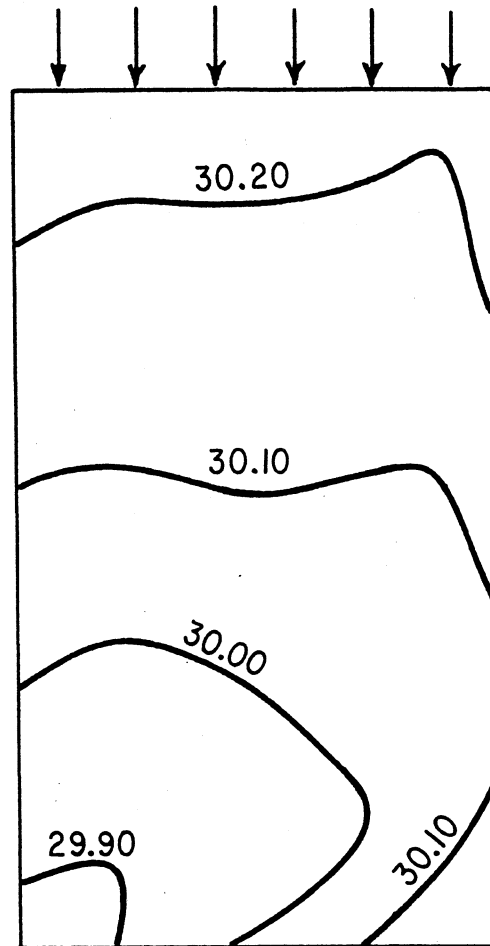
Farm Number 1

5m
CI = 0.10 m

Spreader: Gravel el = 30.26m
