The Study of Mechanical Properties of Welded and Base Material after Exposure to Supercritical CO<sub>2</sub>

A dissertation submitted in partial fulfillment of  
the requirements for the degree of

Doctor of Philosophy  
(Nuclear Engineering and Engineering Physics)

UNIVERSITY OF WISCONSIN-MADISON

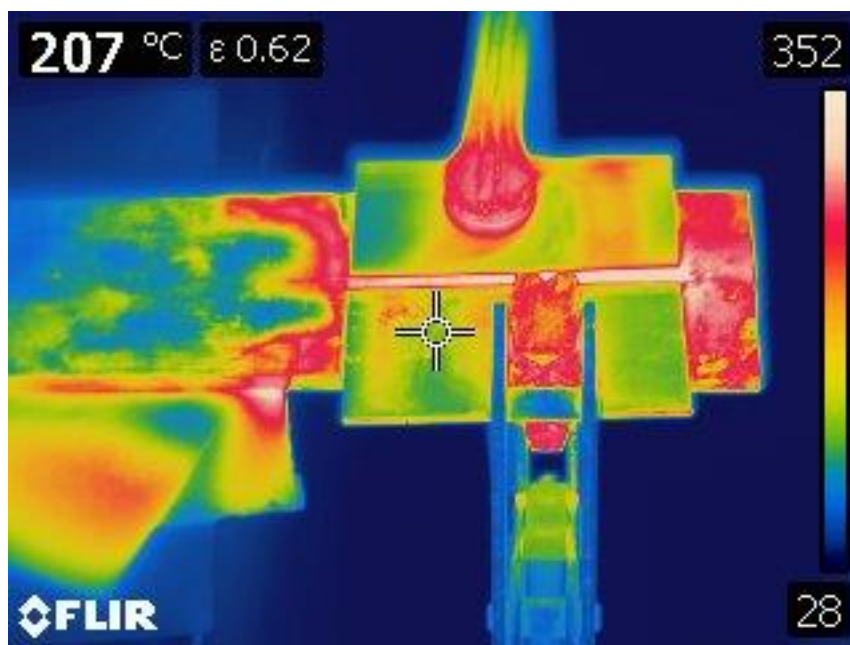
The welding of P92 is somewhat difficult, because the martensitic microstructure must be maintained as well as the hardening phases regrown. First, the base material must be pre-heated into the martensitic range (200-350°C) before beginning the welding process [72]. A thermal imaging camera was used to ensure the temperature was in this range prior to welding, and an image is shown in Figure 24. Second, a slightly dissimilar filler rod is used (9CrWV-TIG, see Table 19) with a composition designed for maximum fracture toughness after welding (including a higher Ni content). Following the completion of the weld, the weldment must be cooled to below the martensitic finish temperature, 120-150°C, in order to ensure a full martensite structure. A PWHT of 760°C for a minimum of 2 hours is then performed to regrow the hardening precipitates ( $M_{23}C_6$  carbides and MX carbo-nitrides) for correct hardness and strength. The longer the PWHT, the higher the resulting fracture toughness. In the case of dissimilar welds, this procedure was replicated to similarly regrow the hardening precipitates in the P92, anticipated to be the weaker of the materials in any heat-treated condition.

Figure 24 - Thermal image of P92 plates prior to similar welding ( $>200^{\circ}\text{C}$ ), clamped on a copper backing plate

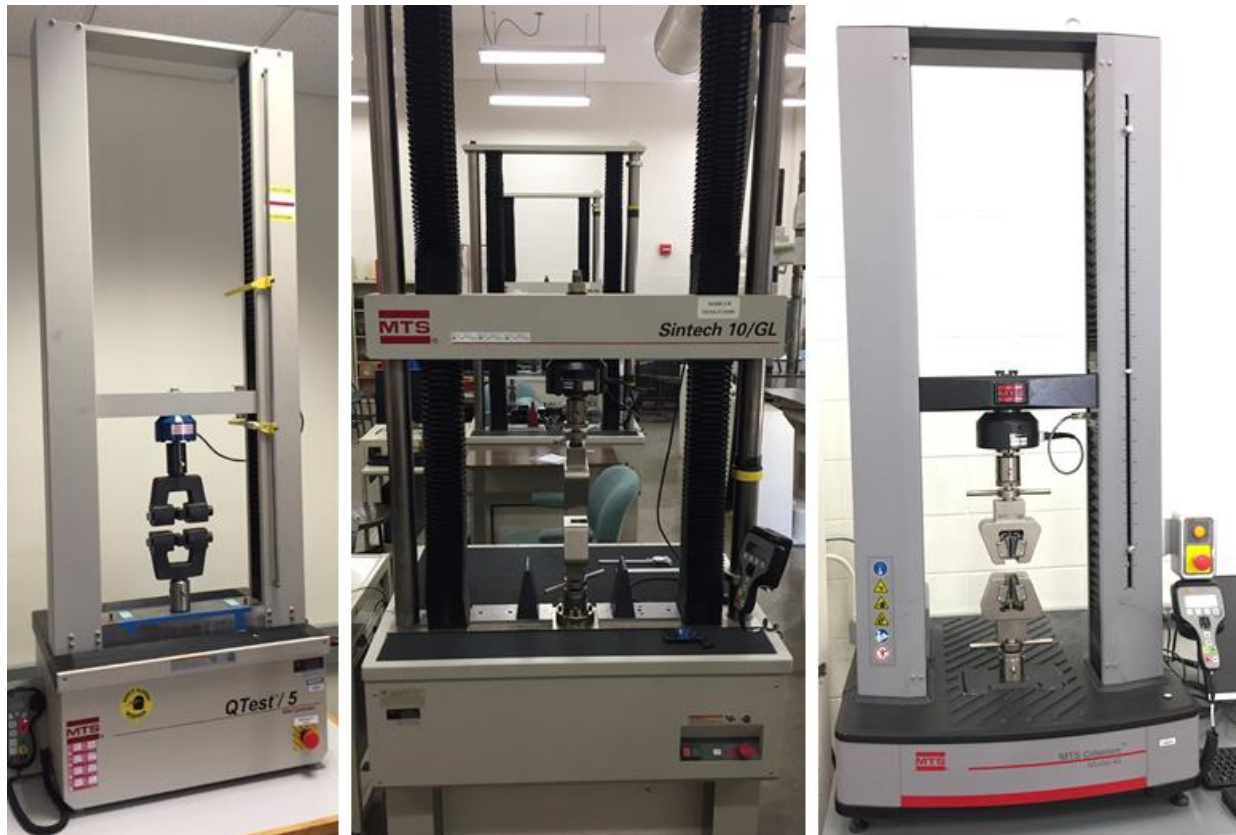
An MTS QTest 5 with a 5kN load cell, see Figure 27, was used for the of the 740H and 282 base material as well as their similar welds (that were removed from plates). An MTS Sintech 10/GL with a 50kN load cell was used for 316 and its similar weld (as well as copper coated) exposed to 750°C. The rest of the analyses will be performed with an MTS Criterion 43 with a 5kN load cell. While it is not necessary, one goal of testing was to attempt to have yield and fracture occur within the range of 10-90% of the maximum capacity of the load cell. As most ruptures were designed to occur from 1-3.5kN this was only possible with the 5kN load cell, so that size cell was used when possible.

Figure 27 – MTS QTest/5 tensile machine

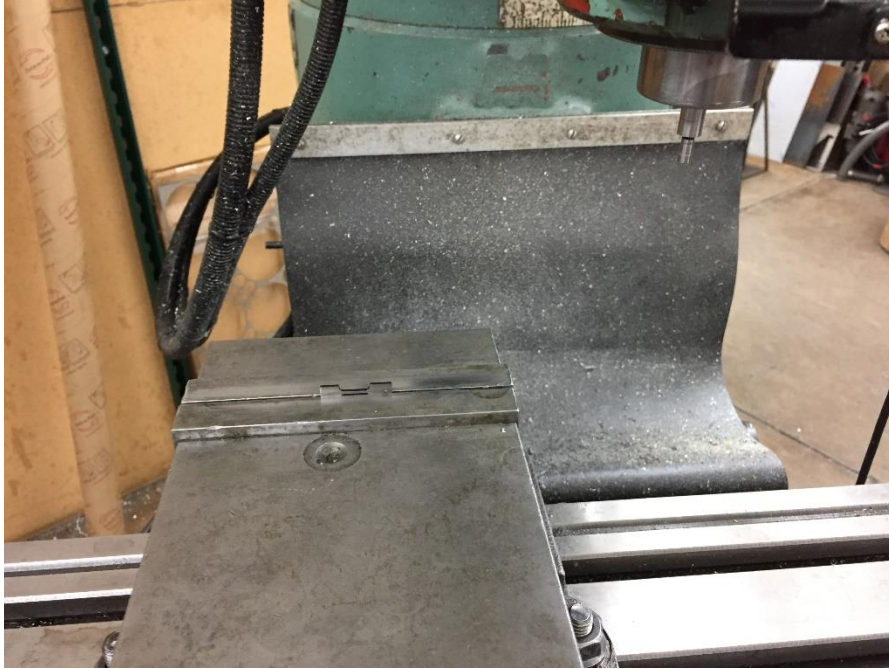
Samples were prepped for the video extensometer by covering the appropriate sample edge with black marker. Overall strain – applicable to the strain at rupture was measured through analysis of markings on the sample tabs. Samples were levelled in a vice on a mill and marked at precise points along the tab by creating a horizontal line using a very small centering bit (three points on the short tab, four points on the long tab), see Figure 28. These seven markings were then used to measure all 12 distances between the markings on opposite tabs. Each of these distances were then compared with the initial measurement and then averaged into a measurement of the total displacement, and therefore elongation, of the sample during the test. While this technique was incredibly accurate, it inherently incorporated a small amount of error due to strain in the sample outside of the gauge – in the fillet between the gauge and the tabs. This error was very small at large strains, but very large at small strains (often incorrect by a factor of two for yield strain). An additional technique was, therefore, necessary in order to get an accurate measure of the Young's modulus and yield strength.

Figure 28 – Tensile sample clamped in the mill, with the edge-finder in the mill chuck

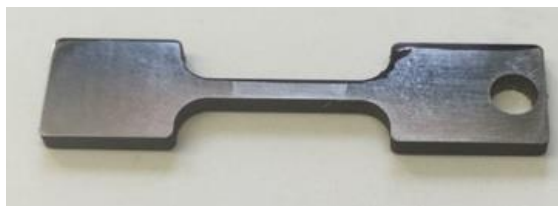
Samples of both base material and weld were tensile tested in the unexposed condition. Samples were polished to the same standard as corrosion samples (800-grit) so no additional error would be incorporated from differences in initial surface roughness. In order to identify the location of failure of the welded samples, they were again etched with glyceresia until the fusion zone was visibly identifiable, then images were taken of every sample. An example of this is shown in Figure 30.

Figure 30 – 740H welded tensile sample etched with glyceric acid showing the weld in the center of the gauge

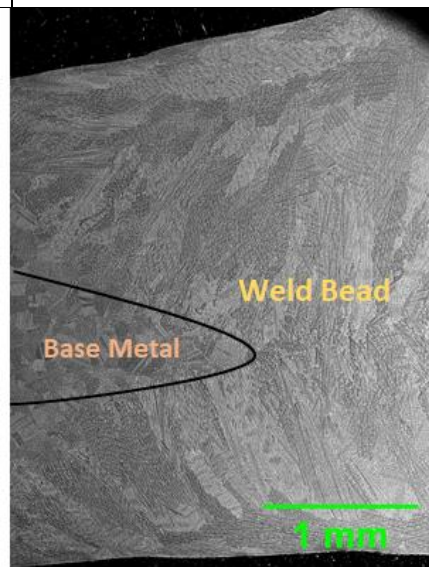
The above results were relayed to Special Metals, who had previously not had the experience of welding thin plates such as this – their work had focused on the welding of pipes, and mostly thick-walled pipes due to the inherent difficulty of such a weld. They changed their procedure to ensure a fully penetrating weld between the two plates. The original and new welding procedures are given in Table 3, with the final procedure given in the appendix (Table 20). The new welding procedure introduced a root gap of 3/32” between the plates as well as increased the heat input by about 40%. This resulted in a fully penetrating weld, with confirmation in the form of SEM of etched 740H shown in Figure 32.

Figure 32 – SEM image of etched 740H weld interface after new weld procedure
