An evaluation of beach nourishment on the Lake Superior shore. No. 157 1985

AN EVALUATION OF BEACH NOURISHMENT ON THE LAKE SUPERIOR SHORE

**Technical Bulletin No. 157
Department of Natural Resources
Madison, Wisconsin**

By John W. Mason, Melvin H. Albers,
and Edmund M. Brick

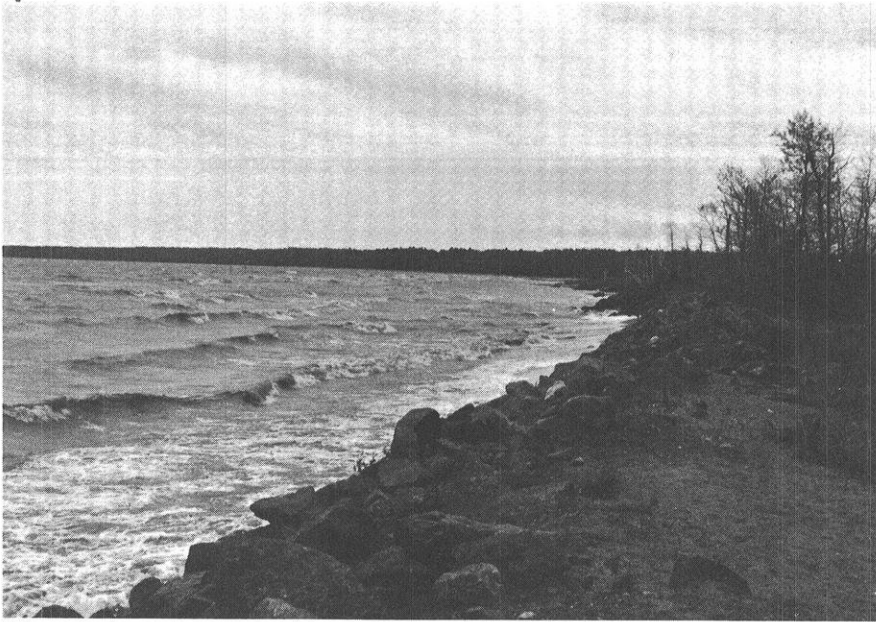
View of riprap along shoreline. Groins can be seen in distance.

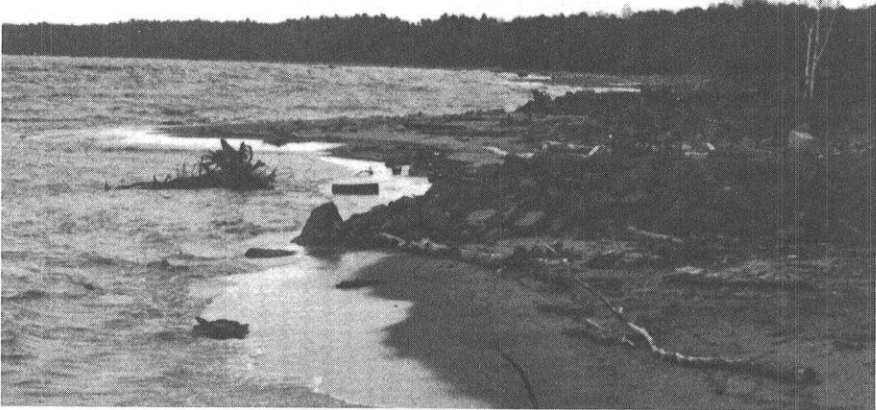
Typical groin. Note placement perpendicular to shoreline.

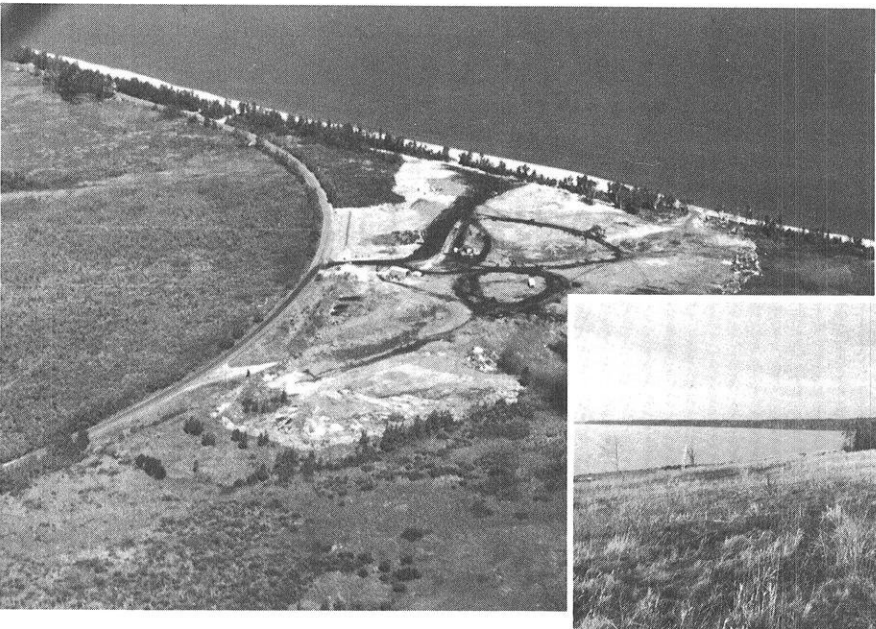
Aerial view of the landfill on Wisconsin Point during its operation by the City of Superior in the 1960s. Inset: A view of the shoreline from the restored landfill area (note lack of trees).

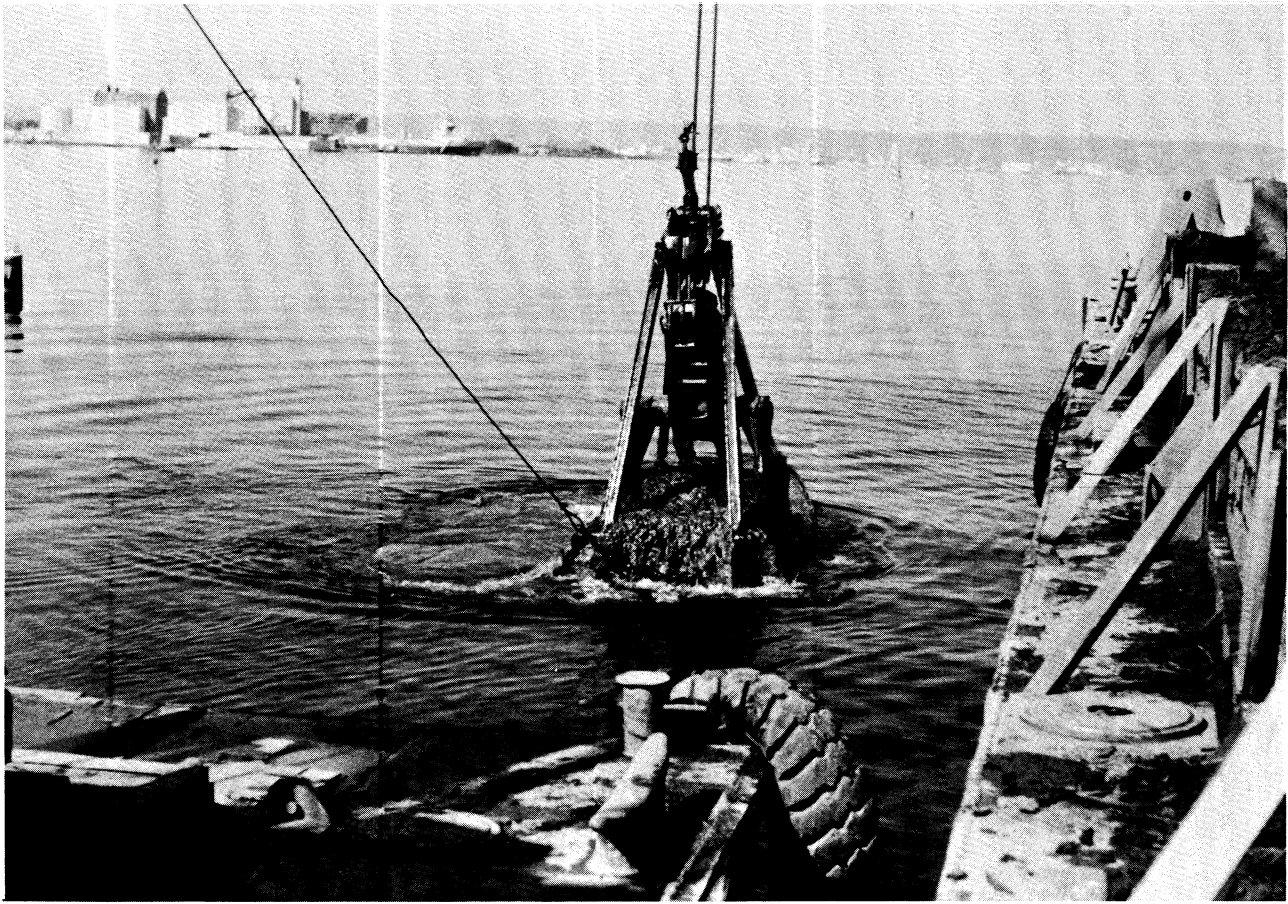
Clam shell dredge removing Nemadji sediments at dredging sites ...

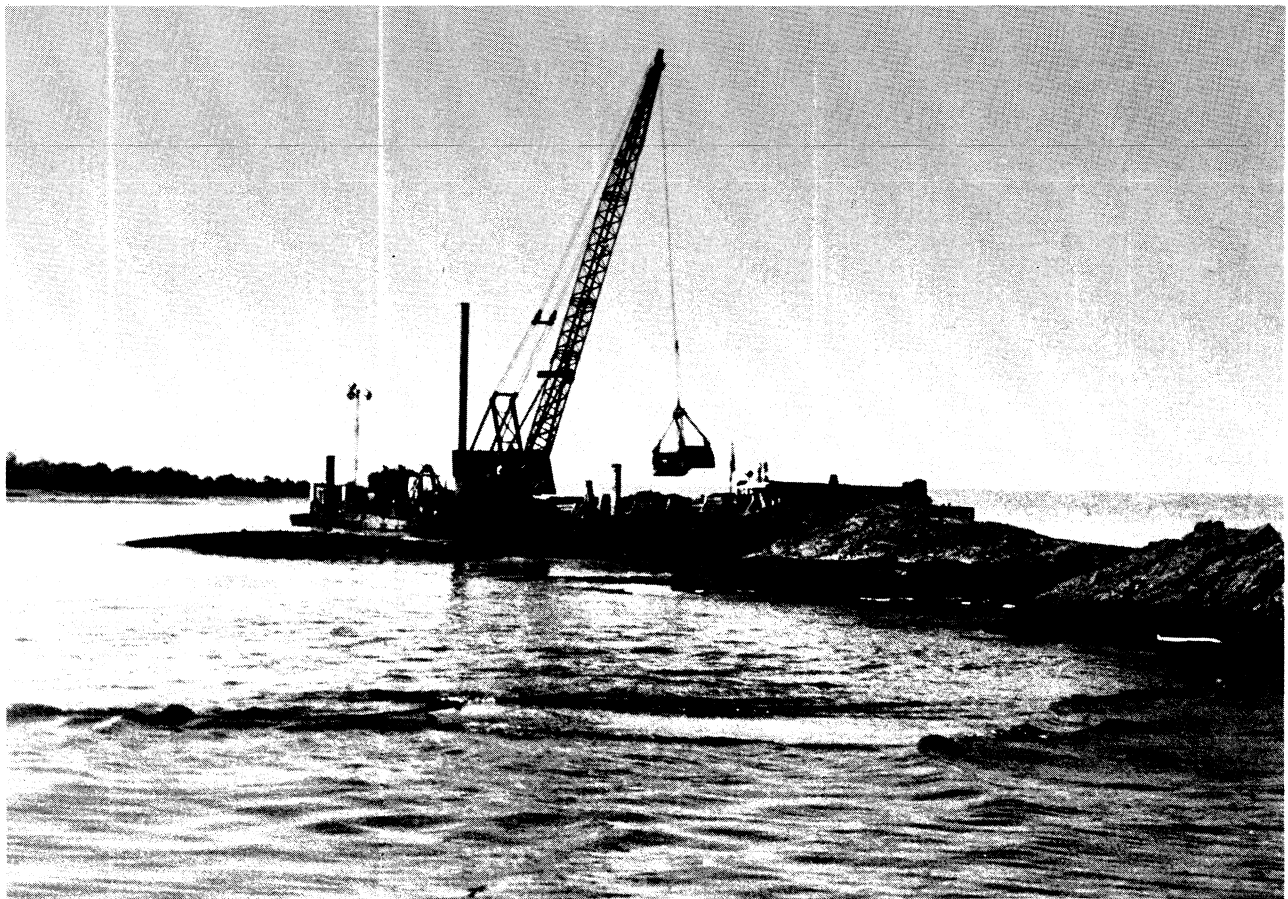
... and unloading them at the nourishment site off Wisconsin Point.

The dredging and placement of materials at Wisconsin Point took place between 14 September and 1 November 1983. Contract letting complications delayed the nourishment operation to the fall storm season. The COE contractor, Durocher Dredge and Dock Company, used a clam shell dredge to remove material from Superior harbor near the mouth of the Nemadji River. The material was loaded onto barges and towed to the nourishment site (Fig. 1). A smaller clam shell crane on an anchored barge was used to place the dredged material in the lake. Original plans called for unloading 50-60,000 yd³ of dredged material along a 2,600-ft reach in the near shore area. However, the contract let by the COE limited disposal to a 1,300-ft stretch immediately lakeward of the groin field. The material was unloaded 400-450 ft offshore in 5-6 ft of water.

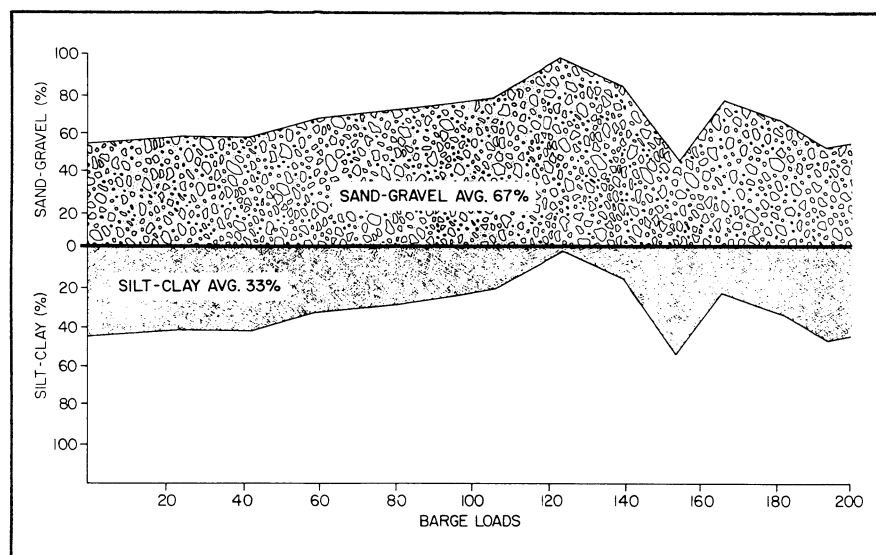
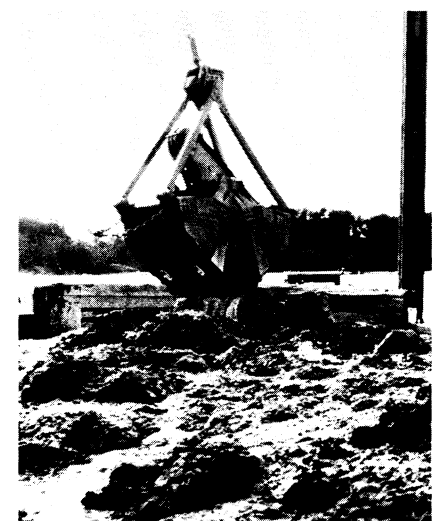
Some of the dredged material was too fine-grained for a beach nourishment project. This barge load was mostly clay and silt.

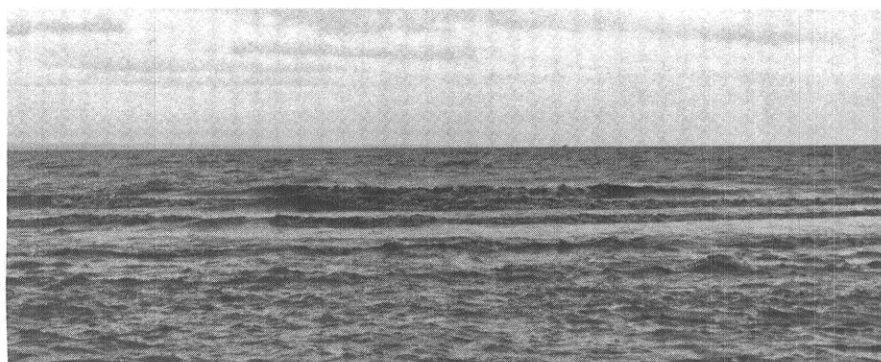
The dredged material placed in front of the old landfill caused waves to break further offshore, expending erosion energy that otherwise would have been brought to bear on the shoreline.

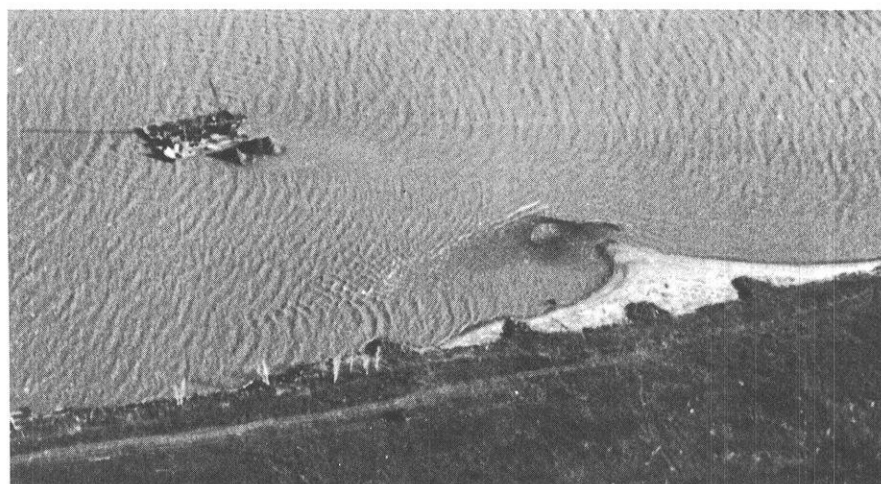
Littoral drift accumulated in front of the groins following the deposition of sediments.

temporary groin effect resulted from this temporary offshore breakwater and accumulated littoral drift. This temporary effect caused new beach buildup updrift of the nourishment area as deposition progressed. At the completion of the project an estimated 33,000-40,000 yd³ of the dredged material remained in place at the nourish-

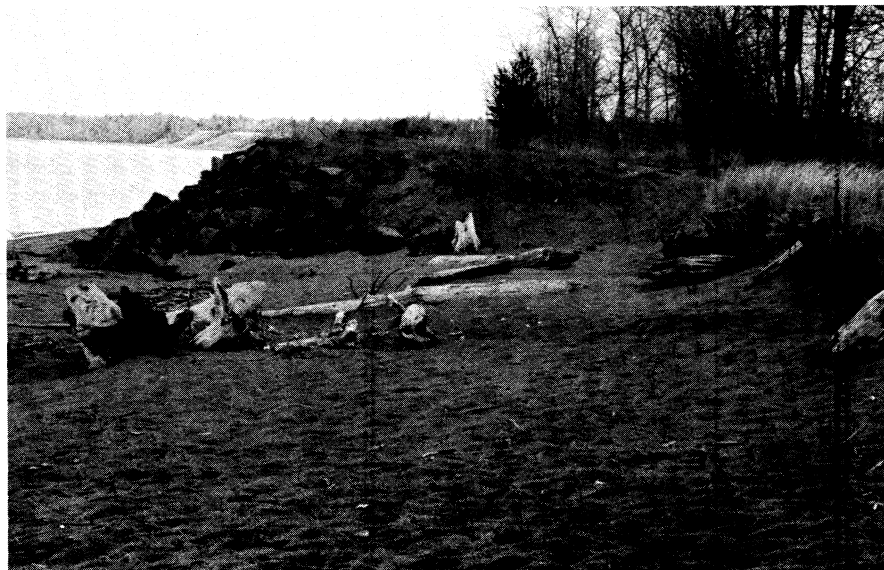
Beach berm erosion at the downdrift end of the riprap (May 1985).

Severe bank erosion took place west of the riprap shoreline at Pts. 9 and 10 (Fig. 8) after completion of the project. The November storm and the dredged material breakwater appeared to have caused the erosion to occur. A survey in May 1984 showed an estimated loss of about 1,400 yds³ of bank material due to the erosion the previous fall. At Pt. 8, approximately 1,000 ft west of the end of the riprap, little bank erosion occurred.

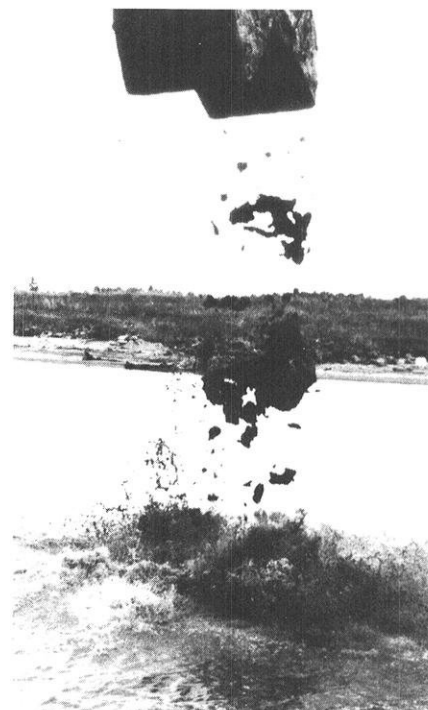
Unloading operations created some temporary turbidity.
