**THE RESTORATION AND CREATION
OF WETLANDS**

PROCEEDINGS OF
THE SIXTH ANNUAL CONFERENCE
ON WETLANDS
RESTORATION AND CREATION

May 19, 1979
Hillsborough Community College
Tampa, Florida

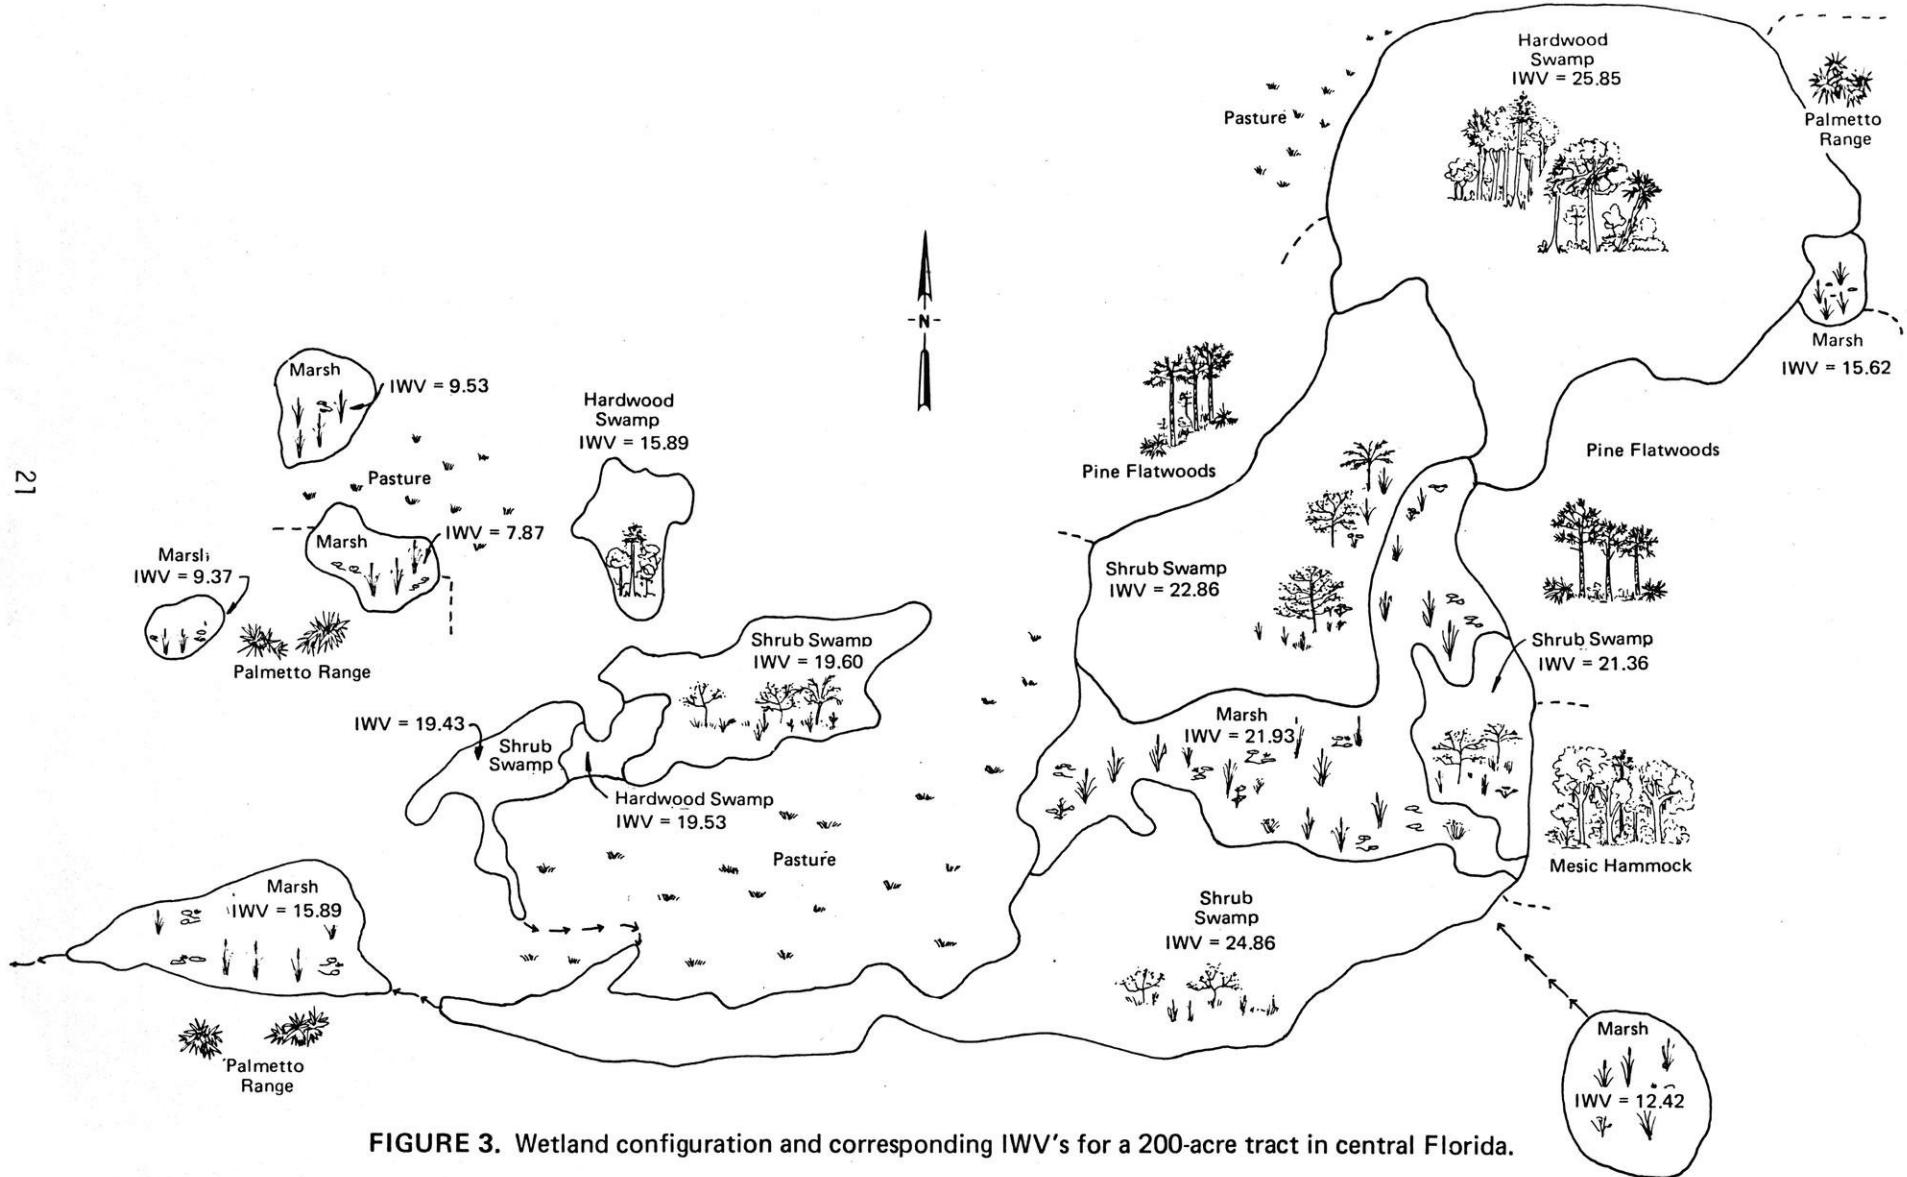
FIGURE 3. Wetland configuration and corresponding IWV's for a 200-acre tract in central Florida.

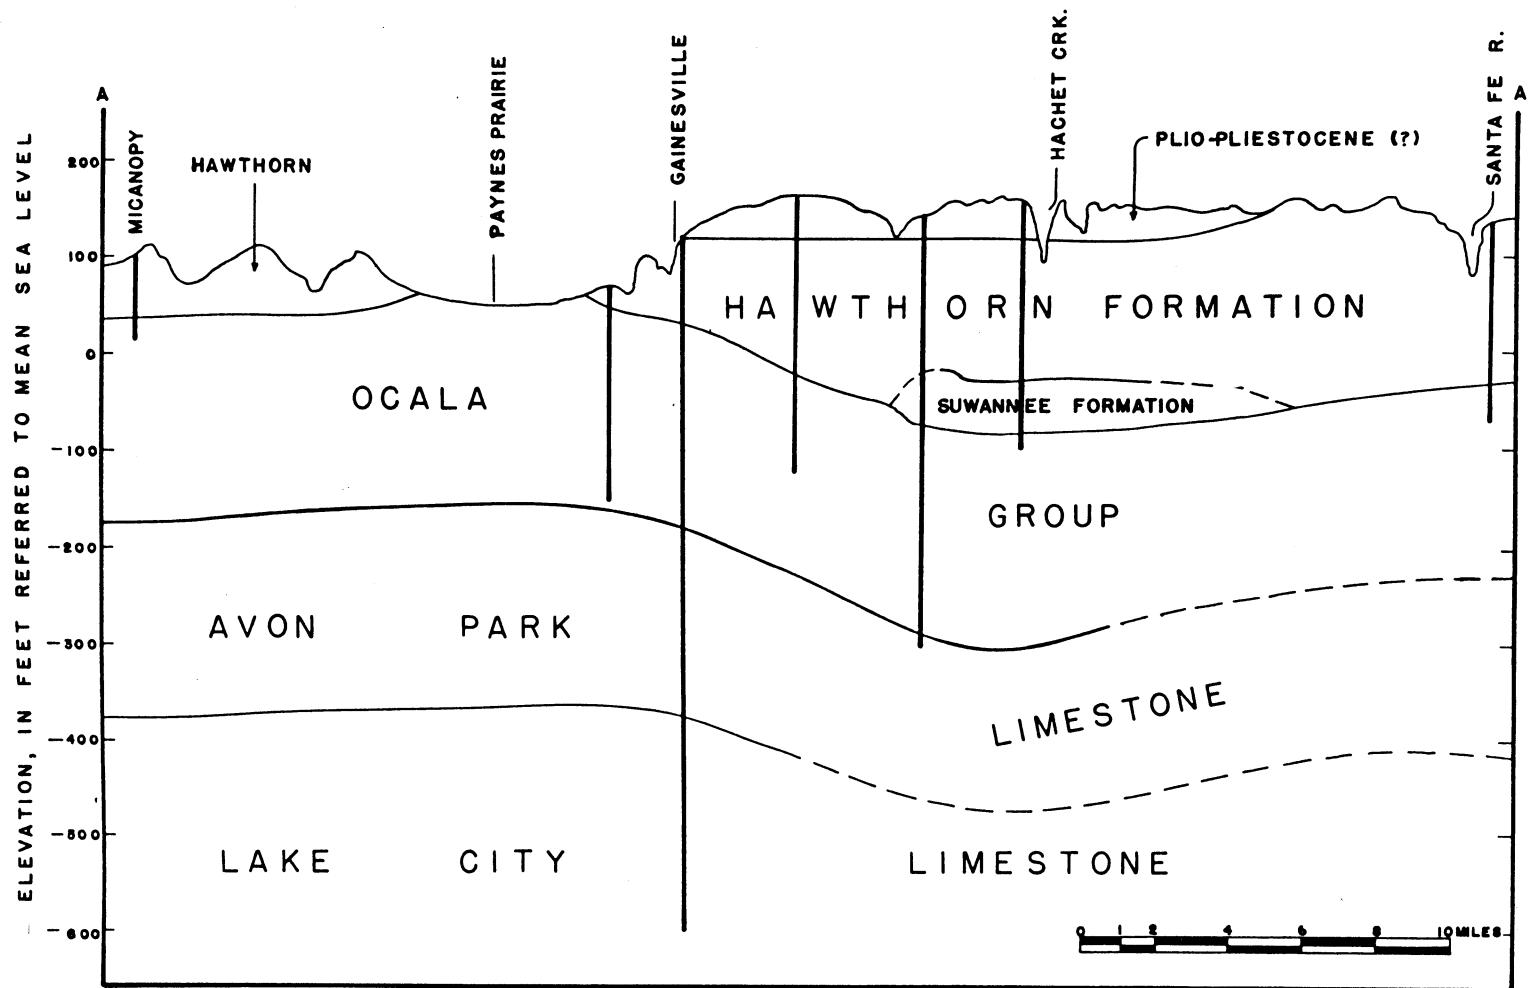
Figure 3. Geologic cross section through Alachua County, Florida showing generalized geology beneath the study site (in Cutright, 1974; modified from Black, Crow, and Eidsness, 1973).

The Floridan Aquifer, the most productive aquifer in Alachua County, consists of interbedded, soft, porous limestone and hard, dense limestone and dolomite (Clark et al., 1964). A potentiometric map with surface geology is noted in Figure 2. The upper 183 meters (600 feet) of the aquifer is noted in cross section A - A' (Figure 3), and includes the Lake City Limestone, the Avon Park Limestone, the Ocala Group, and possibly a small lens of the Suwannee Formation (Limestone). Secondary artesian aquifers in the overlying Hawthorne Formation consist of sands, sandy clays, and scattered lenses of limestone and dolomite several centimeters to as much as 1.83 meters (6 feet) in thickness. Most of the unit, however, is a clay which serves as an aquiclude. Overlying the Hawthorne Formation are clays and marls of Upper Miocene and Pliocene and sands and clays of Plio-Pleistocene and Recent which contain shallow water table aquifers. The upper 30.5 meters (100 feet) of Figure 3 is discussed in more detail under Results.

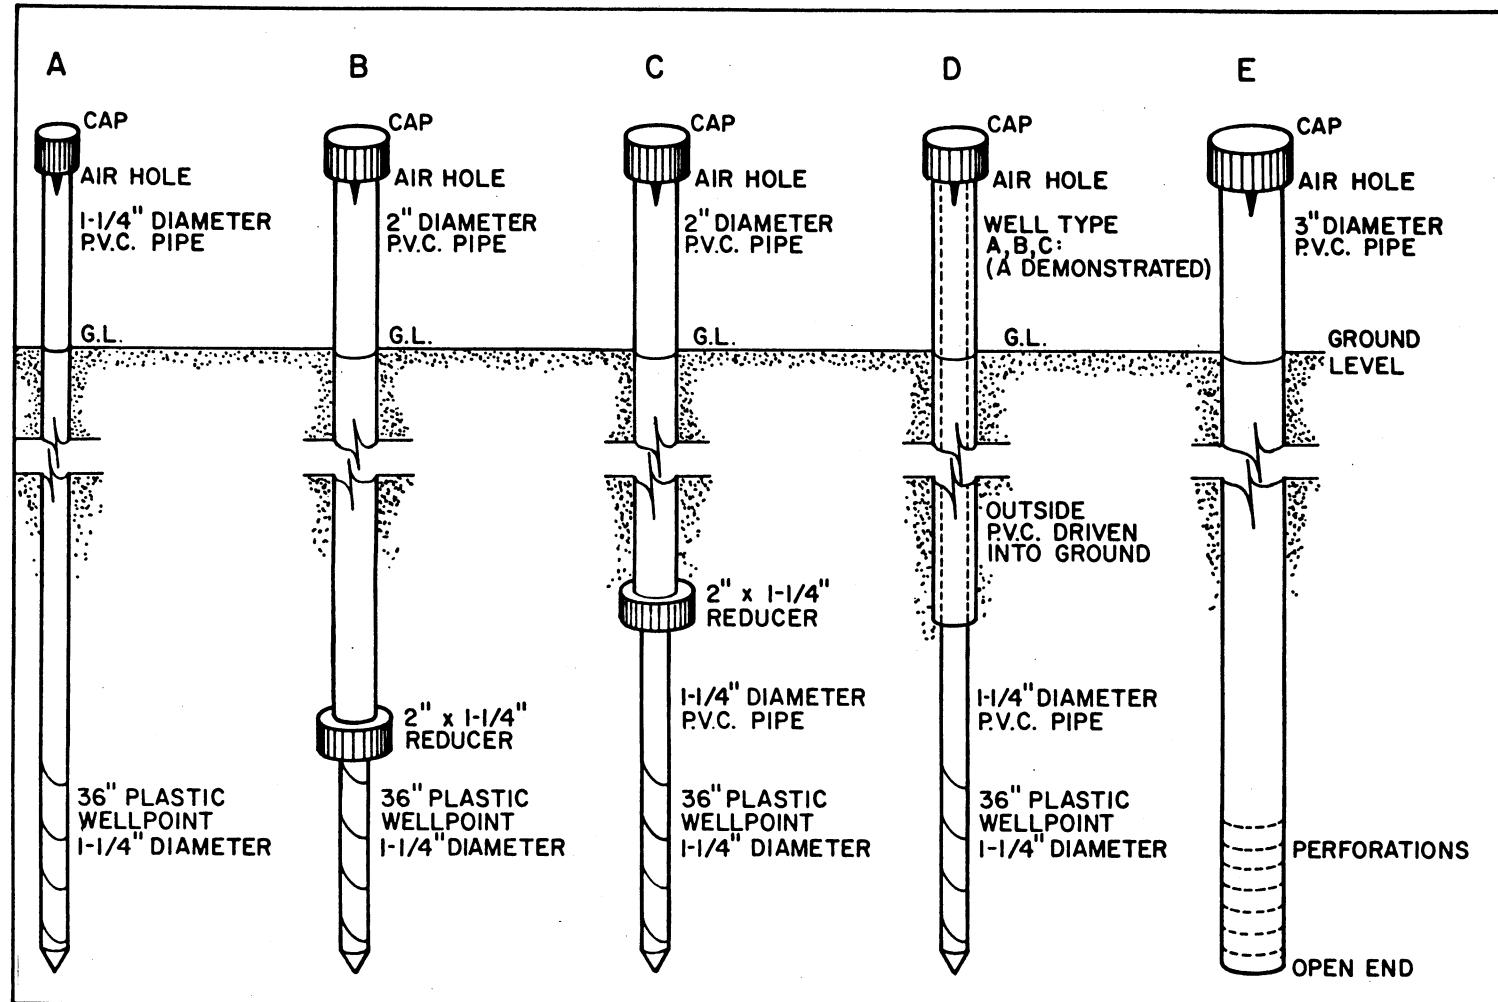
Figure 4. Details of well construction and screens (in Gillespie, 1976).

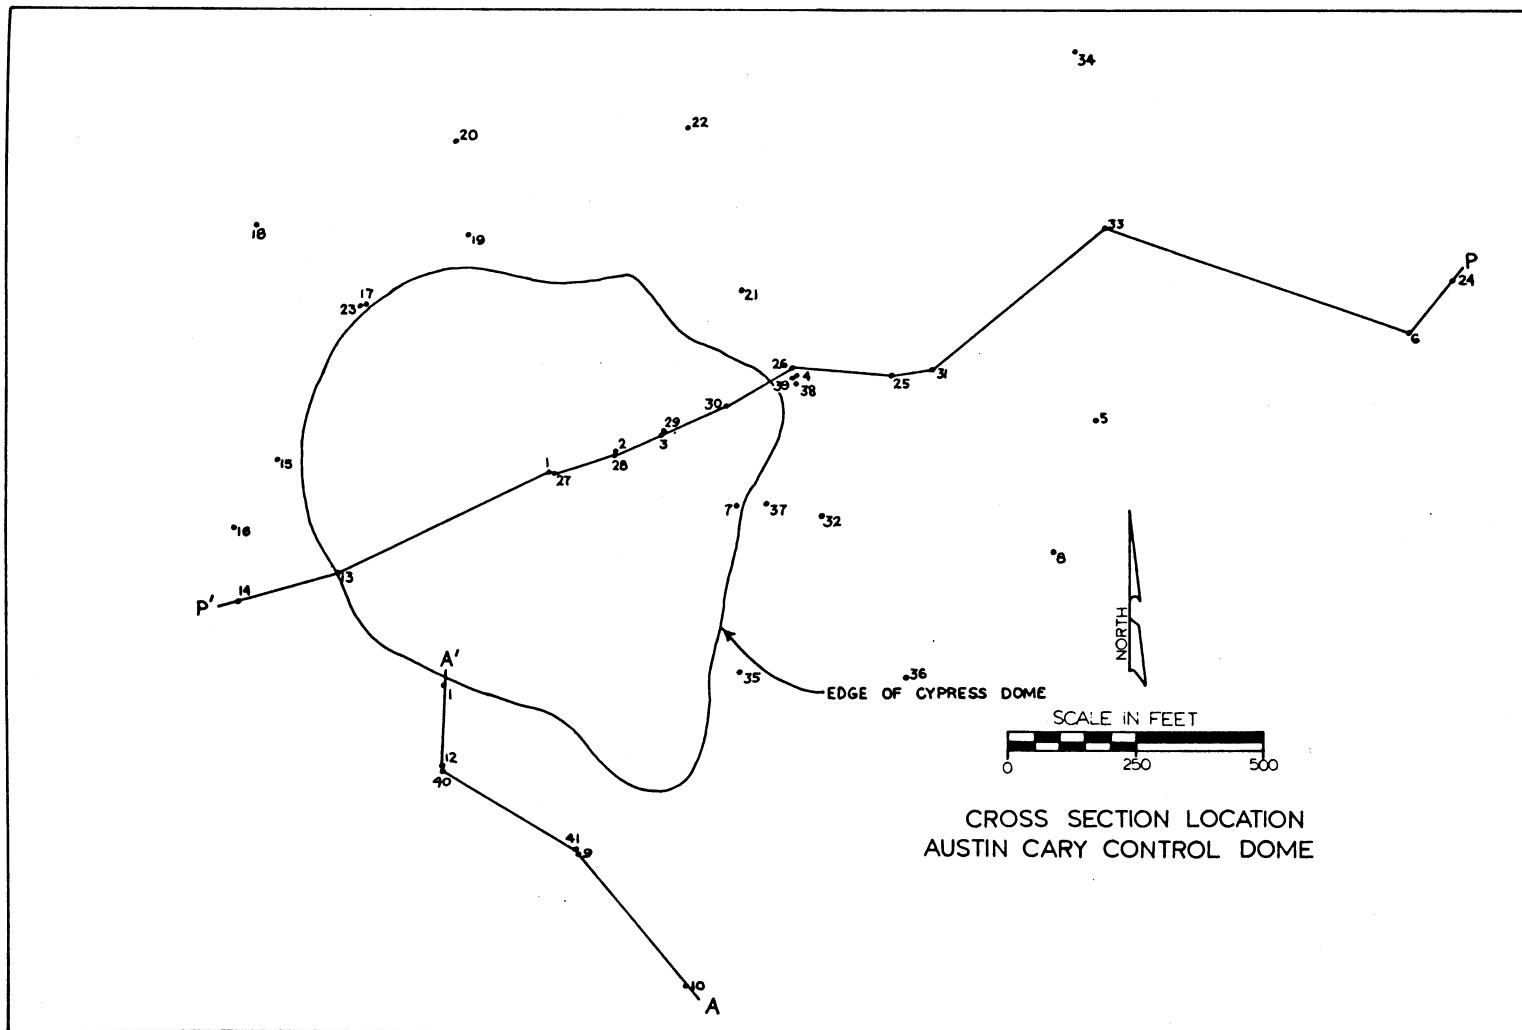
Figure 5. Map of Austin Cary Control Dome (ACCD) showing location of cross section P' - P (Figure 6) and cross section A - A' (Figure 14).

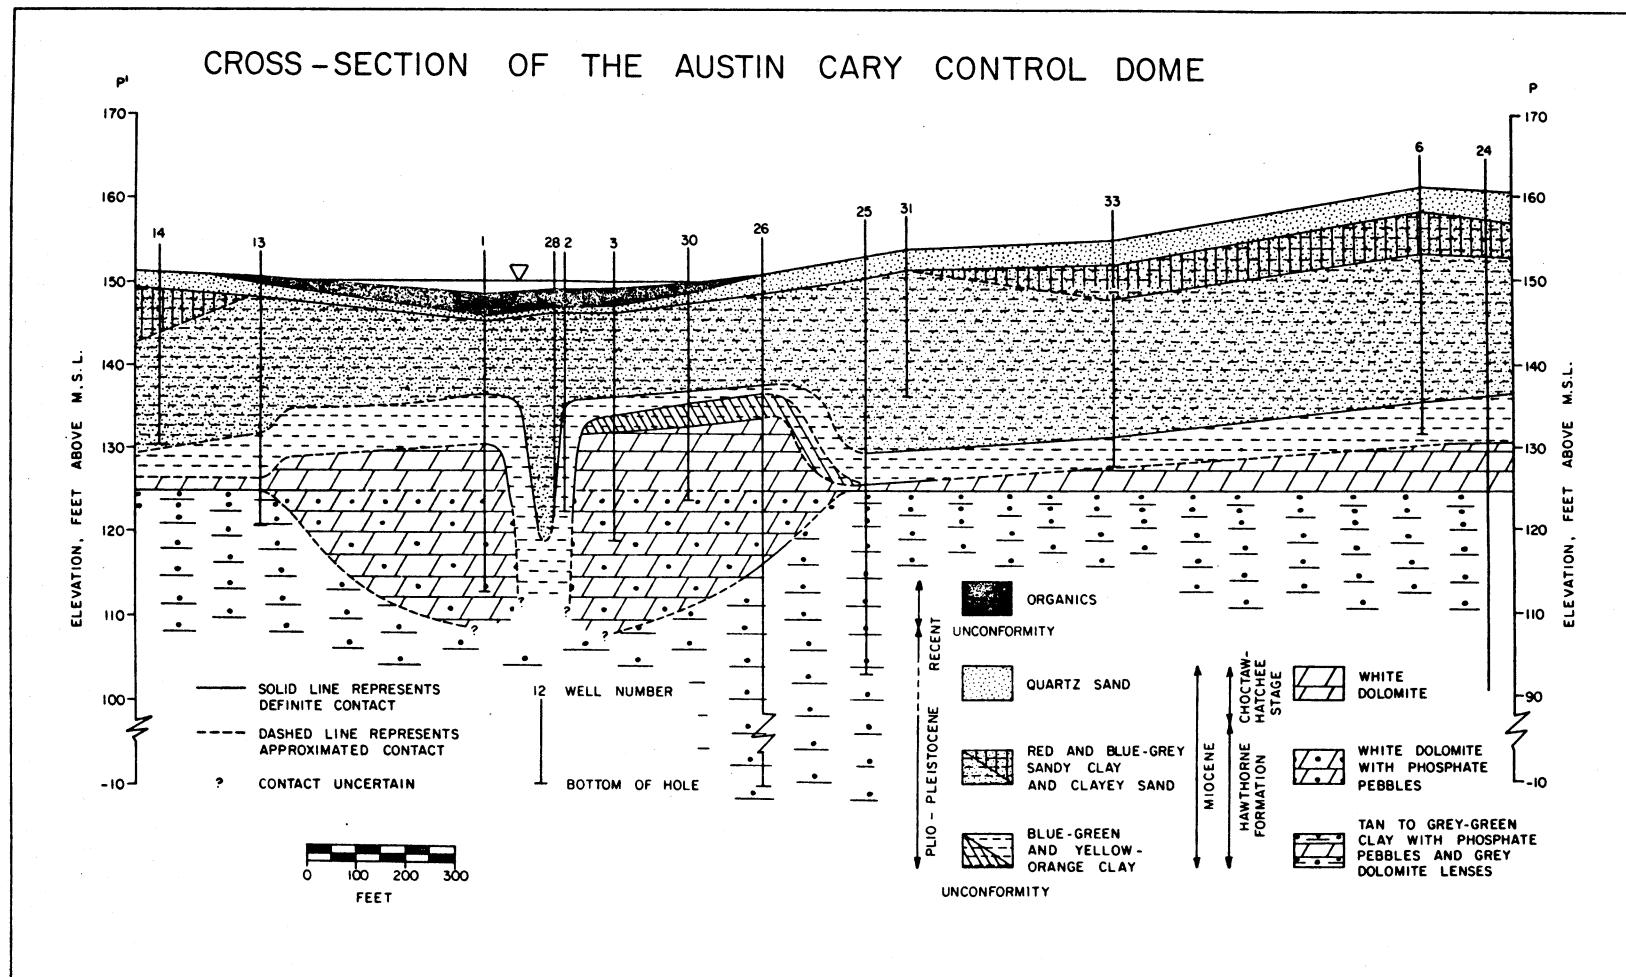
Figure 6. Cross section of the Austin Cary Control Dome (in Gillespie, 1976).

The observation (see Figures 5 and 6) that the thicker quartz sand deposits occur in the pine forest away from the cypress dome (ACCD) was noted by Gillespie (1976). A possible explanation may be that as rain water percolates downward to the water table, 1.53 to 4.58 meters (5 to 15 feet) below the surface in the pine forest, leaching and oxidation of the blue-gray sandy clays and clayey sands results, leaving the sand and removing the clay. Sampling has shown that a possible leach zone does exist immediately below the quartz sands. In this zone, the blue-gray sandy clays and clayey sands have been slightly oxidized to a tan clay and/or bright red sandy clays and clayey sands in heavily oxidized regions. No oxidation has been observed within the ACCD proper, where the water table is near the surface. The downward percolation of oxygenated water would be limited in the dome's stagnant surface waters, and the leaching of the blue-gray sandy clays and clayey sands to quartz sands would be reduced. This is apparently reversed (see Figures 7, 8, 9, and 10) in the HCS and the OIRS, where hardpans suggest an aerobic zone is under the anaerobic pressure filters allowing oxidation of iron and manganese from descending acid waters.

These are predominantly kaolin clays and quartz sand found throughout most of the study sites and Alachua County (Figures 6, 10, 12, 13, and 14). In surrounding pine forest and around many of the dome margins their thicknesses average 4.58 to 7.63 m (15 to 25 feet). Within many of the domes (Figures 6, 12, 13, and 14), these clays are thinner.

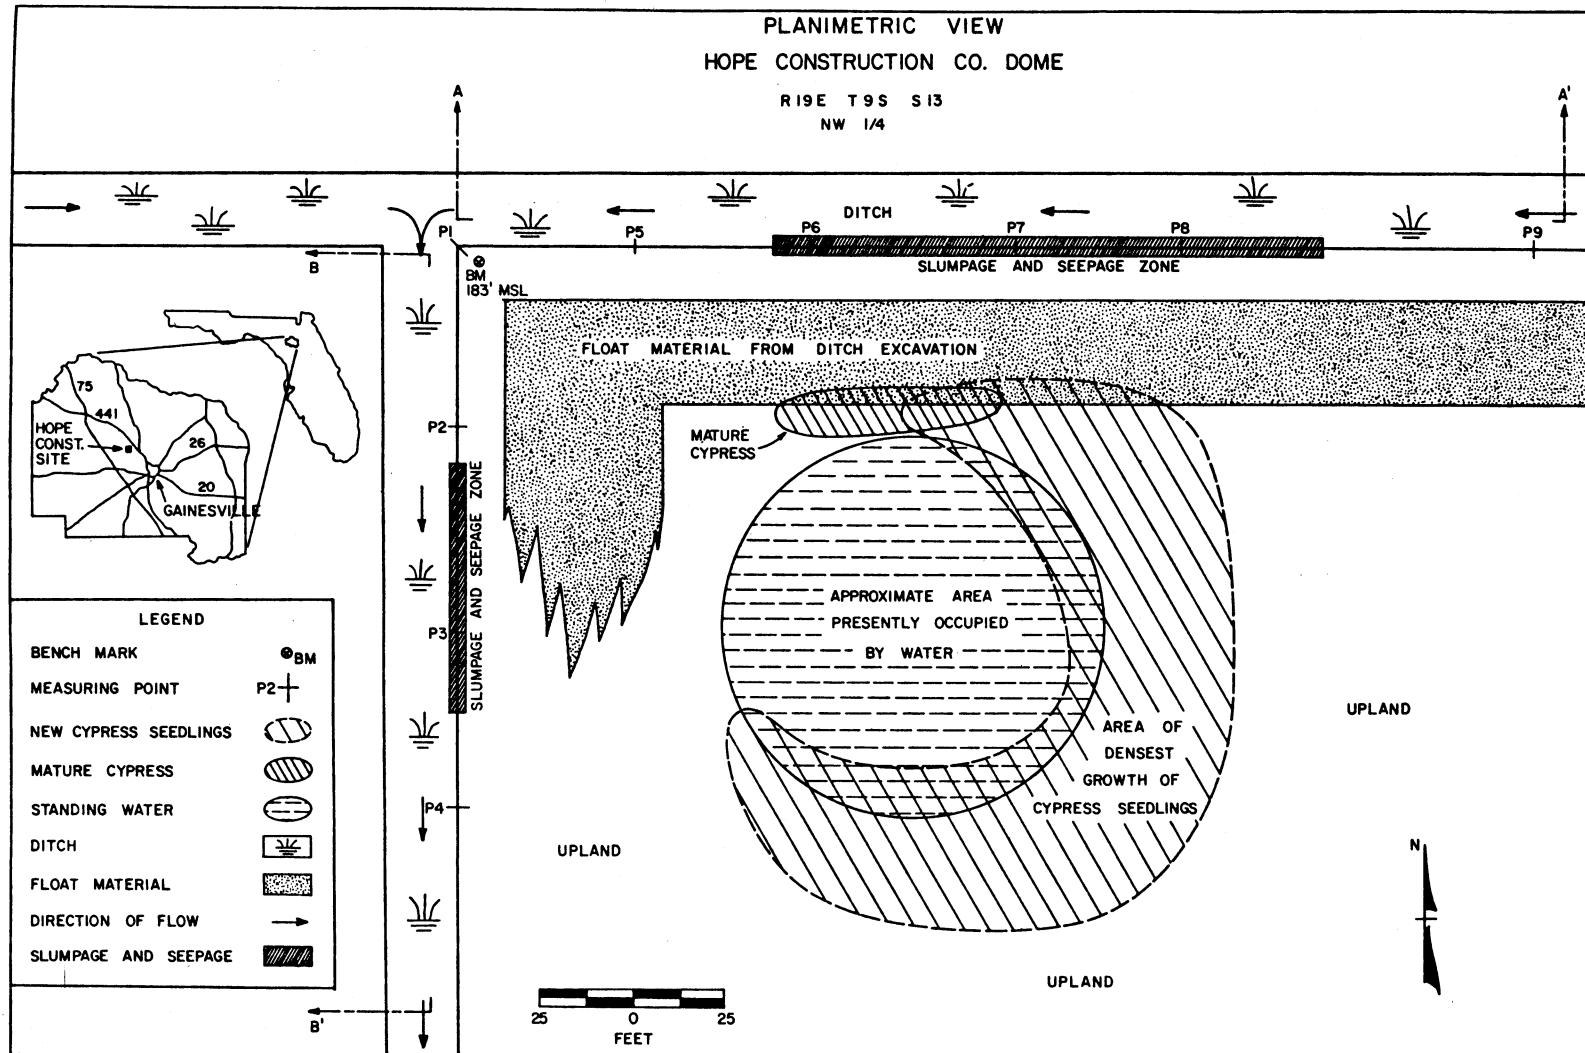
Figure 7. Planimetric view of Hope Construction Site (in Spangler et al., 1976).

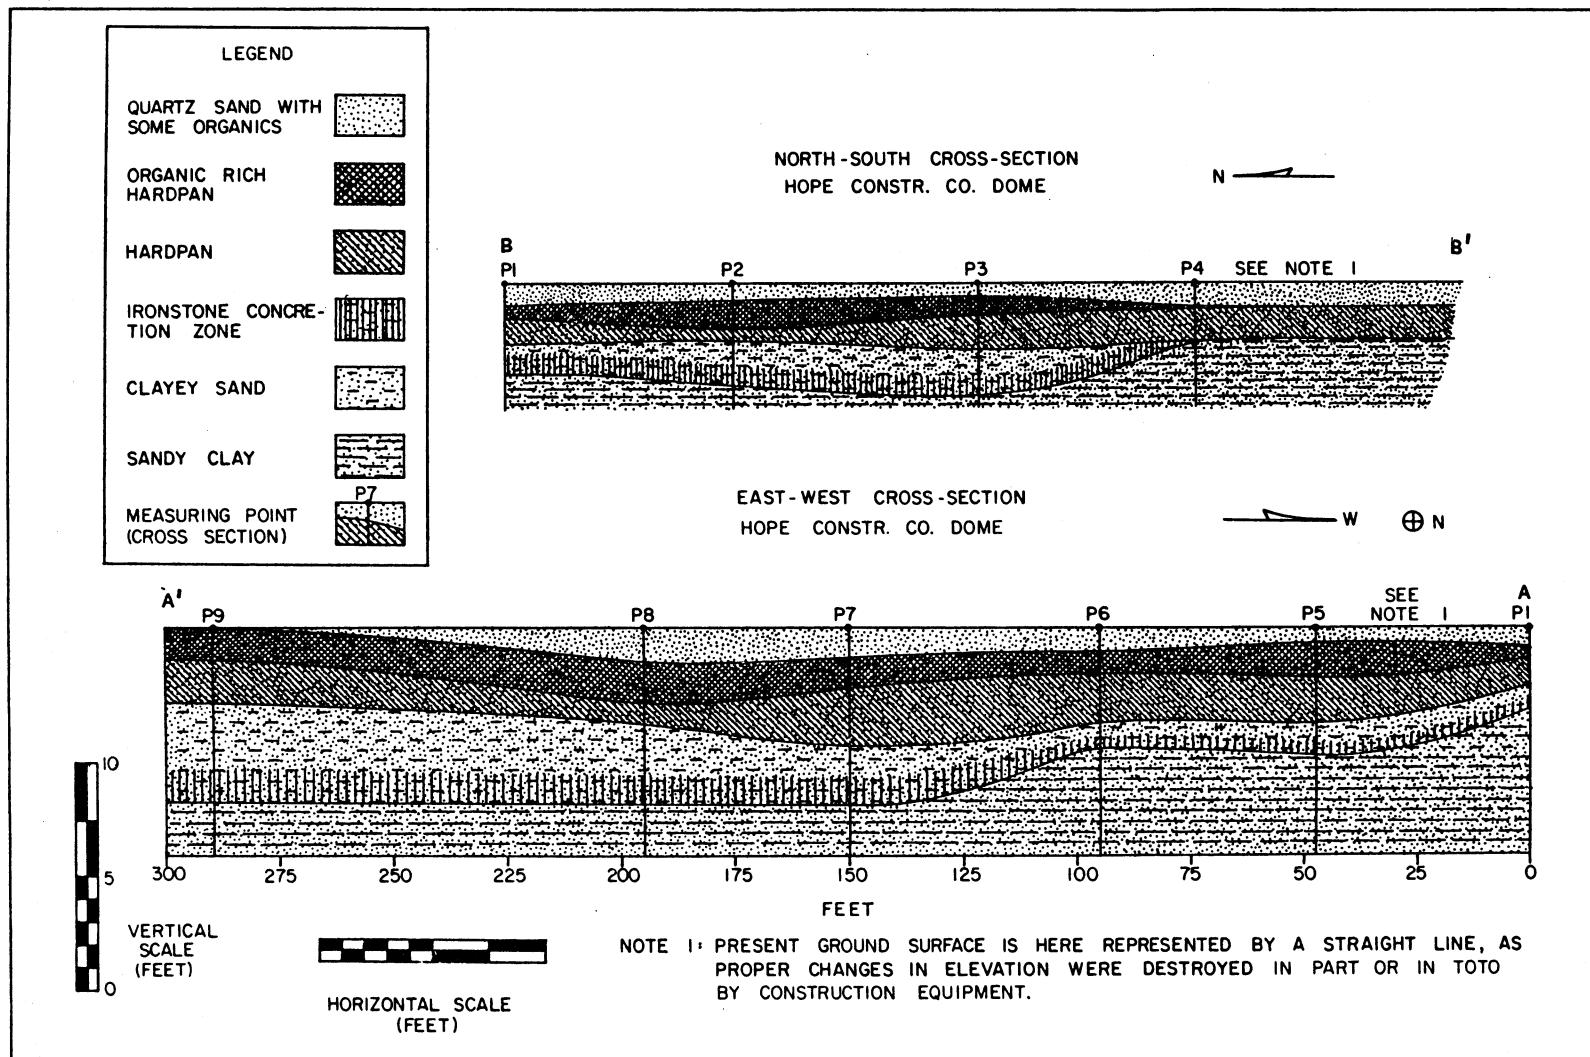
Figure 8. North-south cross section of Hope Construction site

The yellow-orange clays and blue-green clays (Figures 6, 12, 13, and 14), probably facies, lie unconformably above the white dolomite and below the blue-gray sandy clays and clayey sands (Figures 8 and 10) with a gradational contact. They are of identical montmorillonite composition, and frosted quartz grains are commonly associated with them. In addition, the blue-green clays often have red stringer.

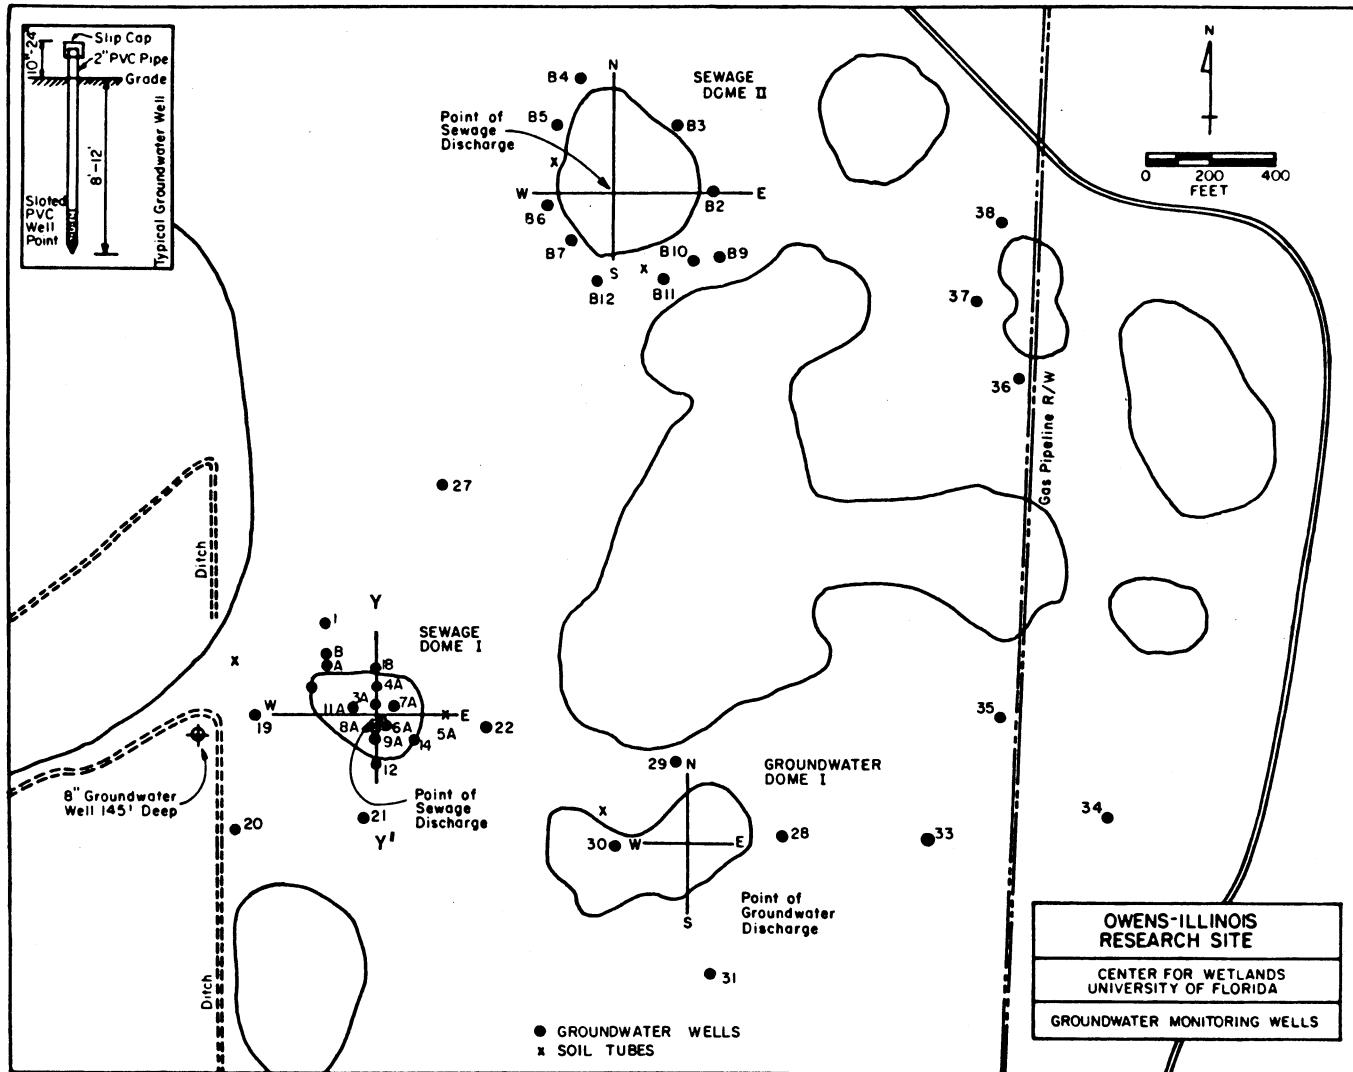
Figure 9. Plan view of Owens-Illinois Research Site showing location of groundwater monitoring wells.

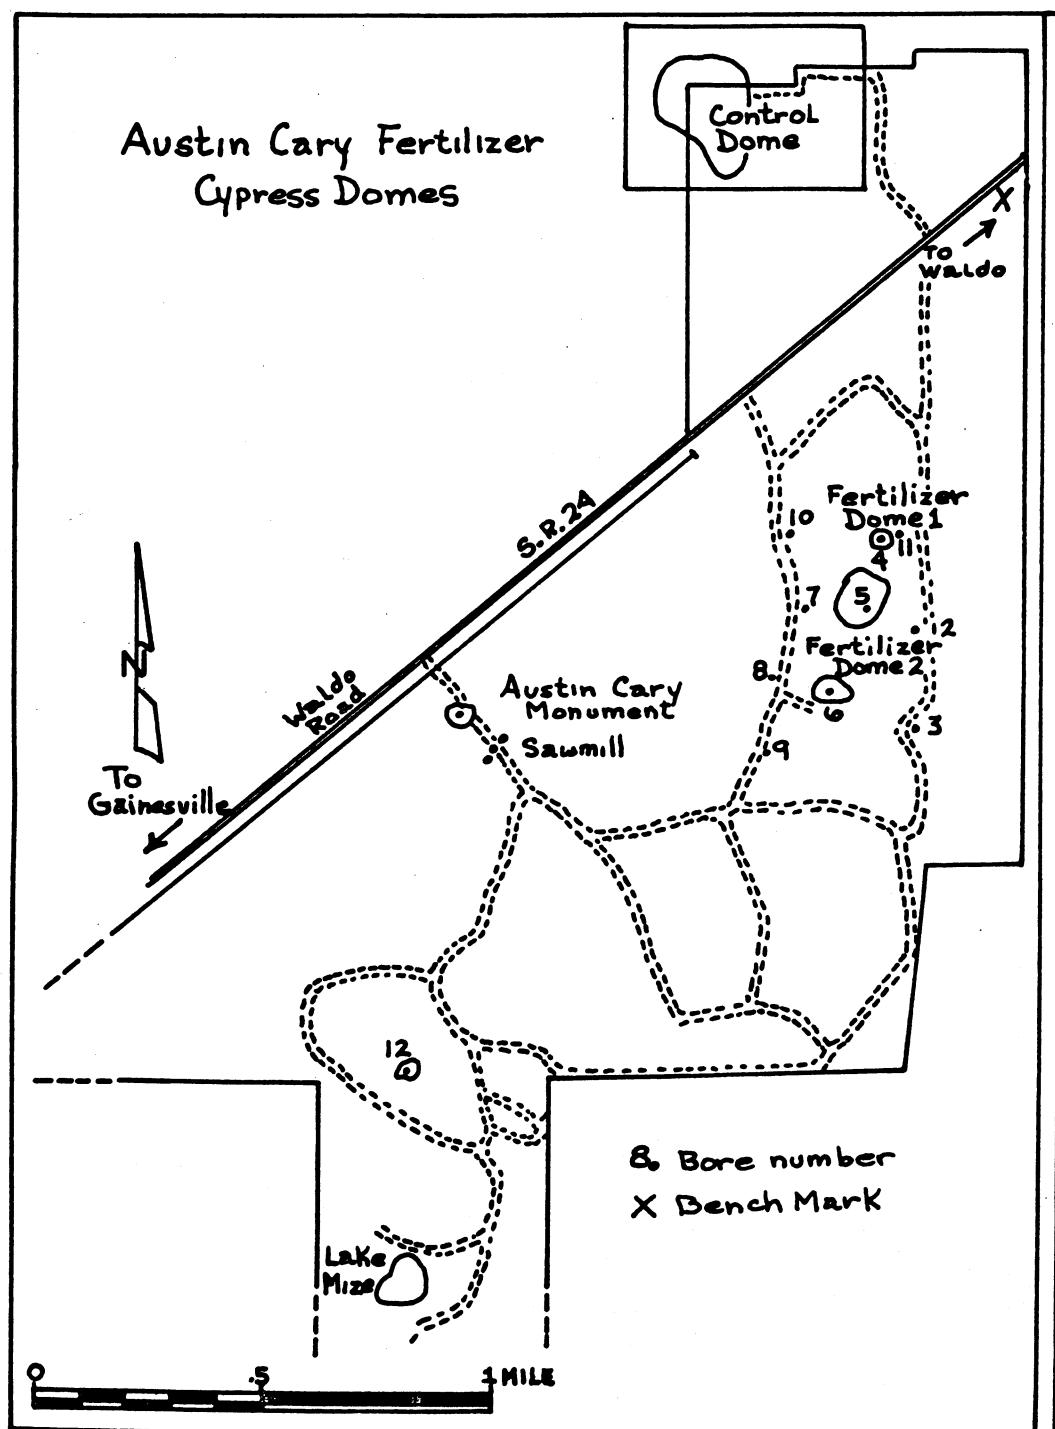
Figure 11. Plan view of Austin Cary Fertilizer Domes and test borings.

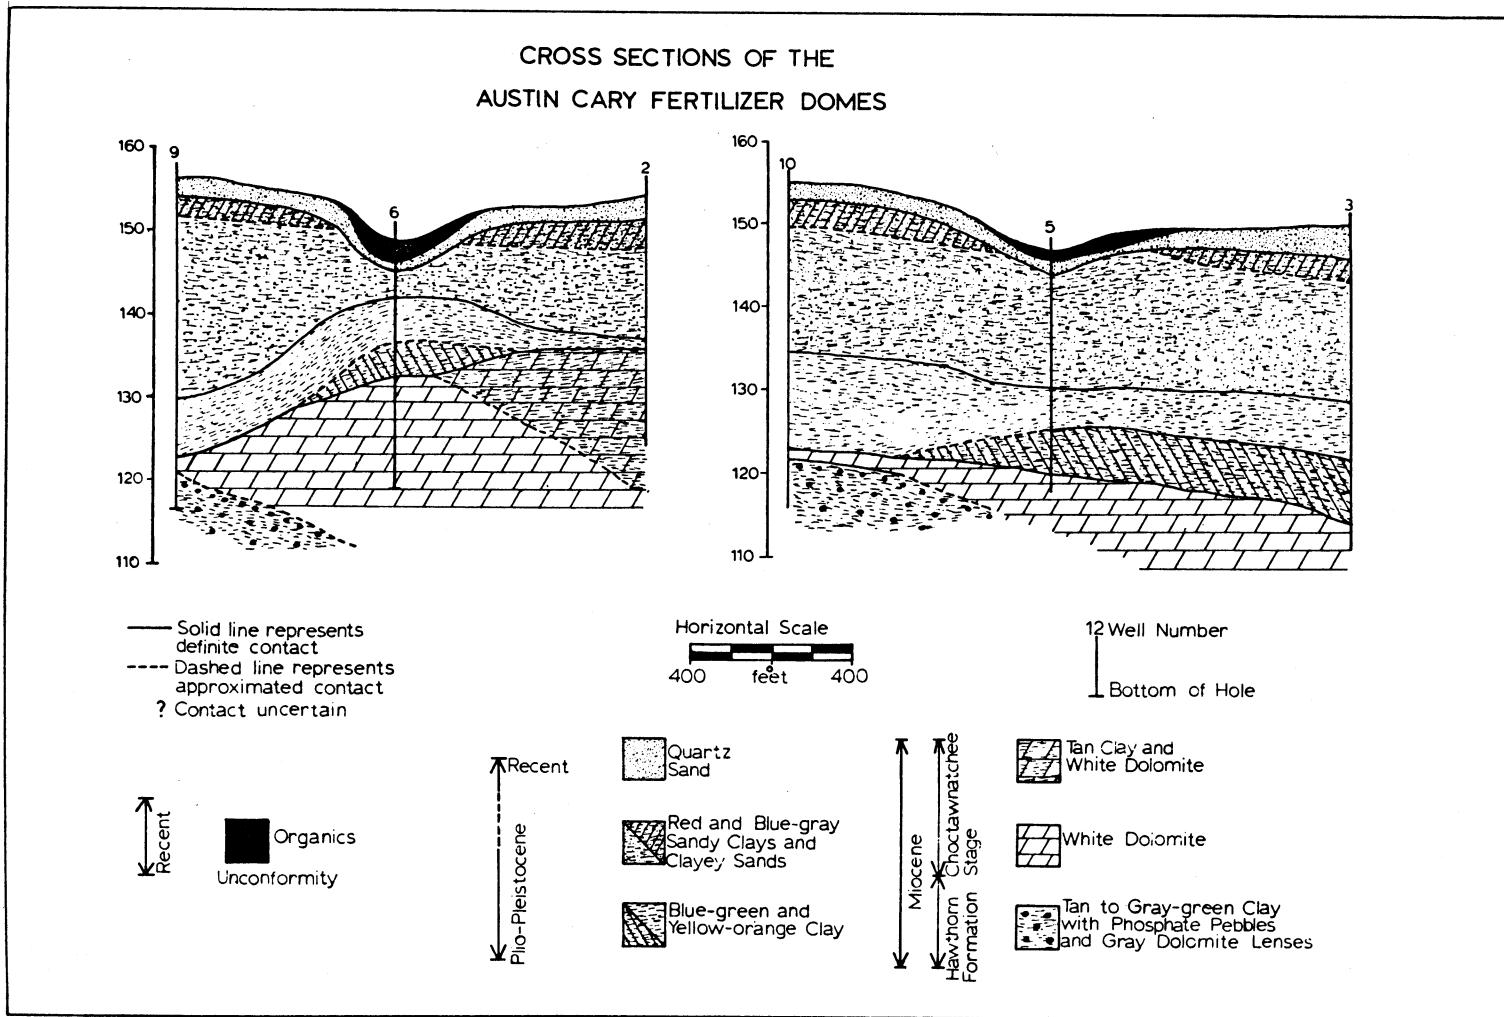
Figure 12. Cross sections of the Austin Cary Fertilizer Domes
(in Spangler et al., 1976).

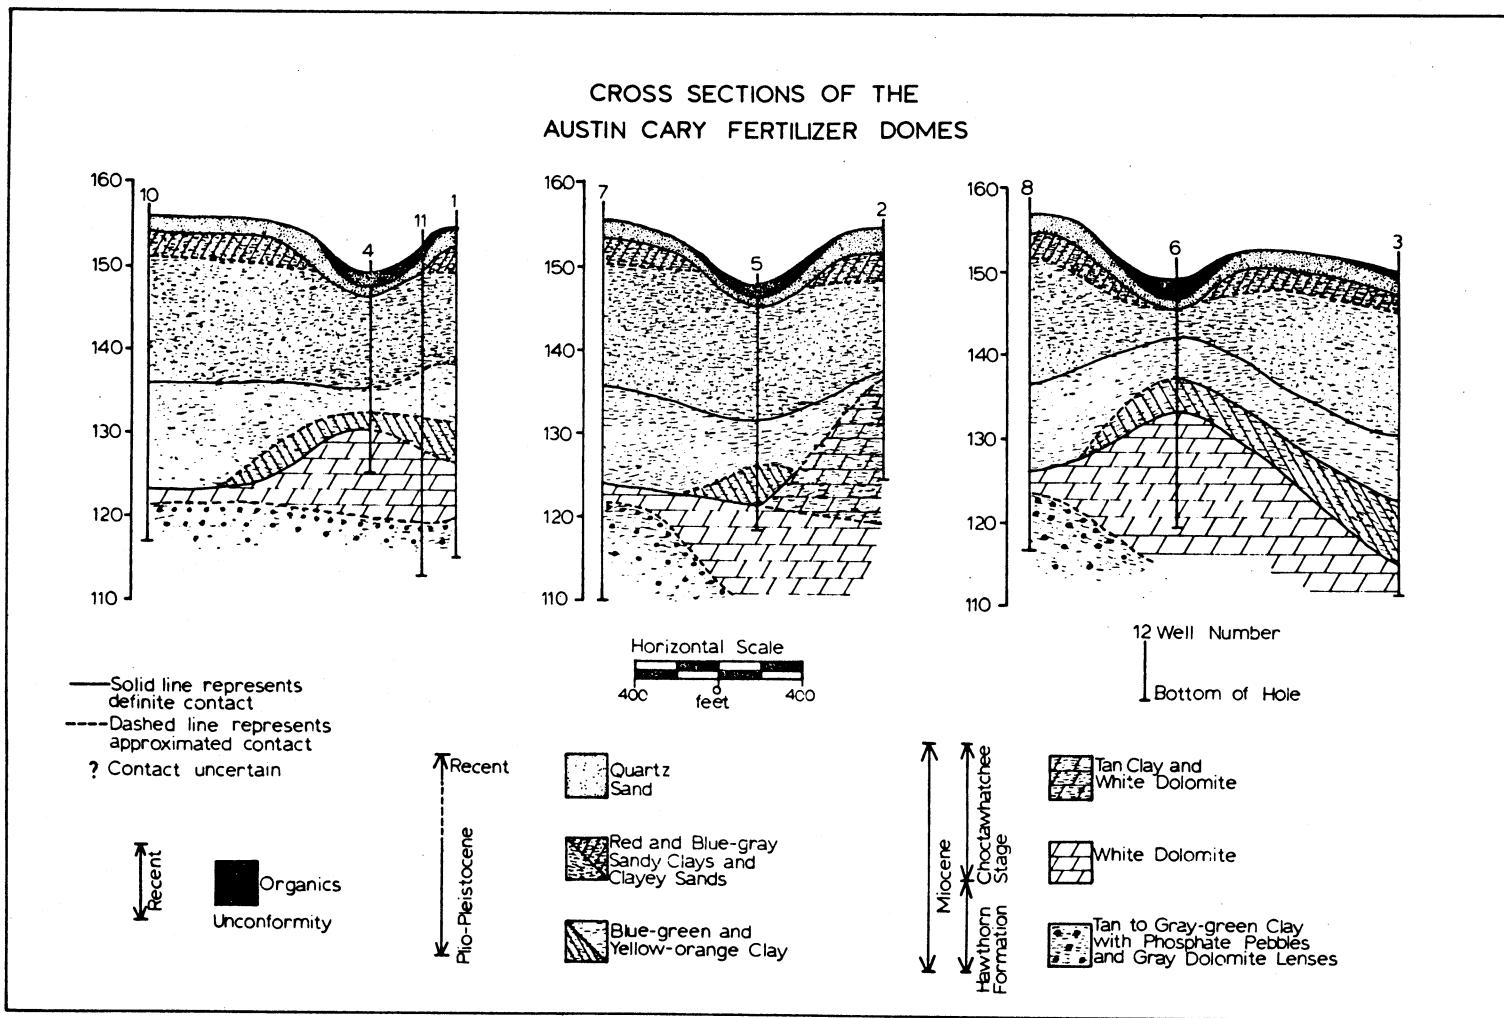
Figure 13. Cross sections of the Austin Cary Fertilizer Domes
(in Spangler et al., 1976).

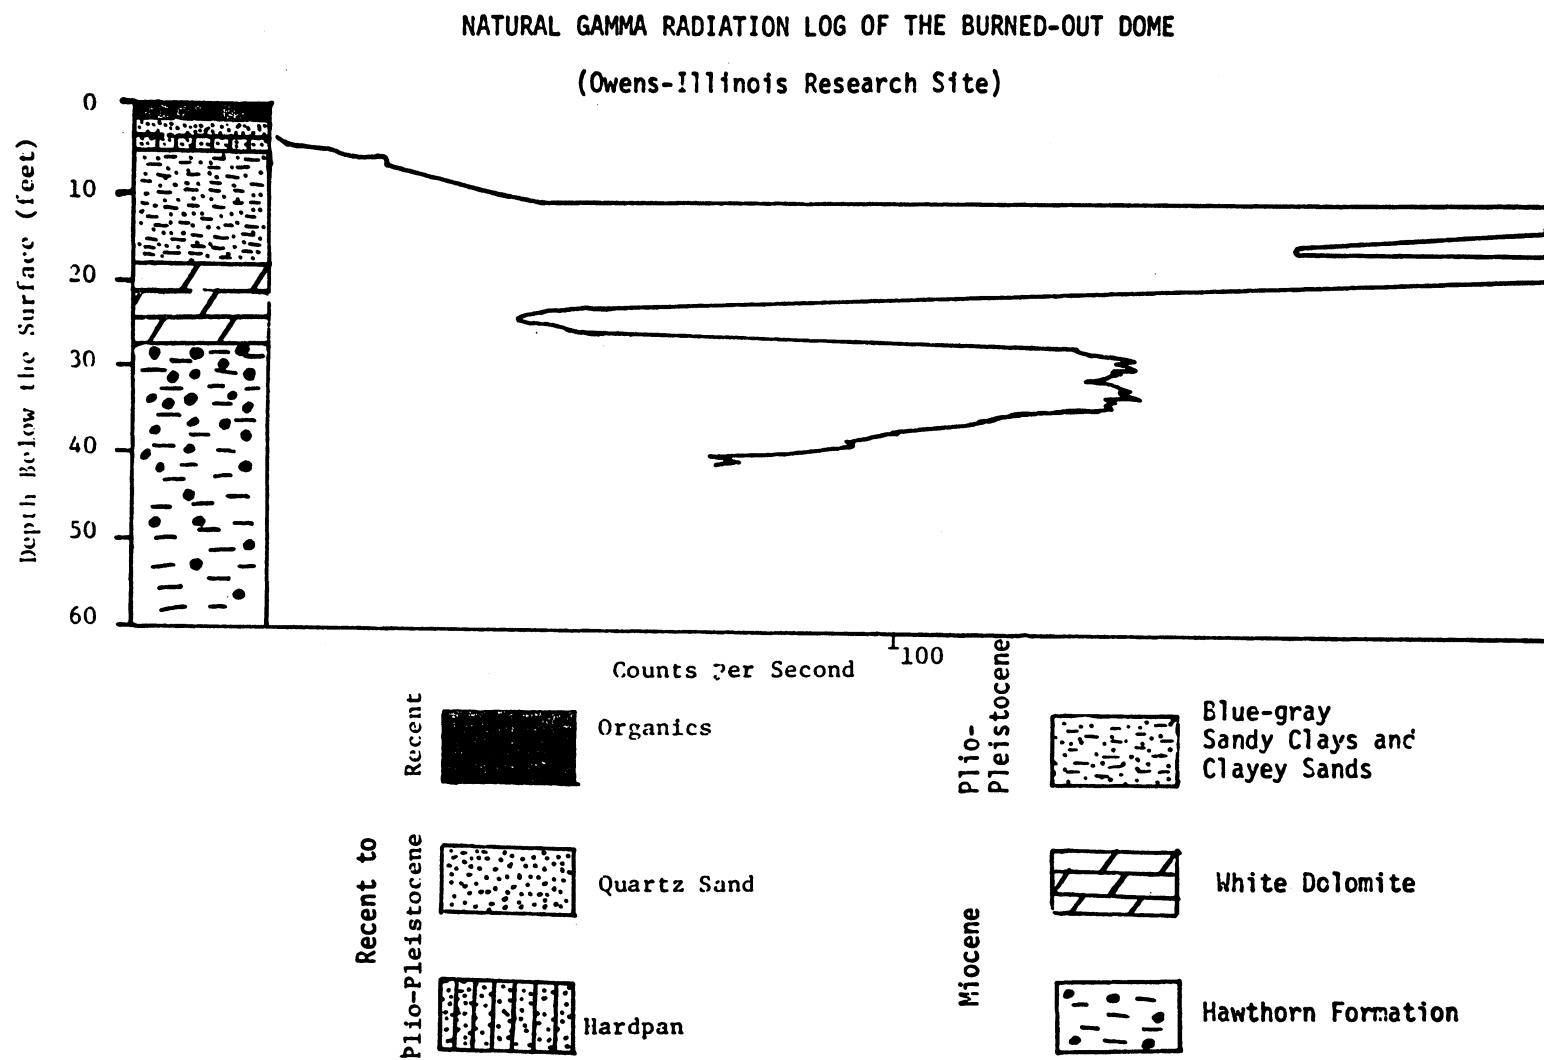
Figure 15. Natural gamma radiation log of a boring in an unnamed dome of Owens-Illinois Research Site south of Sewage Dome I in Figure 9 (in Spangler et al., 1976).

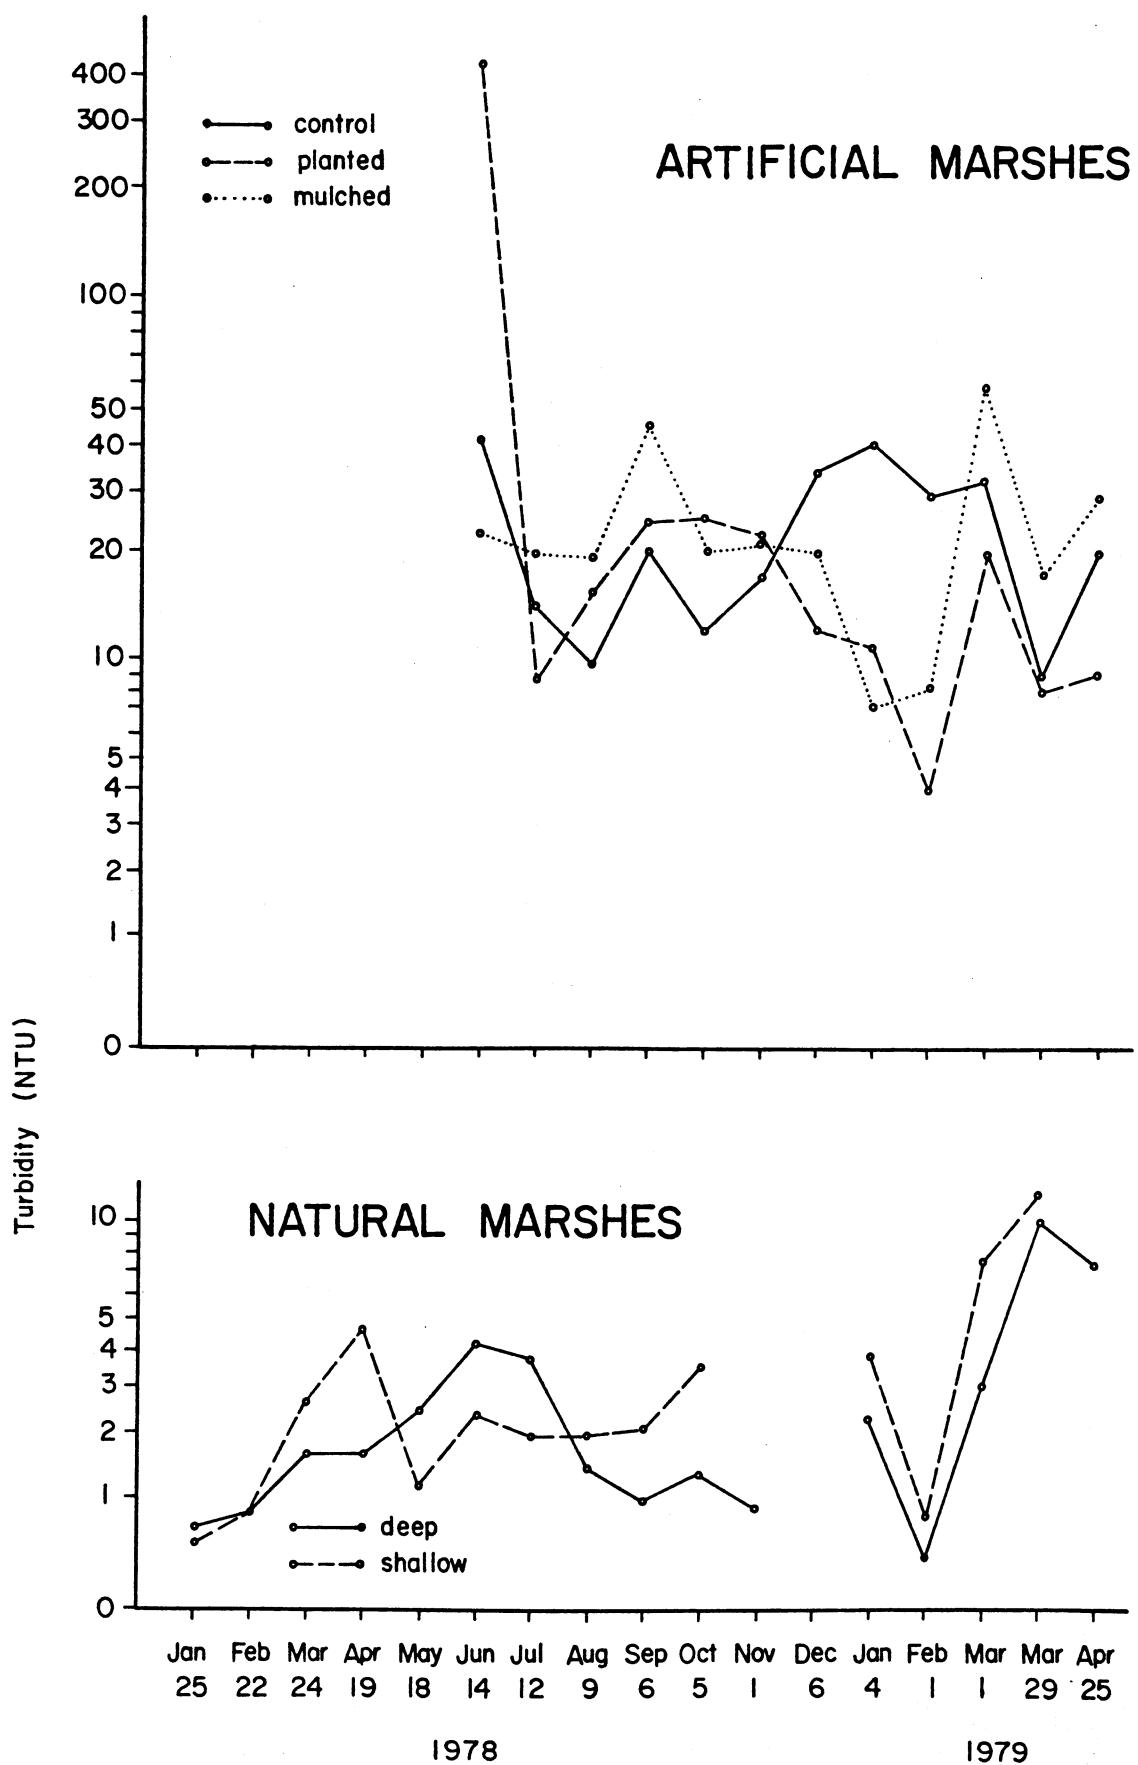
FIGURE 7 : TURBIDITY

Turbidity levels have generally been between 10 and 40 NTU's in the artificial marshes, except for the first month (June 1978) when the planted marsh had a value of 439.9 NTU's (Figure 7). In contrast, the artificial marshes had turbidities which have generally been less than 10 NTU's.
