**THE RESTORATION AND CREATION
OF WETLANDS**

PROCEEDINGS OF
THE SIXTH ANNUAL CONFERENCE
ON WETLANDS
RESTORATION AND CREATION

May 19, 1979
Hillsborough Community College
Tampa, Florida

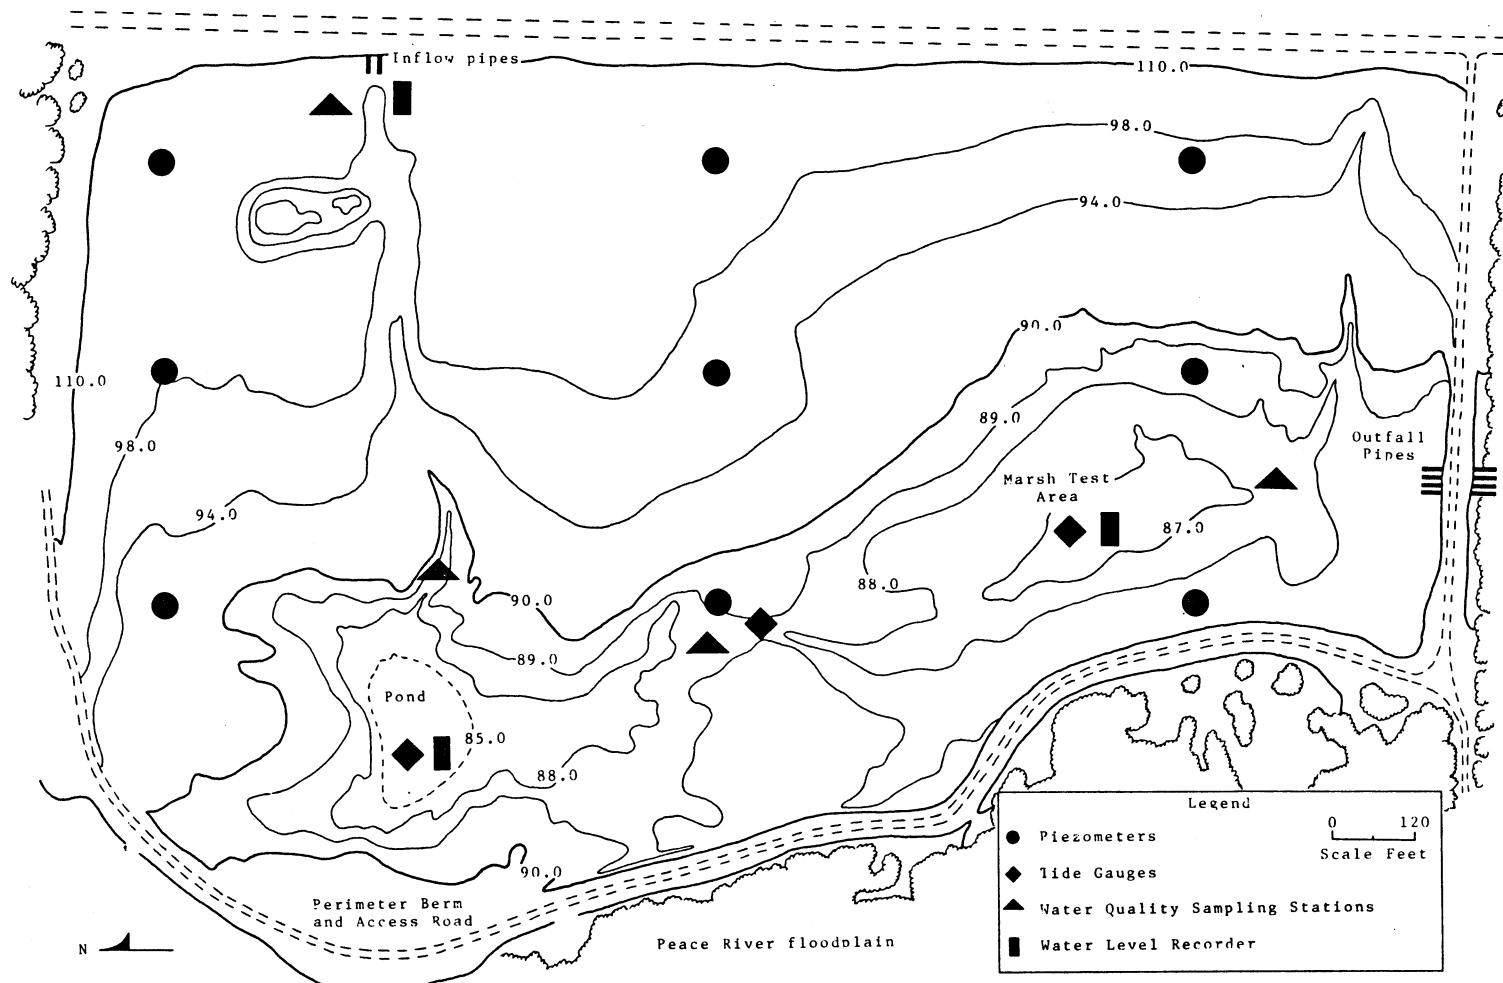
Figure 1. Wetland Test Site showing abbreviated topographic features and monitoring locations

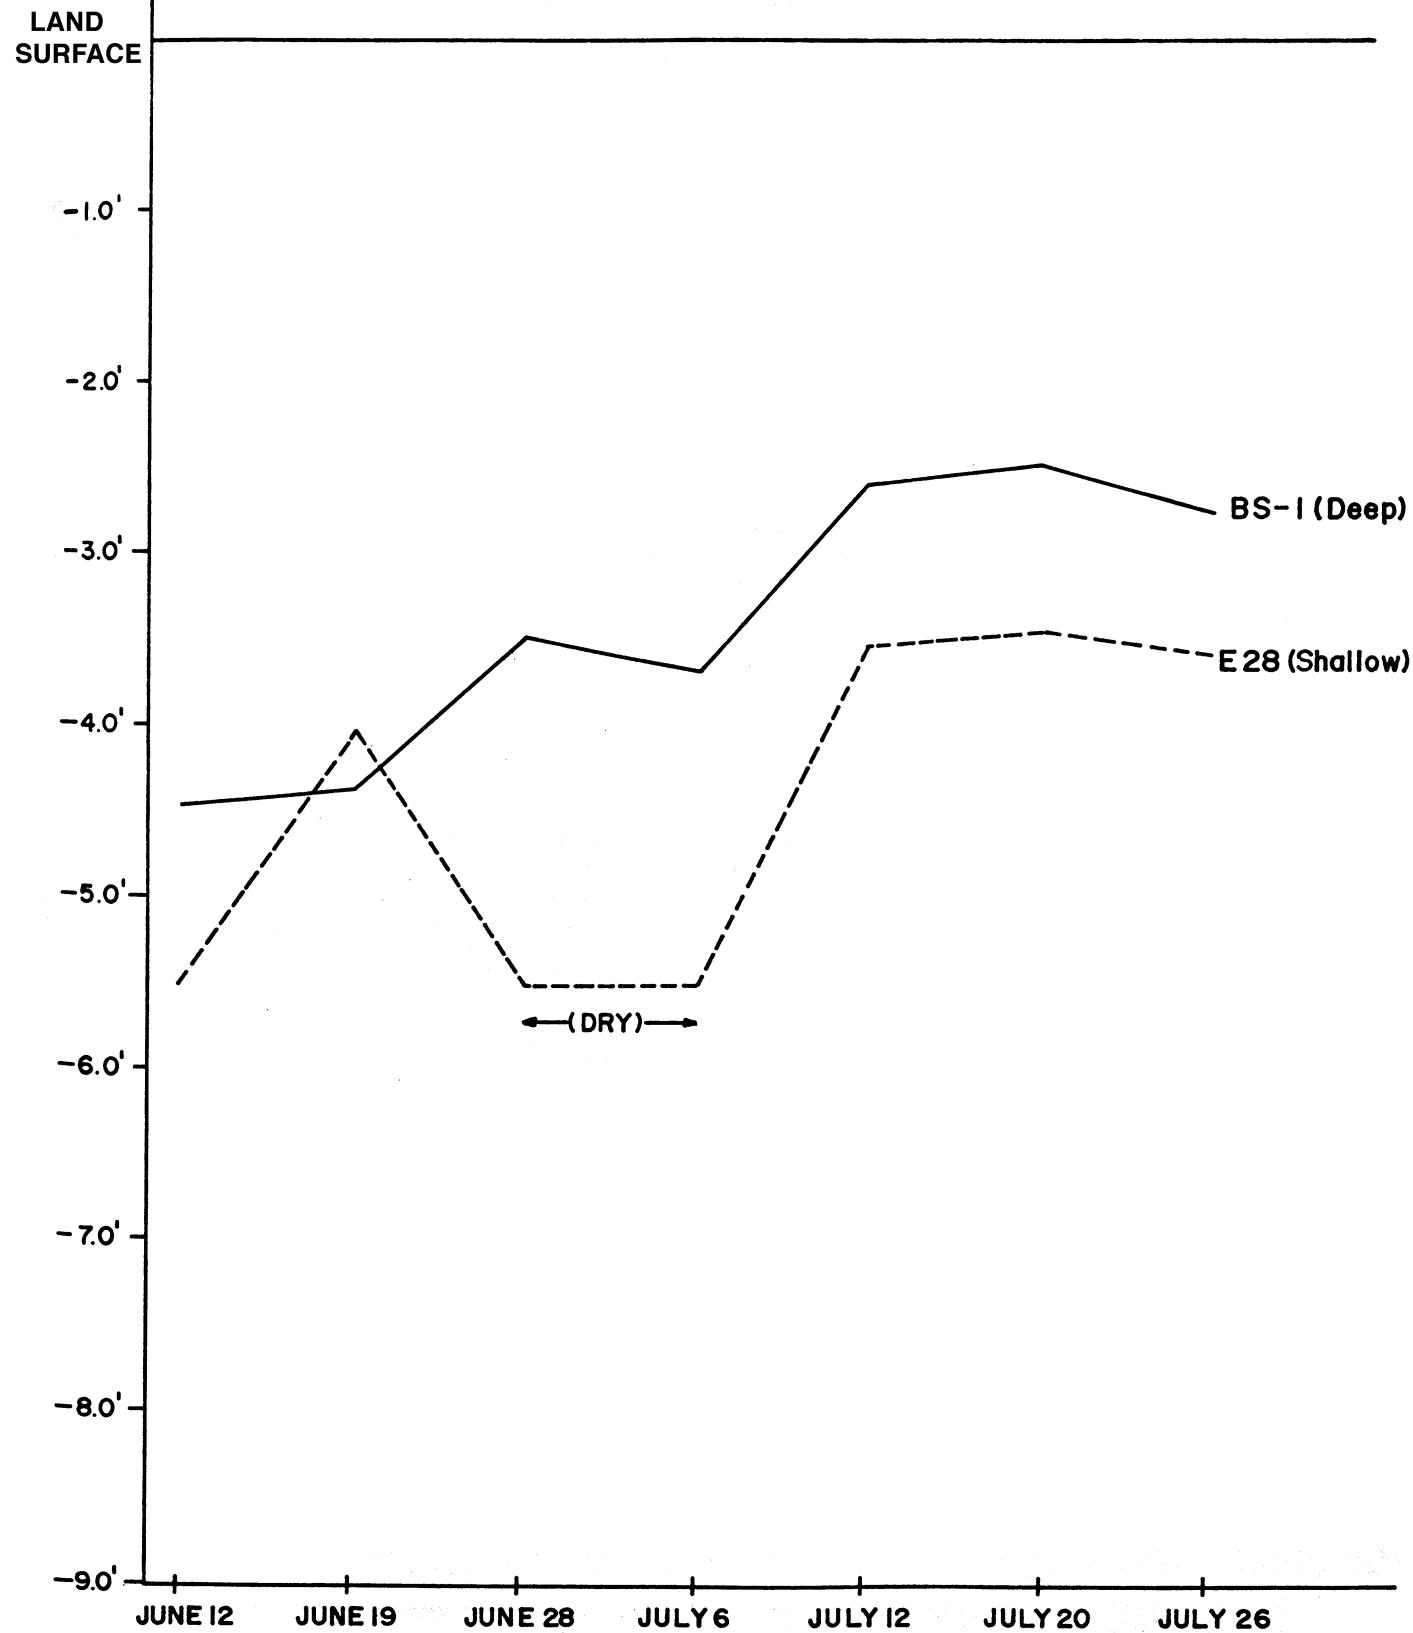
FIGURE 5
HYDROGRAPHS OF WATER LEVELS IN PAIRED
PIEZOMETERS ADJACENT TO BIG SLOUGH
(DEPTH-TO-WATER)

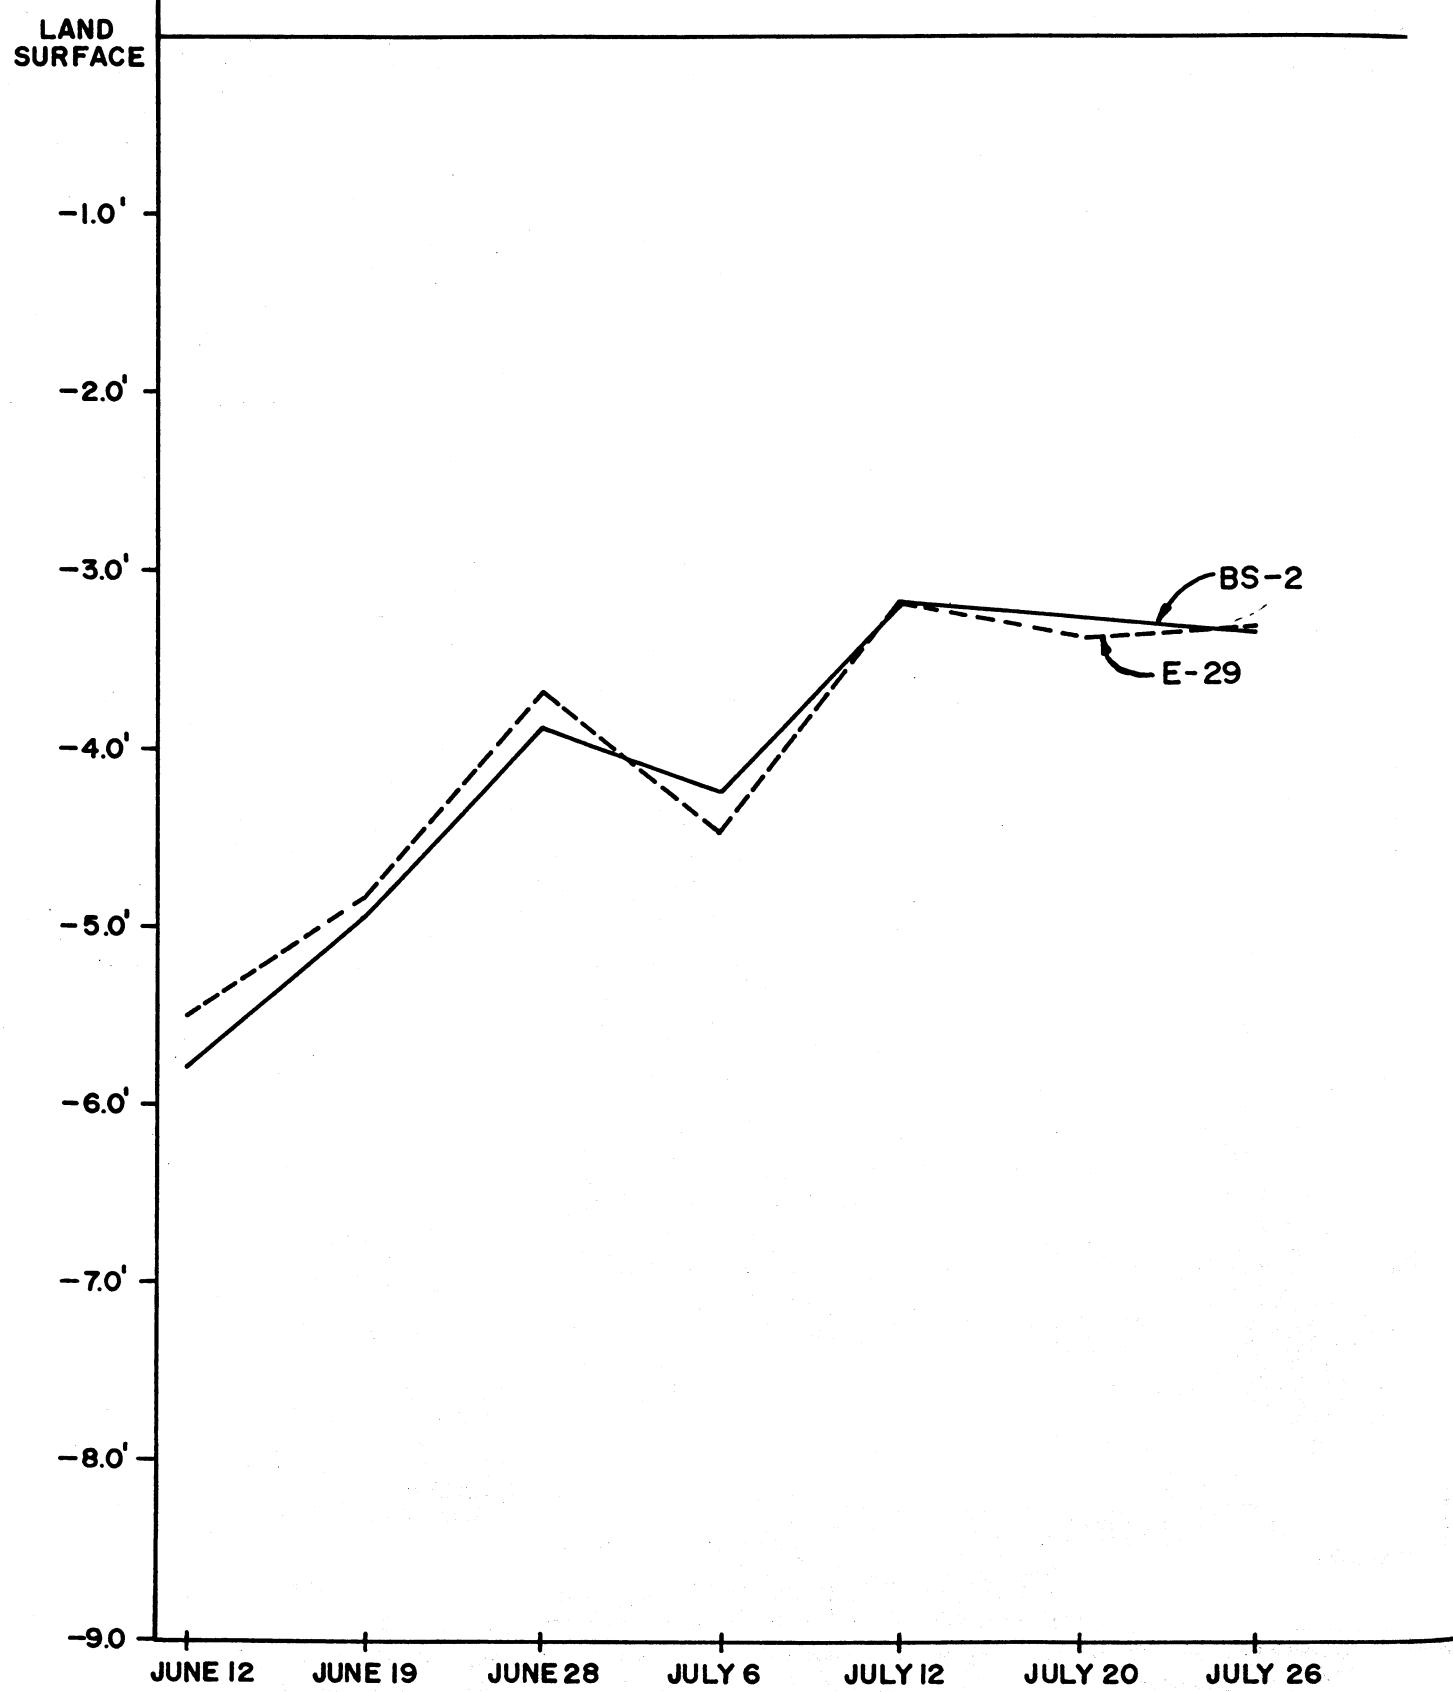
FIGURE 6
HYDROGRAPHS OF WATER LEVELS IN PAIRED
PIEZOMETERS ADJACENT TO BIG SLOUGH
(DEPTH-TO-WATER)

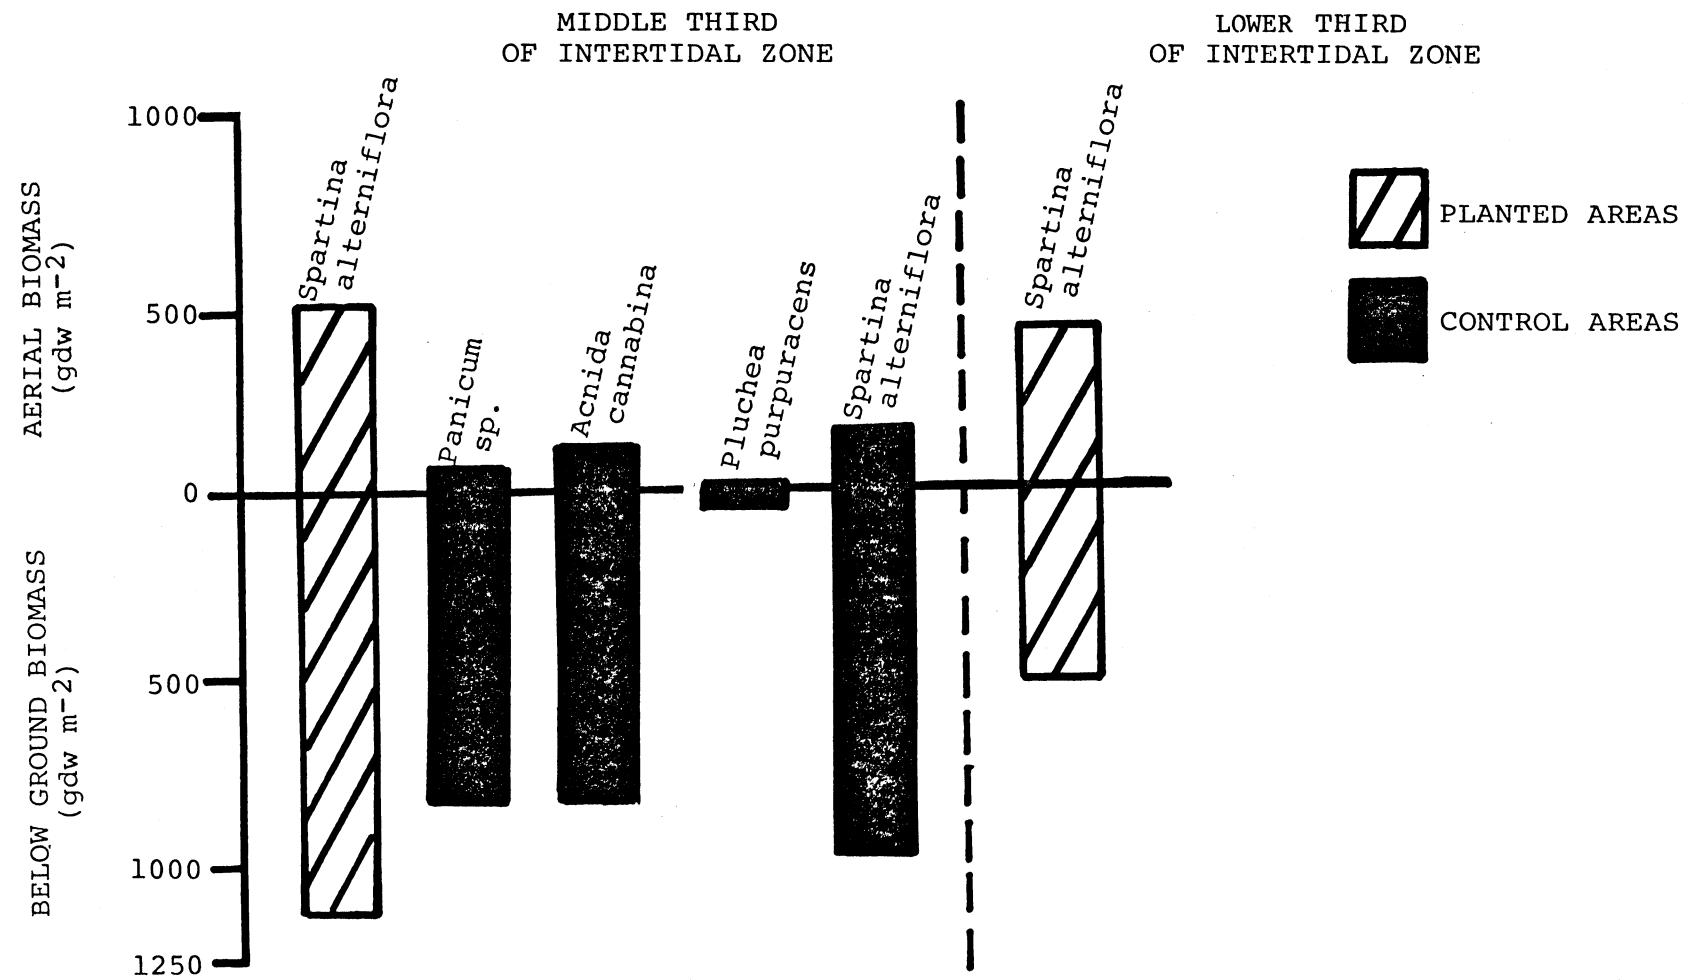
FIGURE 5.

AERIAL AND BELOW GROUND BIOMASS
MIDDLE AND LOWER THIRD OF INTERTIDAL ZONE
7 JUNE 1978

morphology variation within the intertidal zone. *Spartina alterniflora*, *Aenida cannabina* and *Panicum* sp. produced much larger aerial biomass values in the middle third of the intertidal zone than was produced in the upper third of the intertidal zone. Stabilization of a dredged material is directly related to below ground biomass development. Much less inter-specific and elevational variation is evident for below ground biomass. The below ground standing crop biomass appears to be more constant over the annual cycle than the aerial portion. The erosion control represented by the below ground root mat of *Spartina alterniflora* was evident. A deep gully scoured by ground water runoff at the site was healed by the encroachment of *Spartina alterniflora* in the middle third of the intertidal zone. The dense root mat of *Spartina patens* also provides substantial resistance to erosion. The landward progress of a runoff gully in the upper third of the intertidal zone was stopped by a *Spartina patens* sward. These two instances suggest the ability of *Spartina alterniflora* and *Spartina patens* to resist erosion.

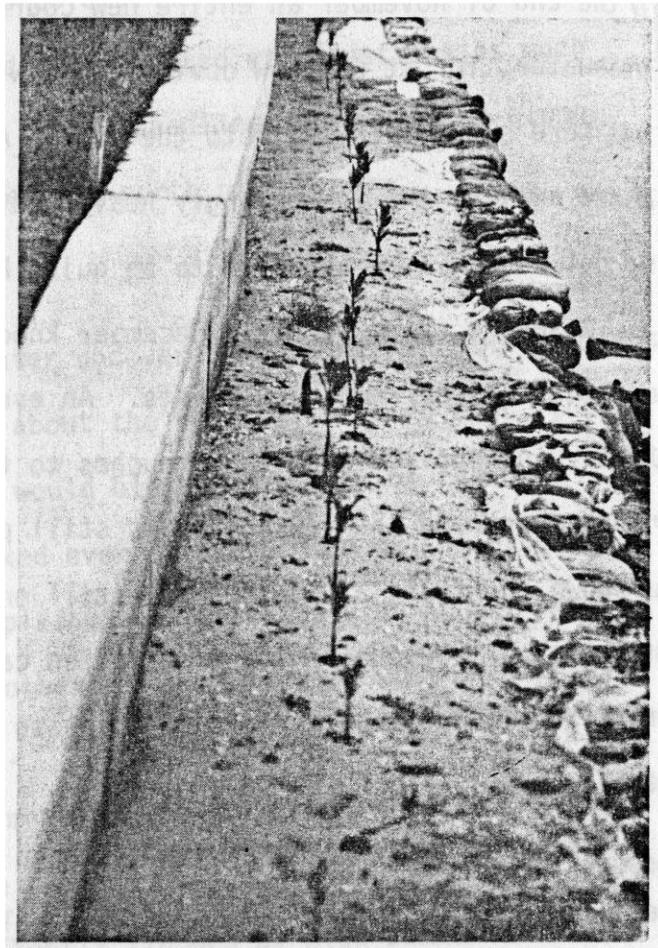
Figure 2. The berm following a storm in early January. No mangroves remained planted. Note the lack of roots extending from the plastic collars after 7 months of growth.

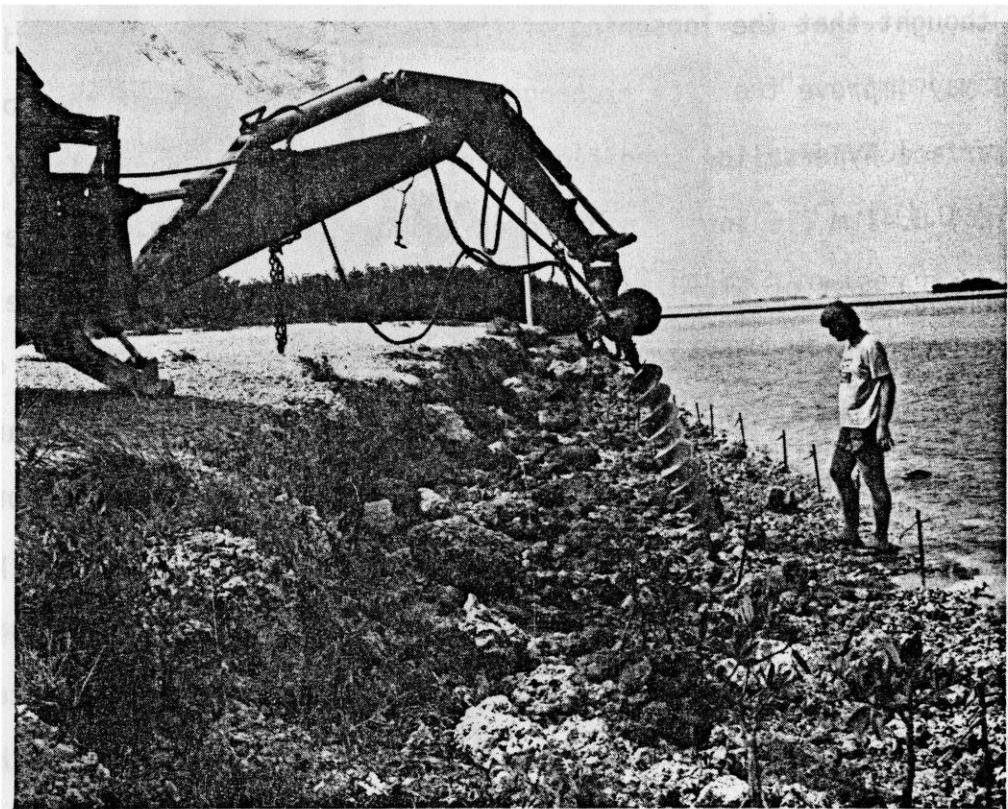
Figure 4. Power auger used to bore transplant holes (Site C).

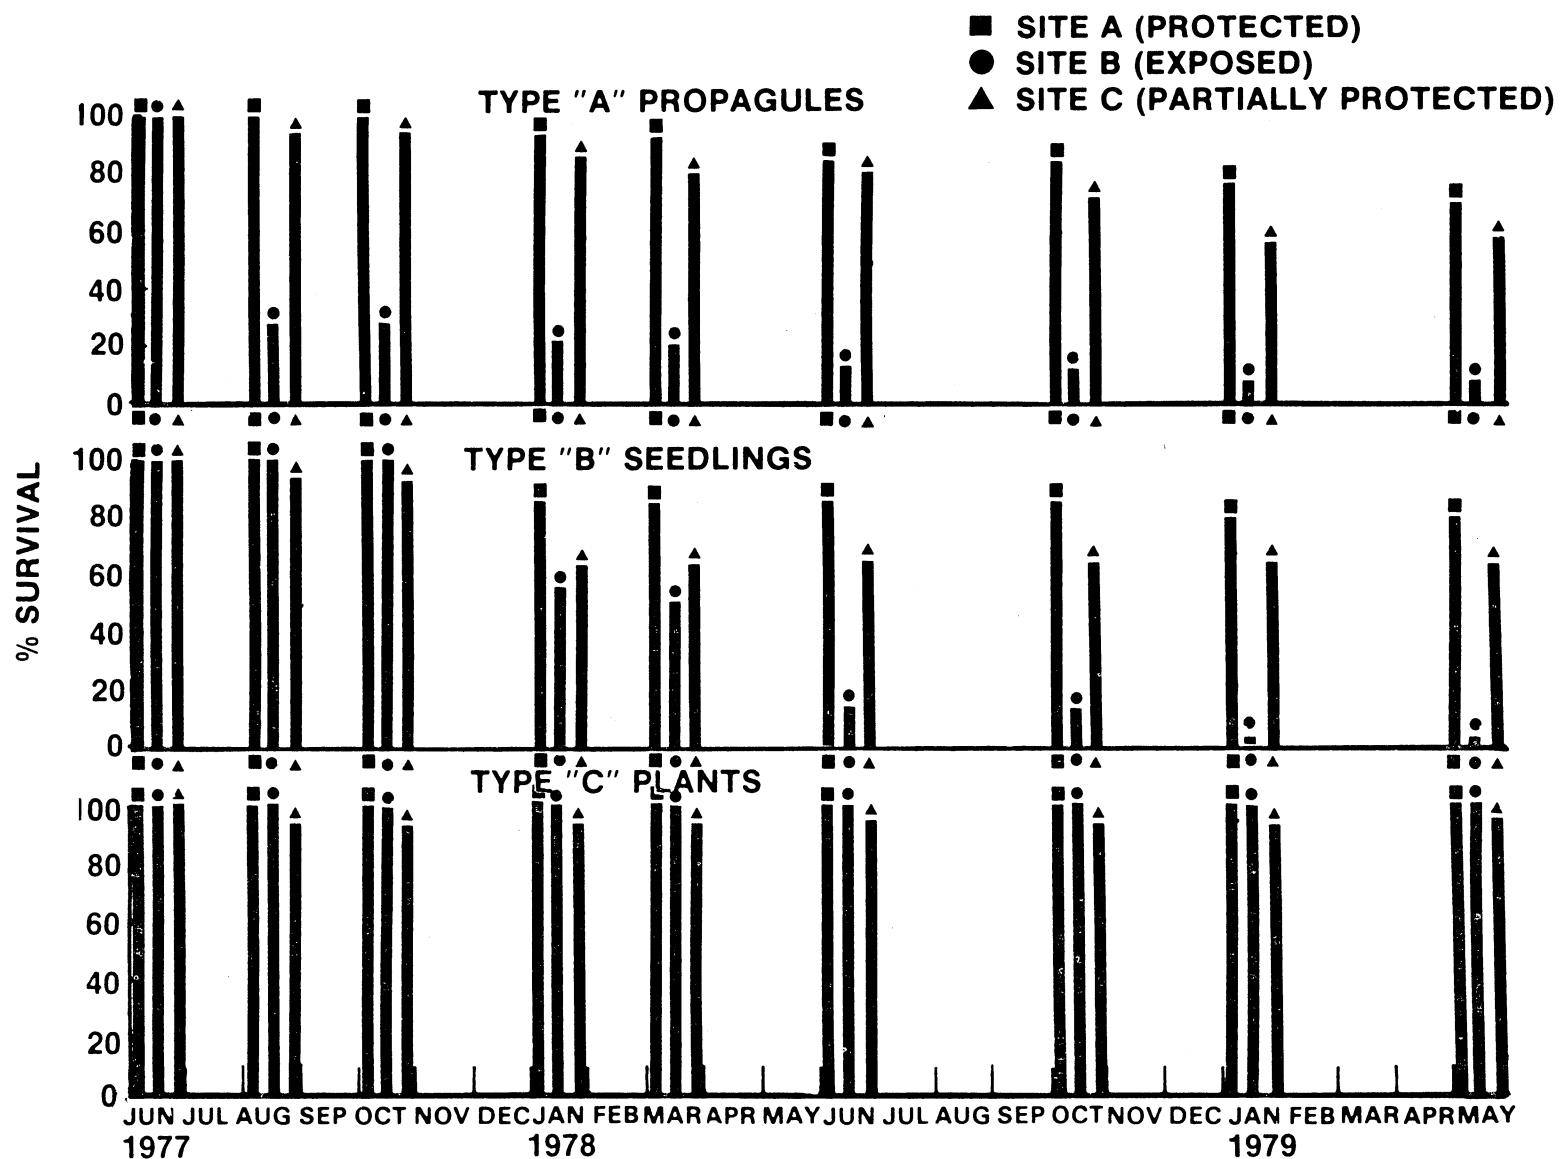
Figure 7. Survival of transplanted red mangroves.

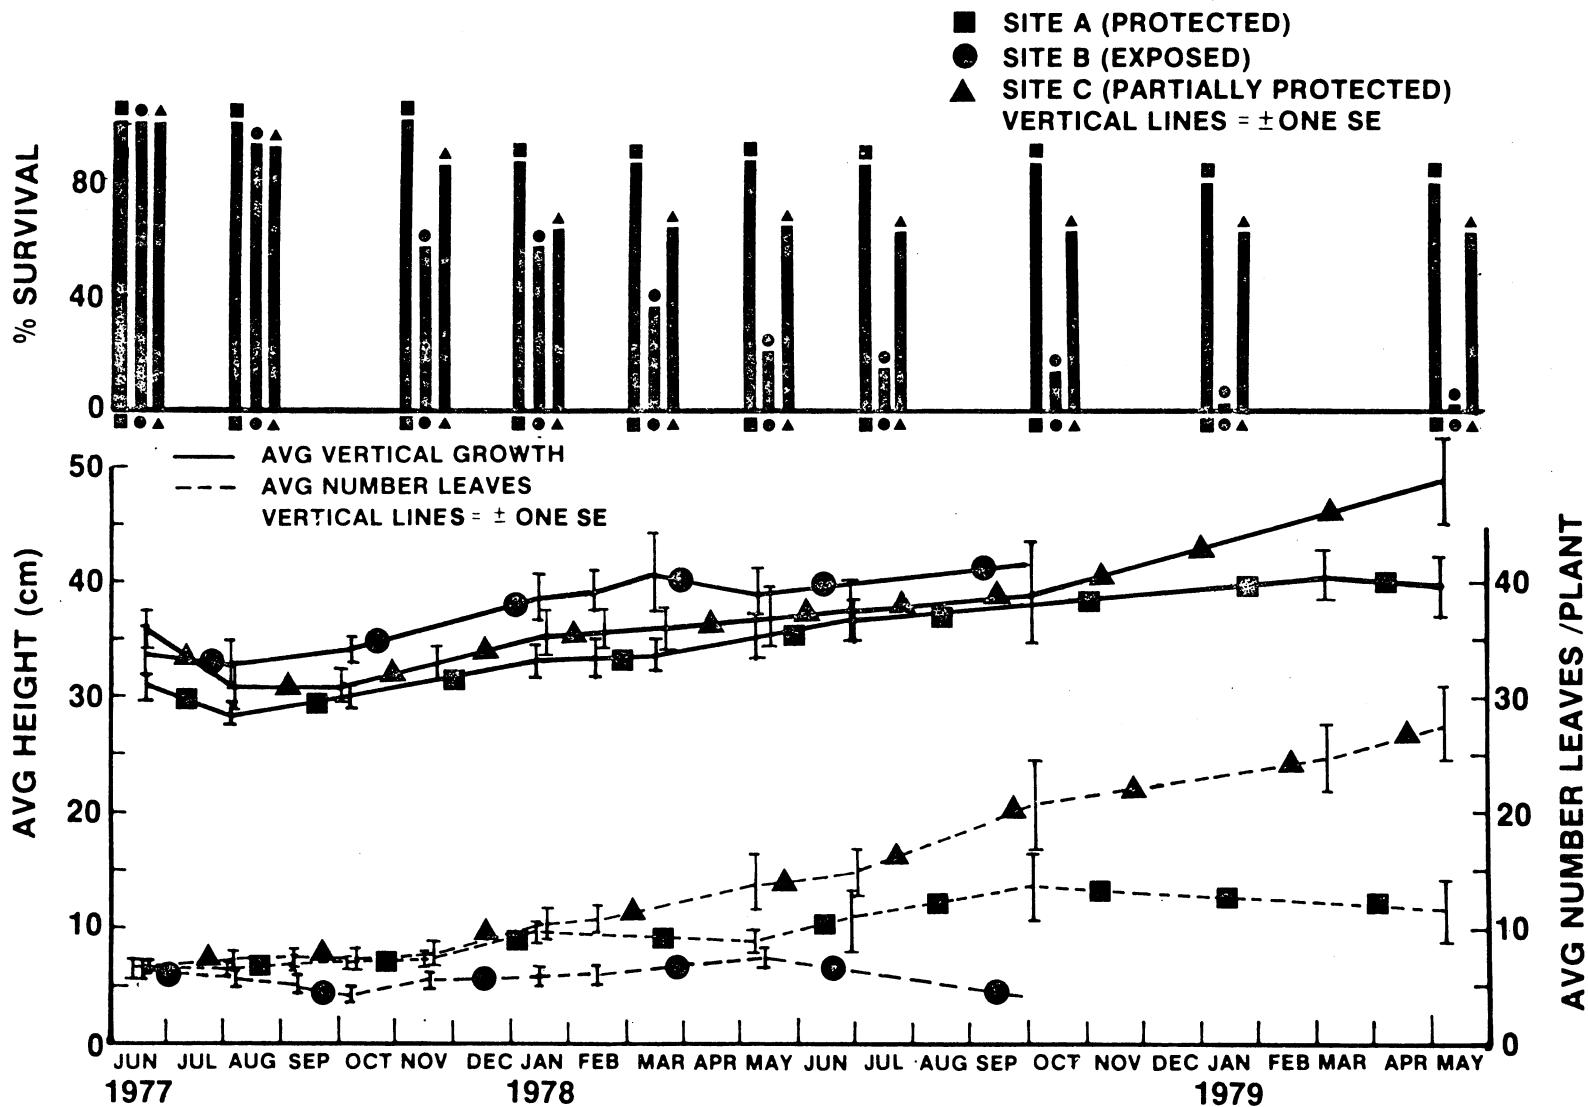
Figure 9. Survival and growth of red mangrove seedlings (Type B).

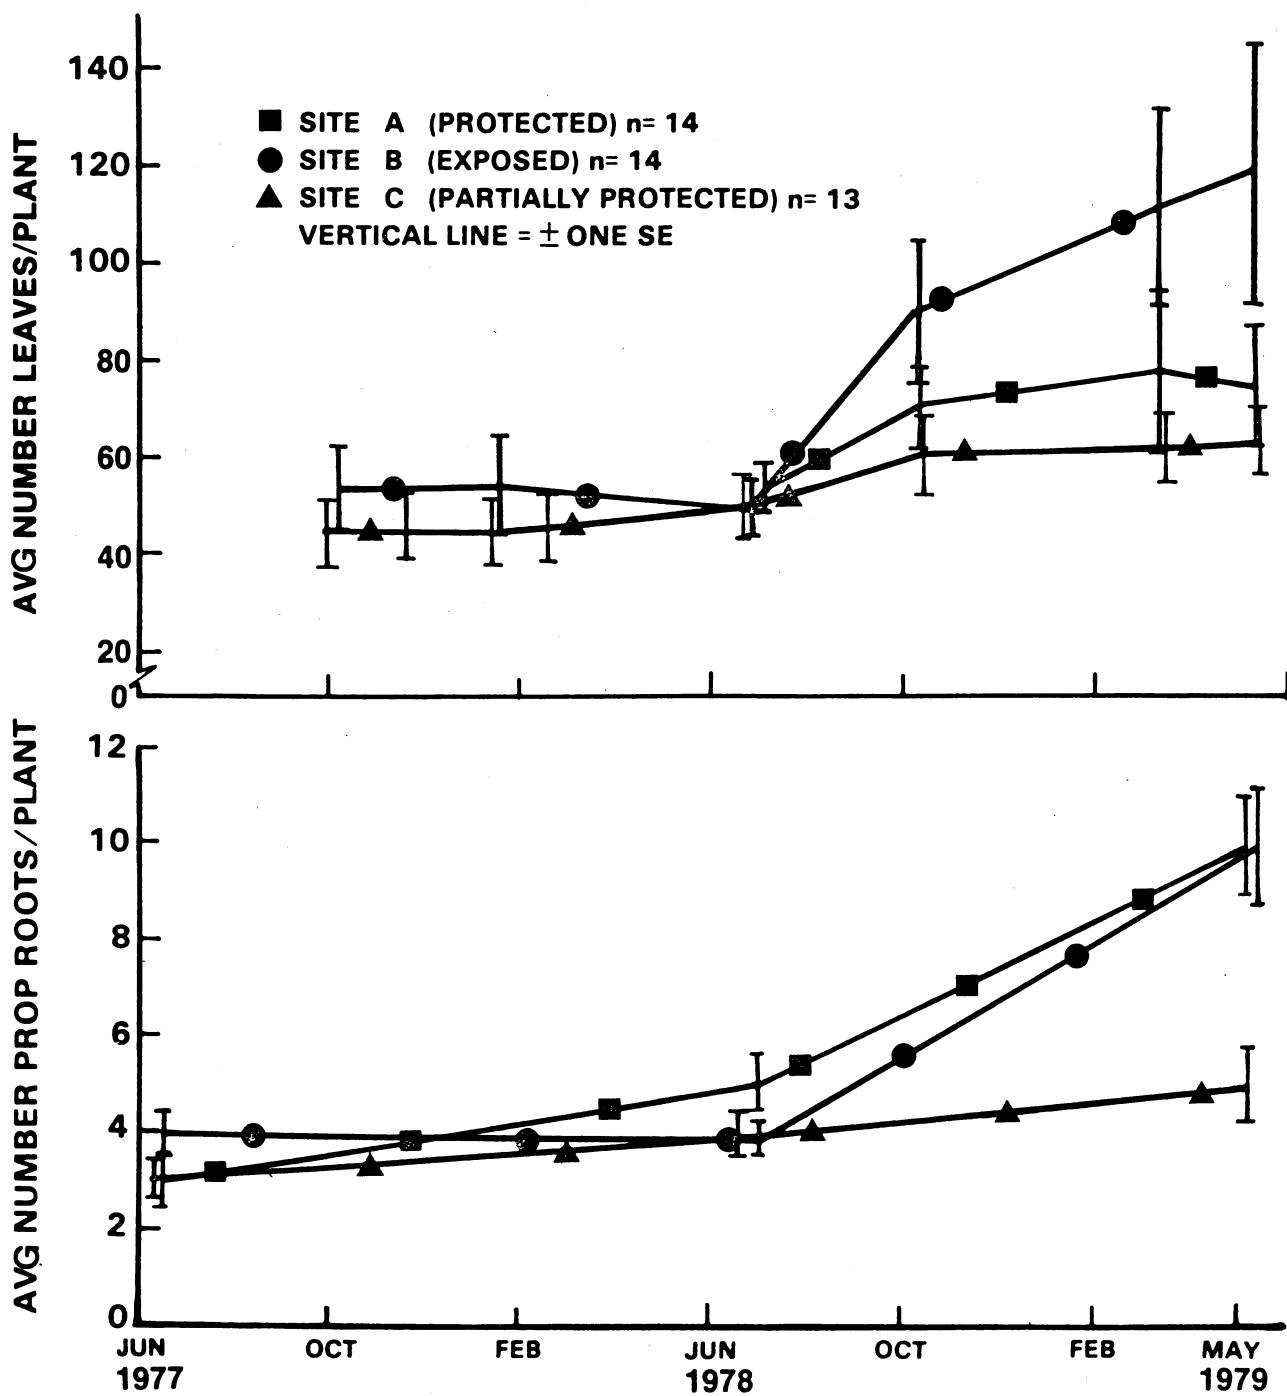
Figure 10. Growth of small red mangrove trees (Type C).

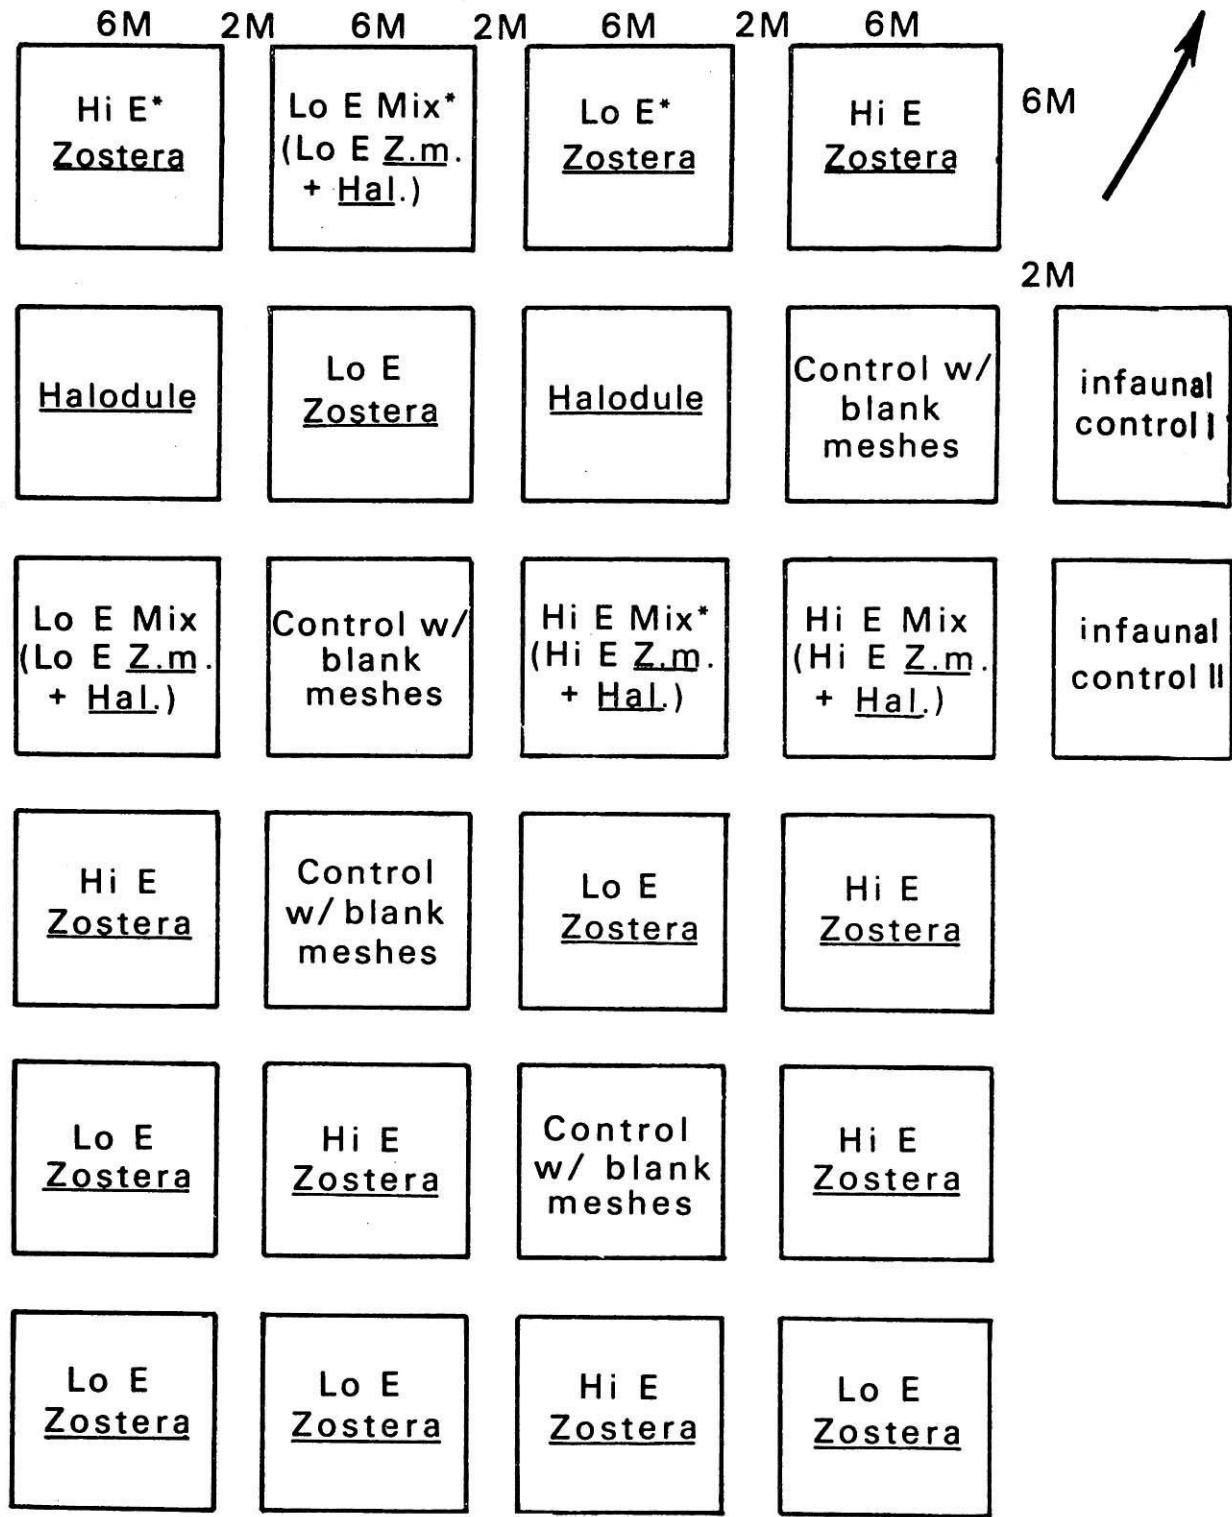
Figure 2. Vertical view of replicated treatments and layout of transplant in Middle Marsh. Each treatment is 6 m on a side with 2 m corridors. Each square is 36 m² with 49 meshes.

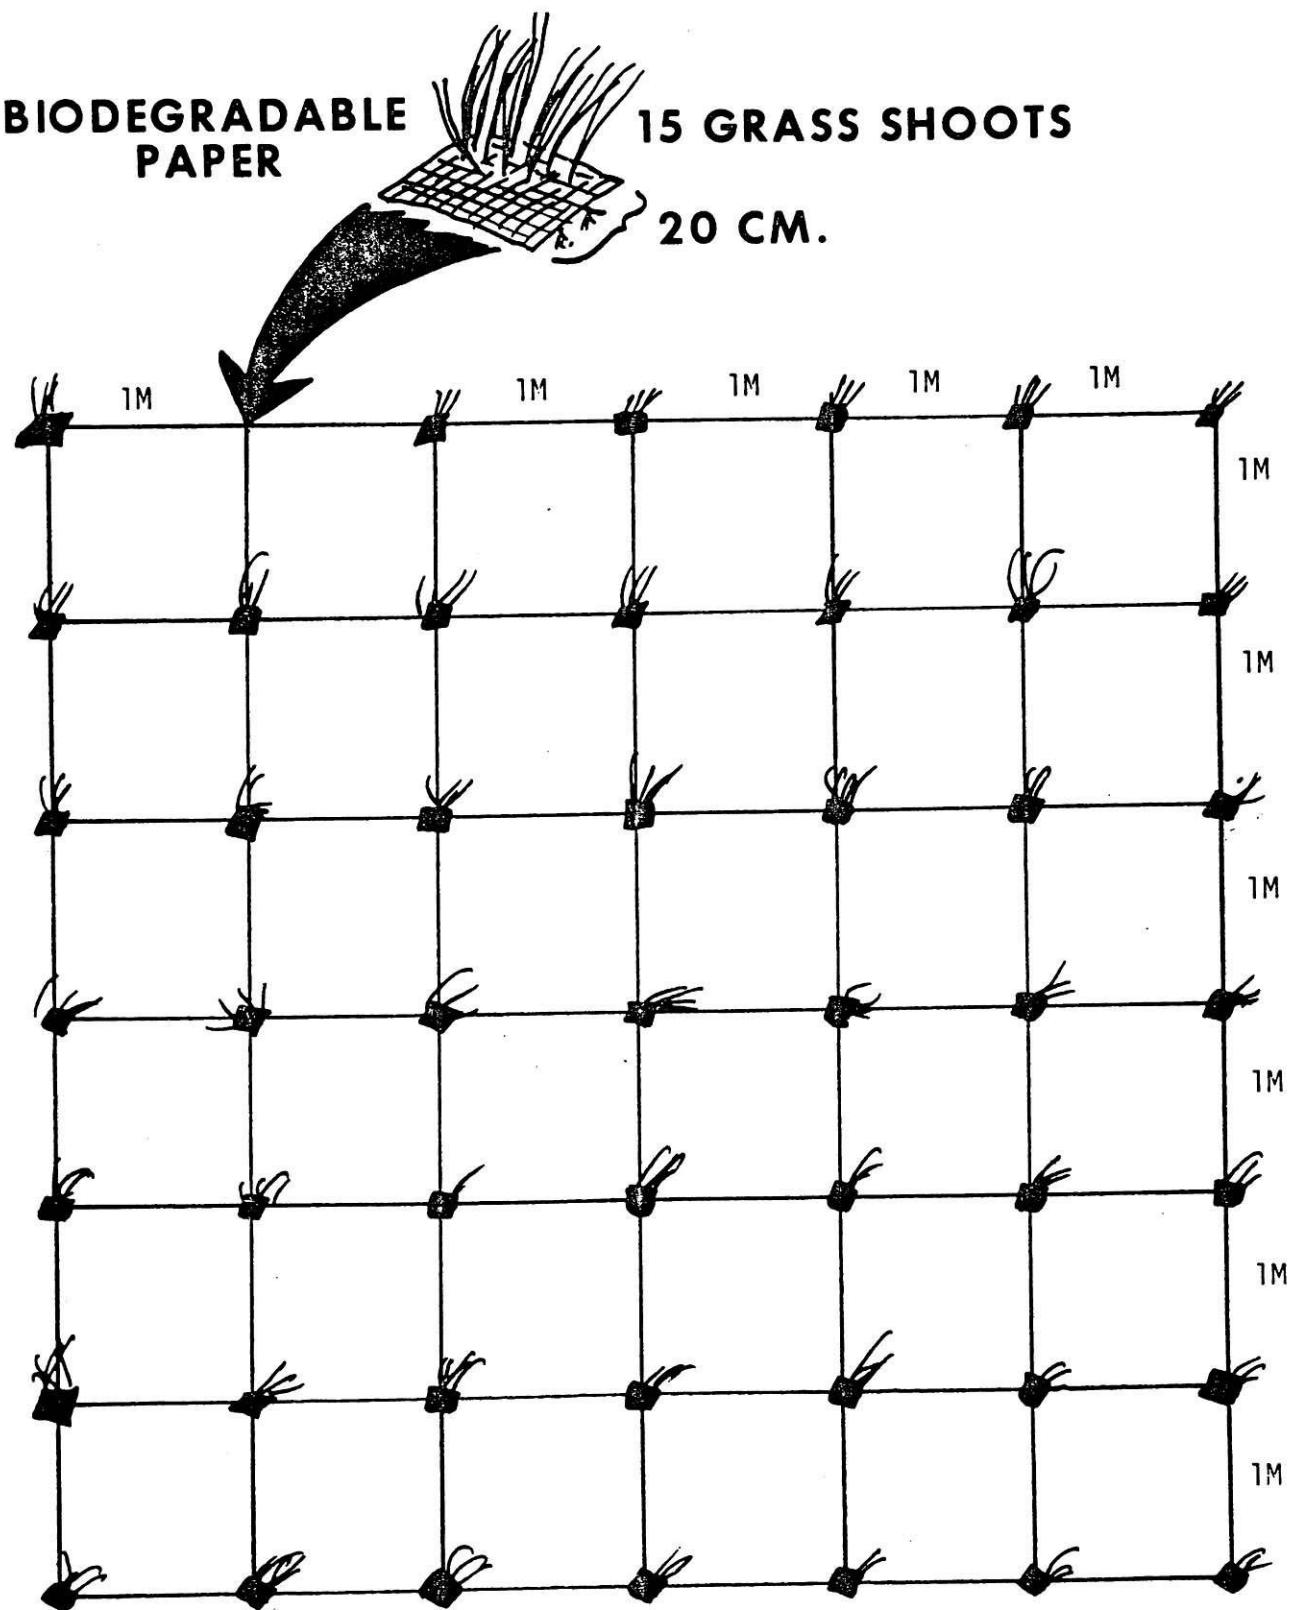
Figure 3. Layout of an individual treatment. Fifteen shoots are woven into a 20 x 20 cm partially biodegradable mesh (1 mesh unit). These are planted on 1 m² centers on a 6 x 6 m grid for a total of 49 meshes/replicate treatment.

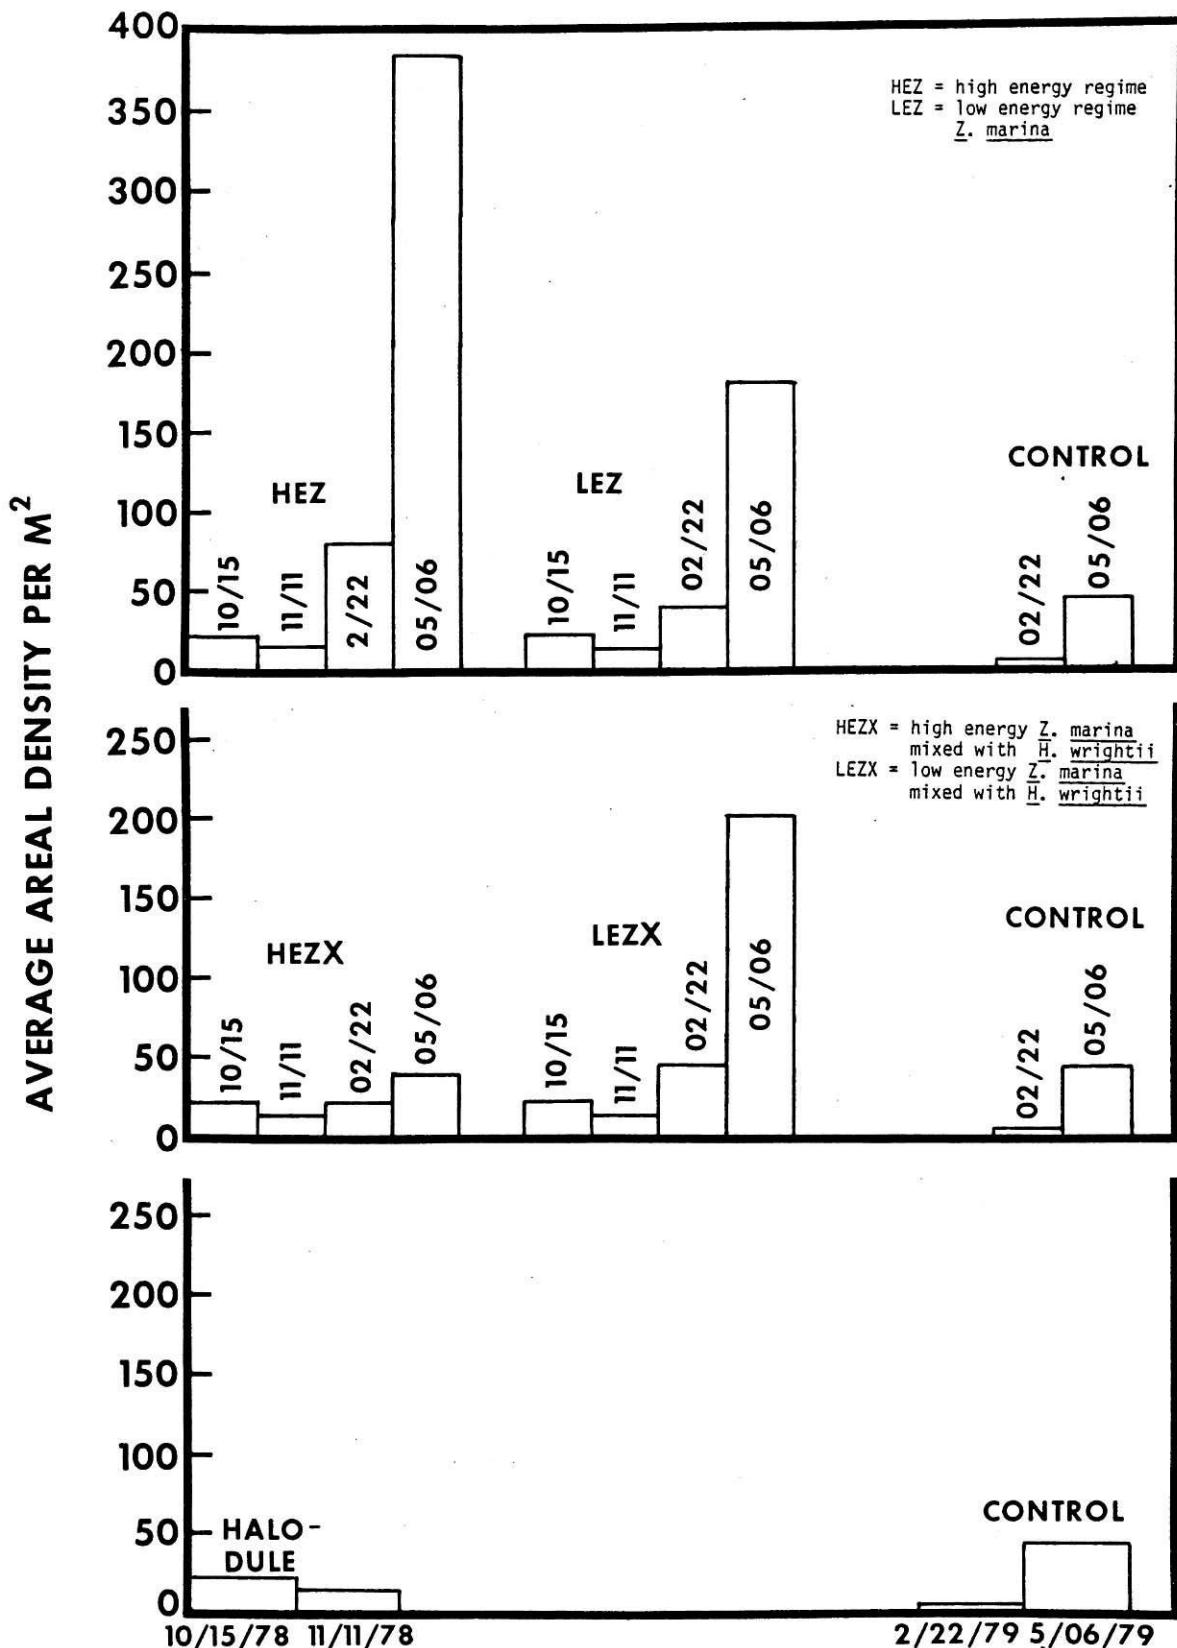
Figures 4, 5, and 6 (top to bottom). Average density/m² (areal) is plotted by sample time. Dates range from 1978 to 1979.

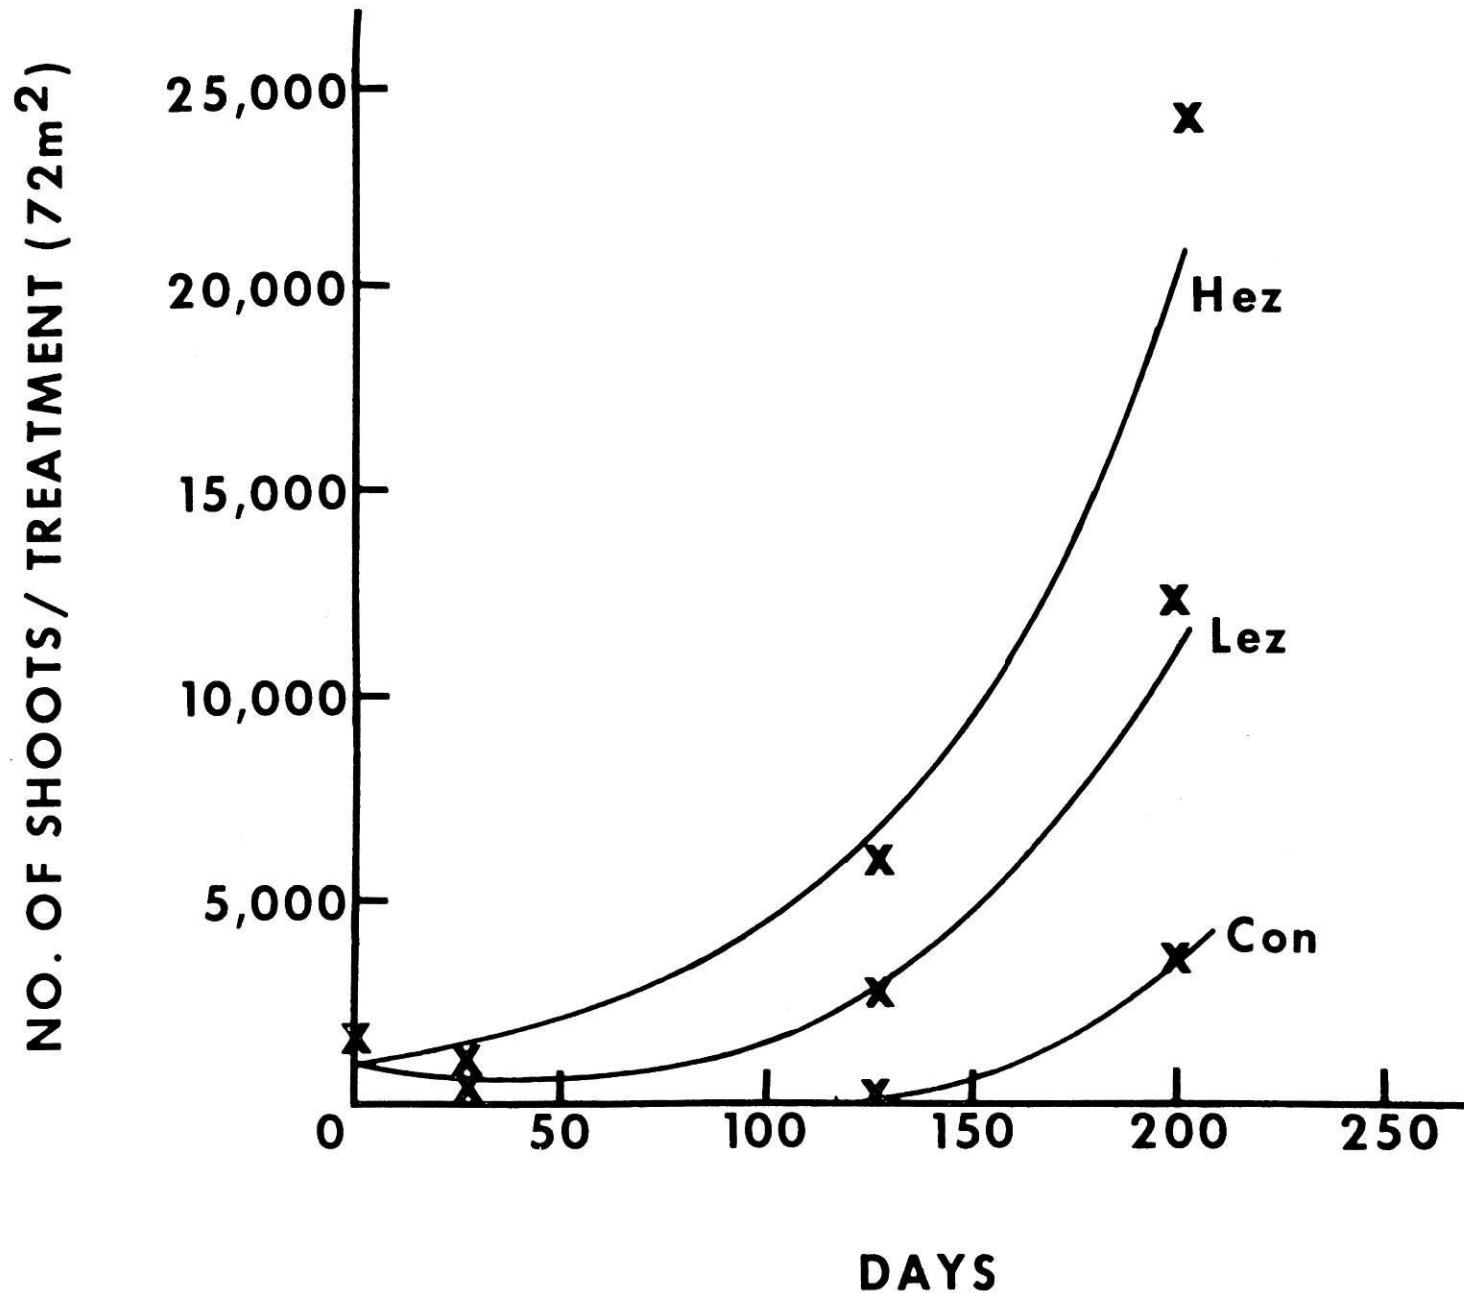
Figure 7. Plots of most successful treatments, HEZ and LEZ, as shoots present/treatment (72 m²) as a function of days. Control is also presented.
