**THE RESTORATION AND CREATION
OF WETLANDS**

PROCEEDINGS OF
THE SIXTH ANNUAL CONFERENCE
ON WETLANDS
RESTORATION AND CREATION

May 19, 1979
Hillsborough Community College
Tampa, Florida

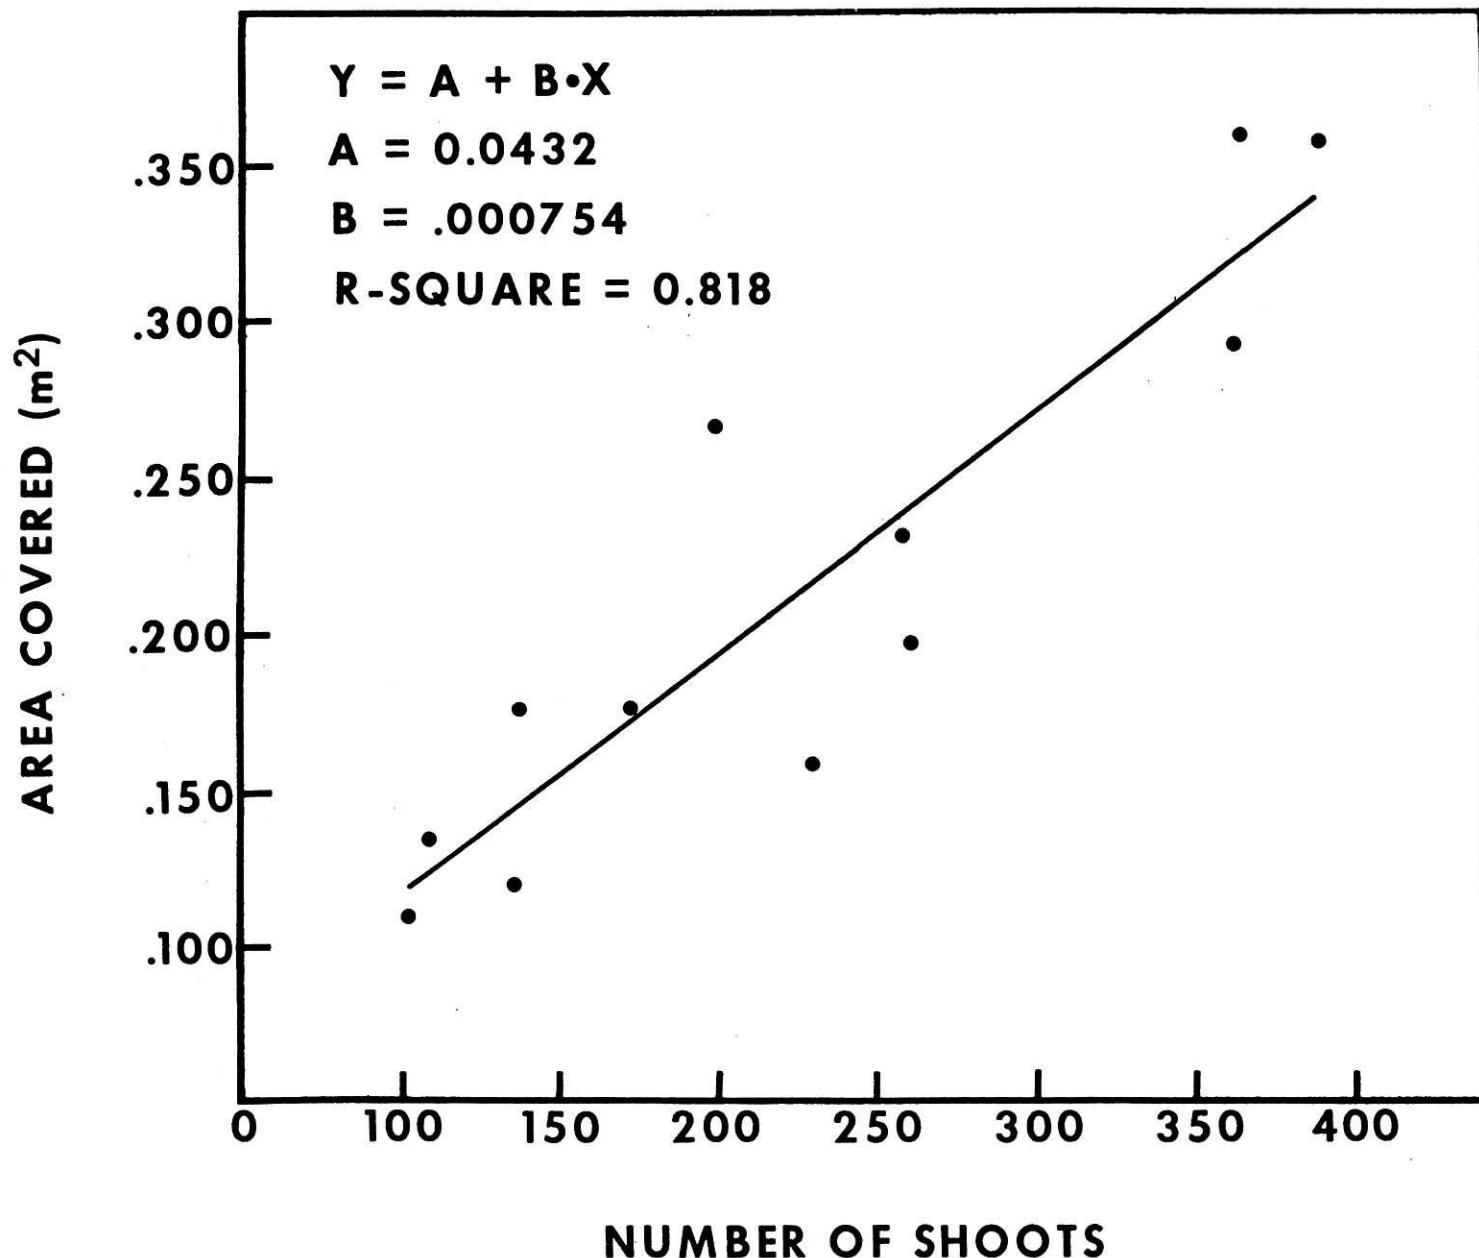
Figure 8. Plot coverage (m^2) as a function of number of shoots present. Included were both HEZ and LEZ treatments in the determination of the regression equation.

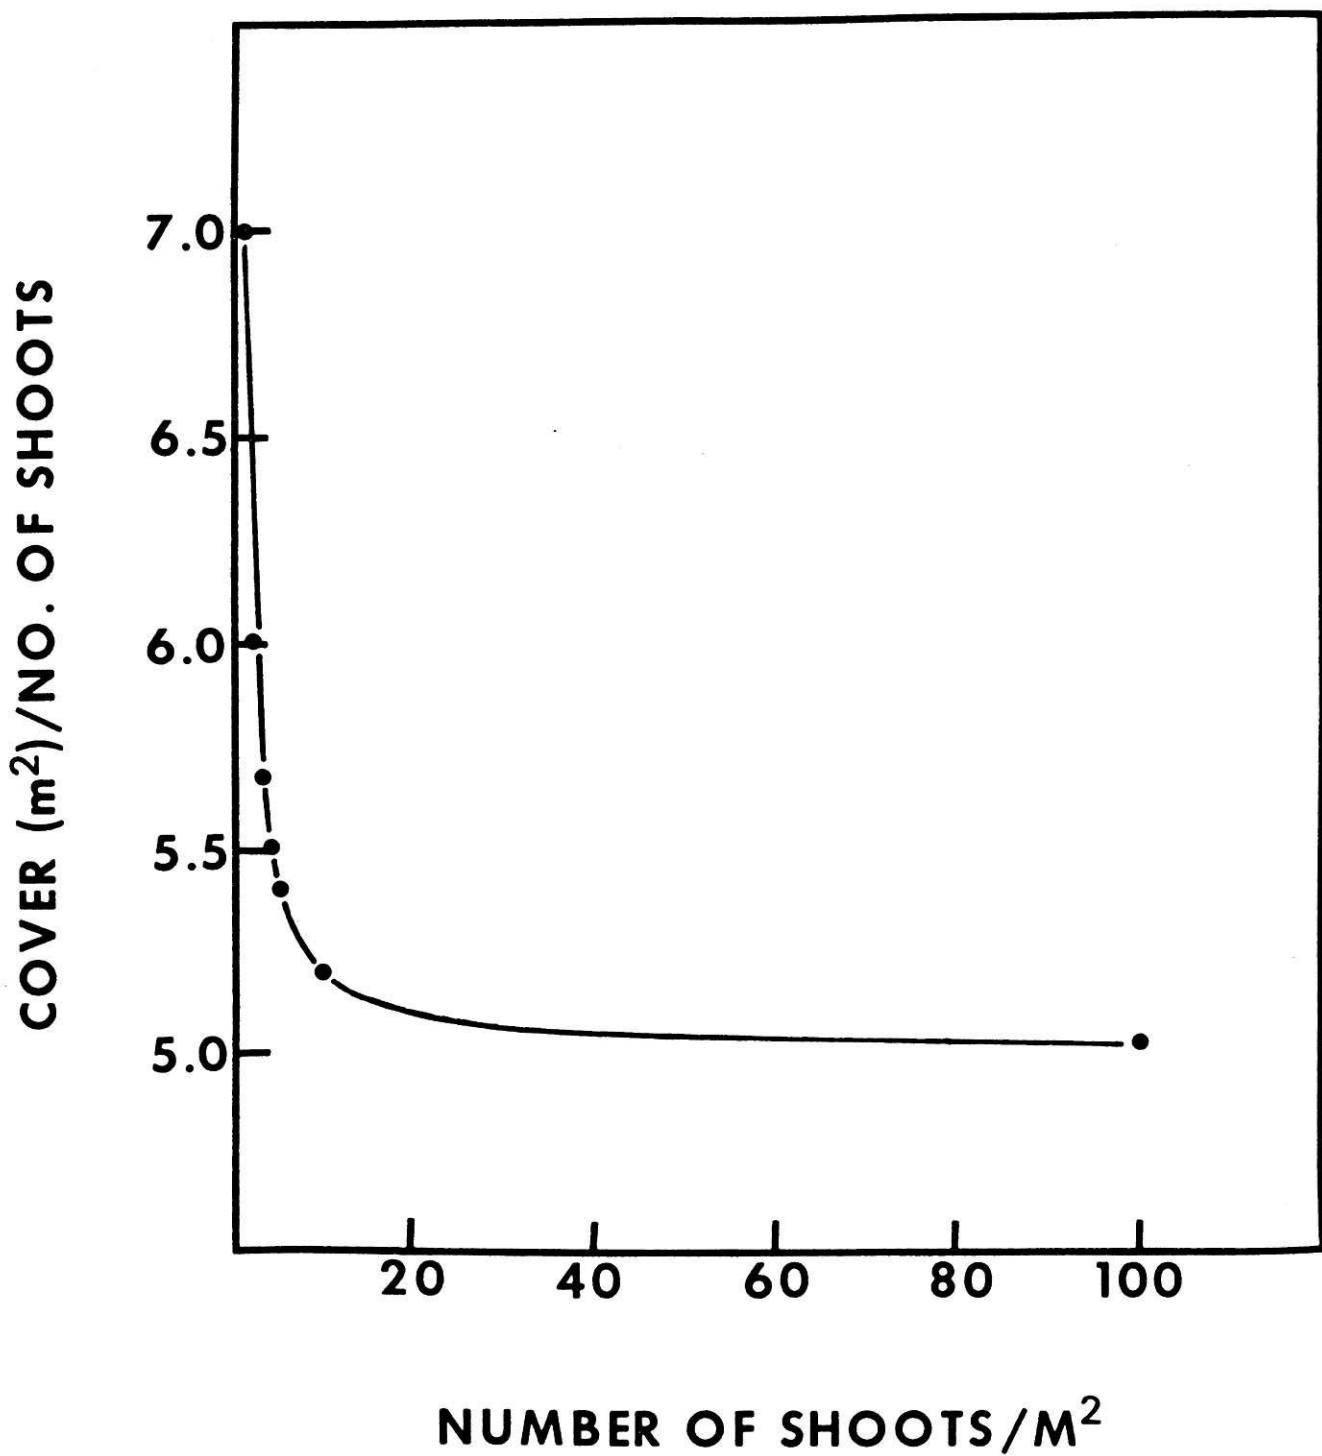
Figure 9. Plot of the ratio of cover (m^2)/ # shoots (y/x = y axis) in respect to the number of shoots present (x = x axis).

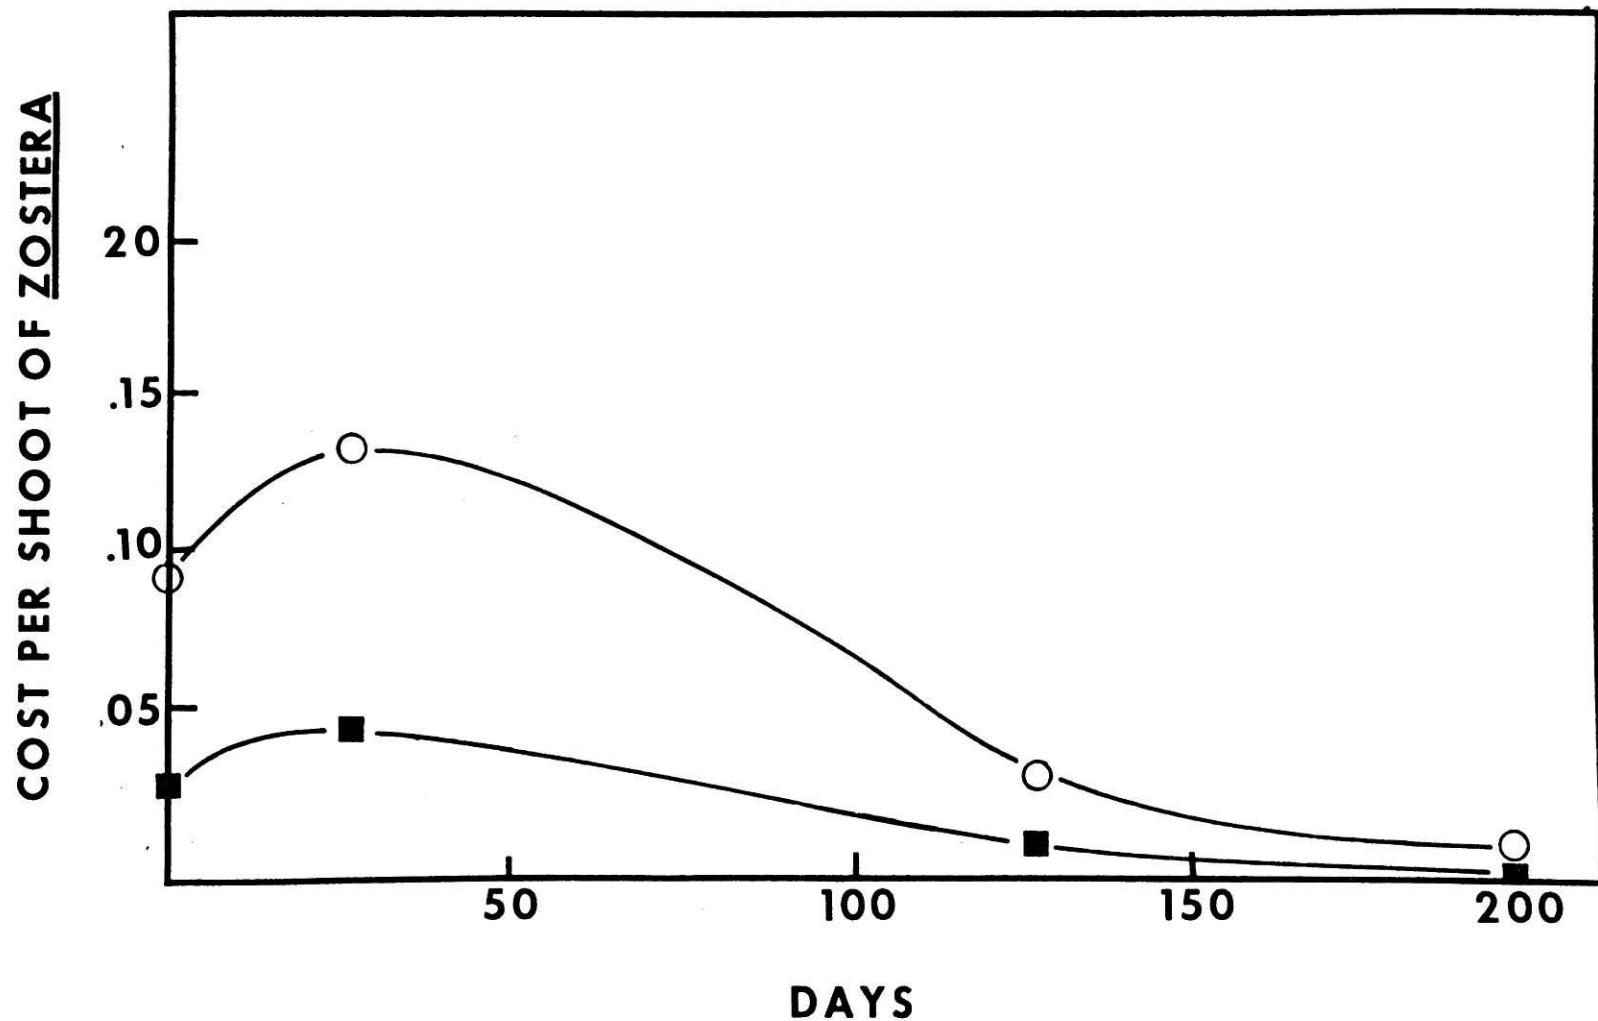
Figure 10. Total transplant cost divided by number of shoots is plotted here against number of days since planting. Top curve is by present technique. Bottom curve is projected cost by technique mechanization.

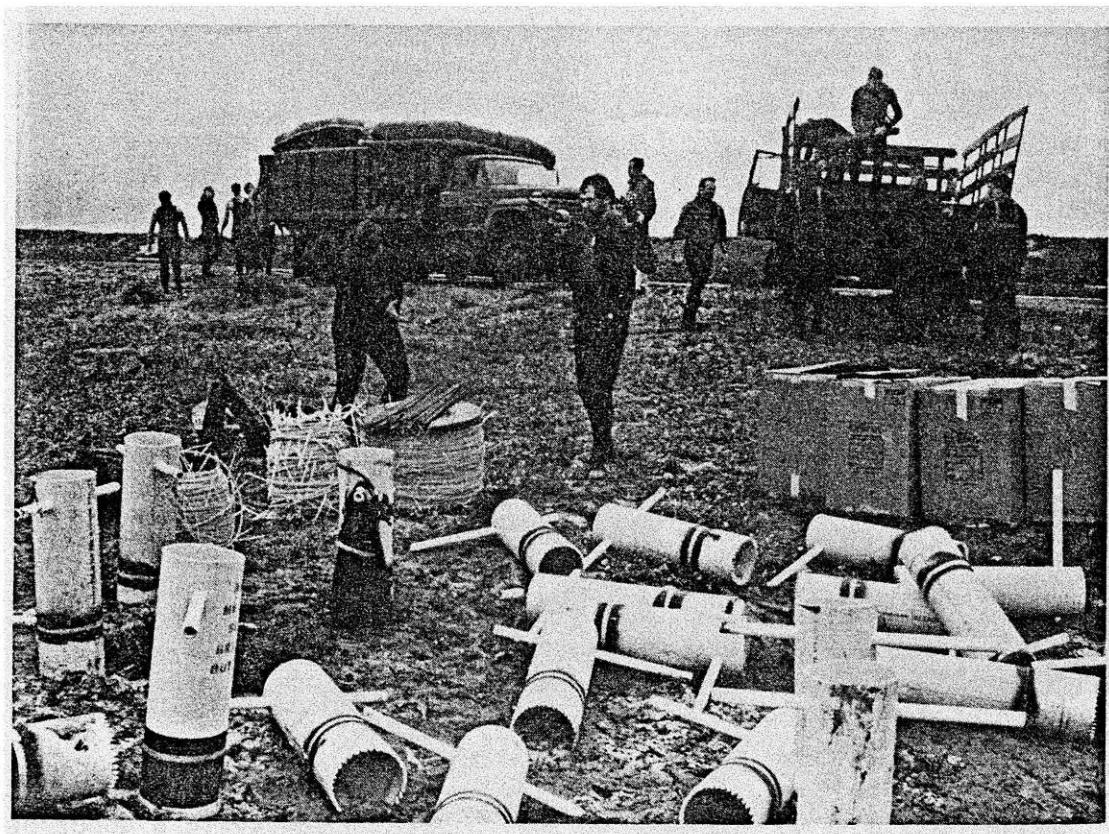
Figure 4. Transplant equipment (e.g., coring devices, cases of pots, grid lines, construction rods, and rubber boats) staged at the Delta Beach transplant site.

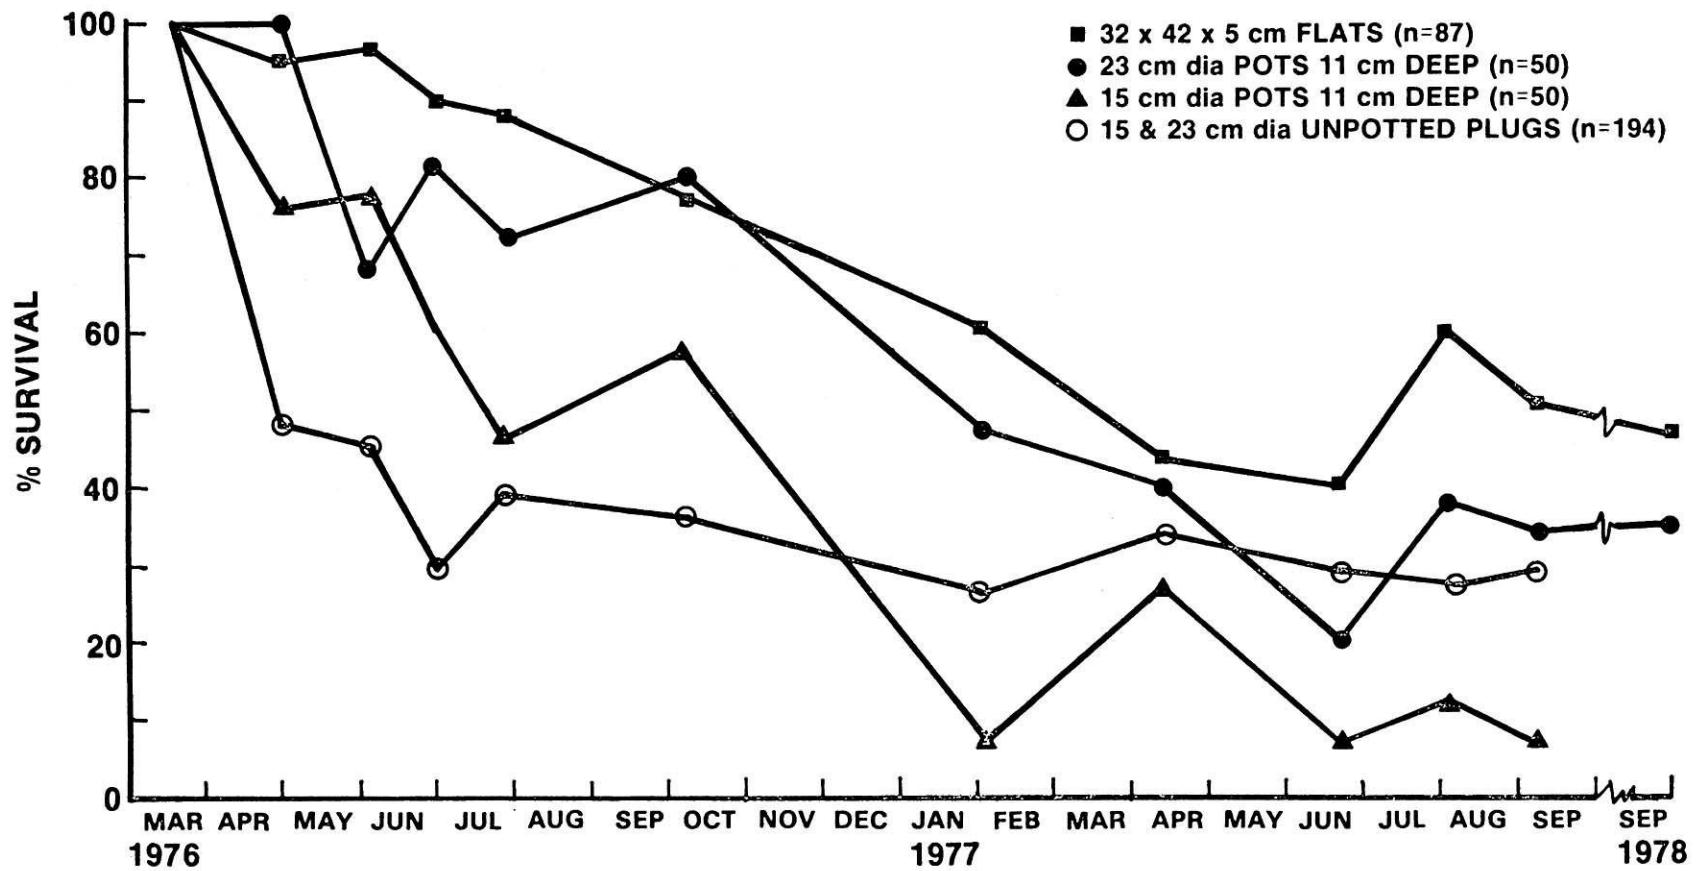
Figure 7. Percent survival of Zostera transplant treatments during the 2.5 year Pilot Study.
