# **Proceedings of the seventh Annual Conference on the Restoration and Creation of Wetlands, May 16-17, 1980. 1980**

**THE RESTORATION AND CREATION  
OF WETLANDS**

Sponsored by  
**Hillsborough Community College  
Environmental Studies Center  
at Cockroach Bay  
in cooperation with the  
Tampa Port Authority**

**May 16 - 17, 1980**

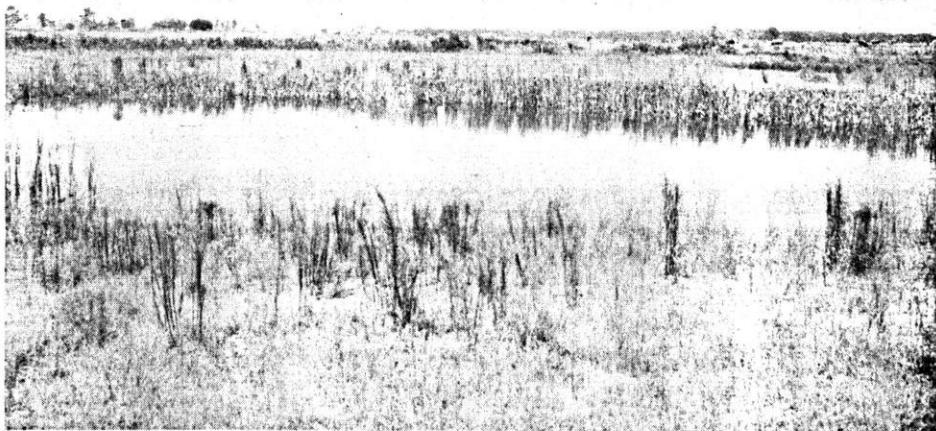
Figure 1. Control marsh - August 1980.

The seventy (70) species of plants present in the control marsh by November 1979, were confined to a narrow band near the edge of the marsh (Figure 1). Cattails (Typha latifolia) were the dominant invading

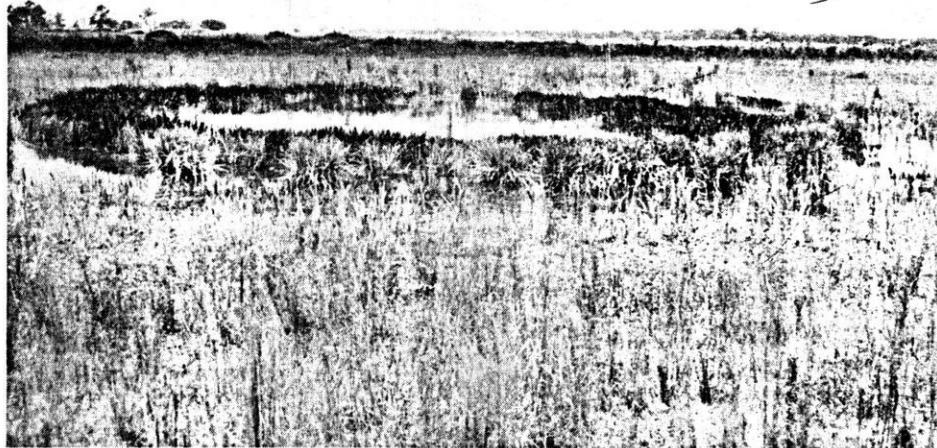
Figure 2. Planted marsh - August 1980.

The planted marsh contained 76 species of plants by November 1979. The dominant species were pickerel weed, maidencane, and soft rush, which are plants which were selectively planted. The additional plants were in the shallow water near the edge of the marsh (Figure 2).

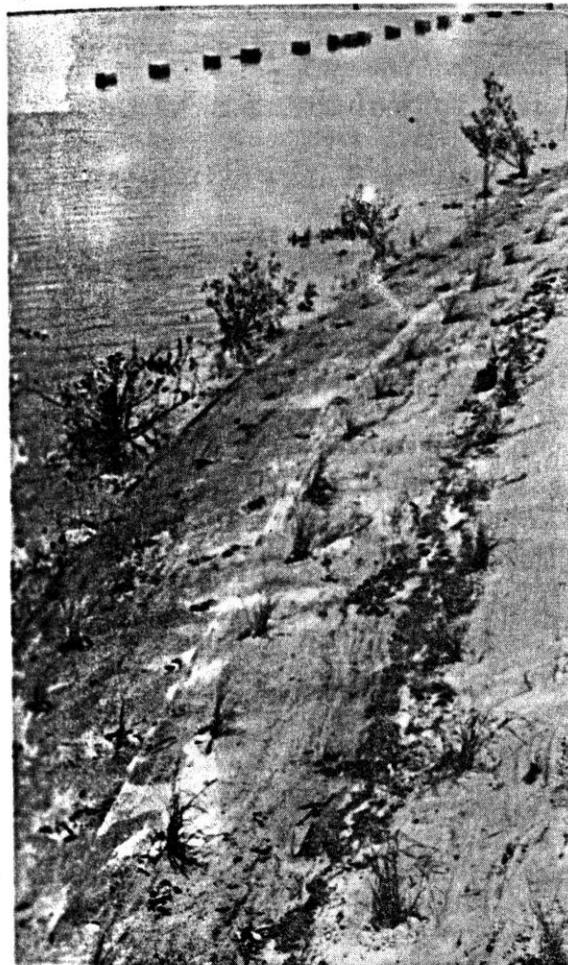
Figure 5. View looking east of the completed cordgrass plantings and mangroves, June 1979.

After seven months (Figures 5 and 6), the Paspalum showed tremendous growth and covered almost 100% of the planted area. The cordgrass was slower in growing and only about 20% of the plants remained in January. However, the remaining plants were established and spreading rapidly. The Bahia sod took readily with no problems. The mangroves planted by the residents survived with the exception of one large black mangrove.

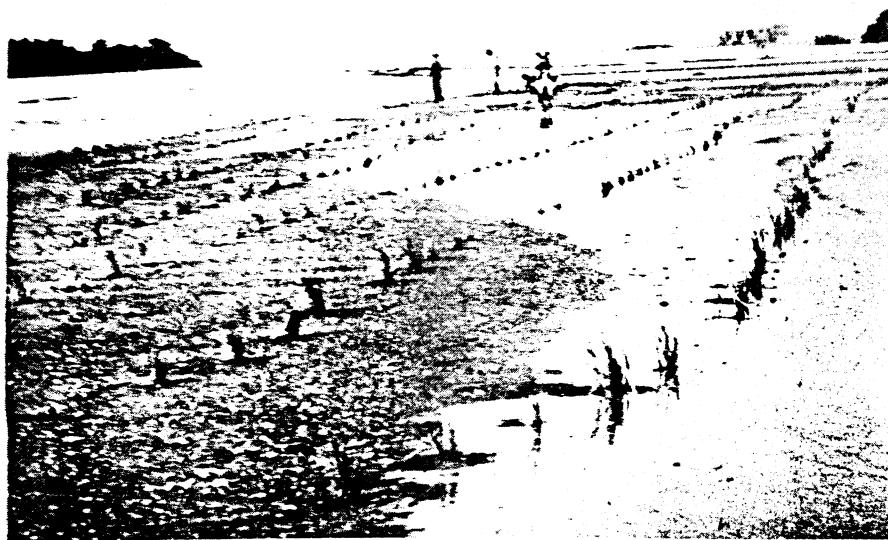
Figure 2. Photograph showing placement of smooth cordgrass plugs on 1 m centers with rows 2 m apart..

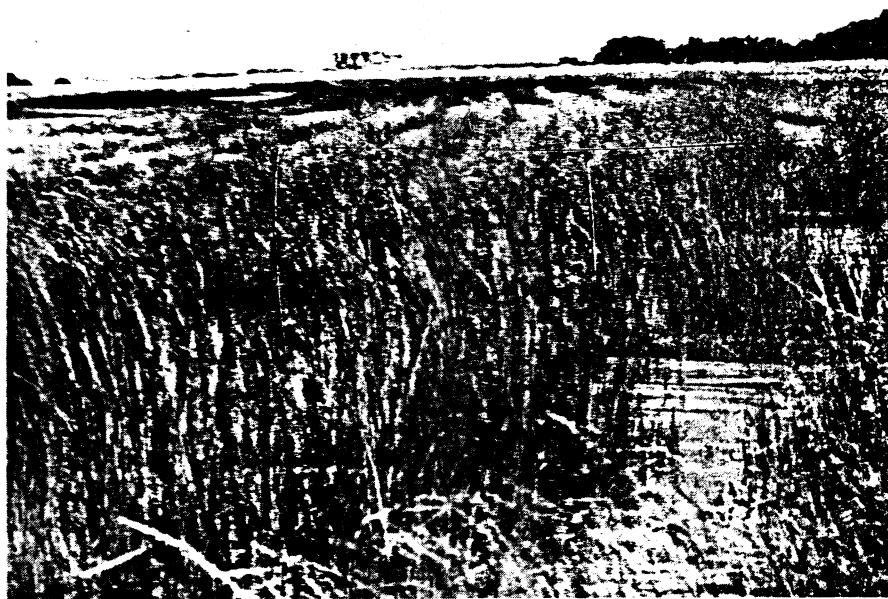
Figure 3. Photograph showing same area as in Fig. 2, 14 months later.

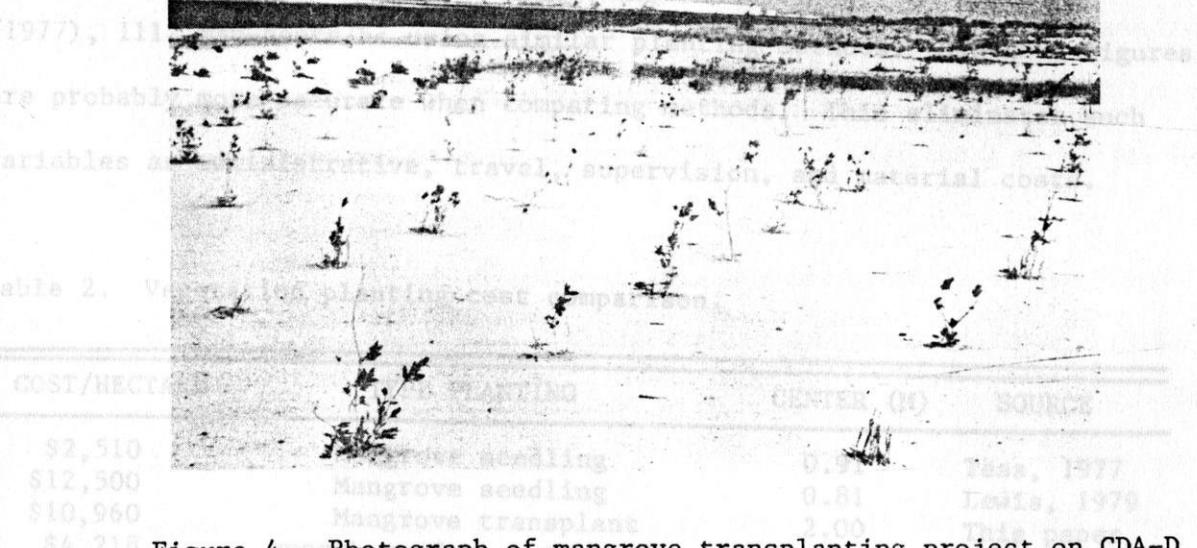
Figure 4. Photograph of mangrove transplanting project on CDA-D.

After 13 months the CDA-D mangroves exhibited 73.3% survival (Fig. 4). Losses were primarily in the lower areas. No difference was found between black and white mangrove survival or between cropped and non-cropped plants. In many cases, severe winter weather and shock produced leaf drop the first year. However, most of these mangroves have recovered. A small number (ca. 10) of mangroves produced flowers last season and are producing seeds this year.
