Measured drawings of some colonial and Georgian houses. Volume 3 1930

Measured Drawings
of
Some Colonial
and
Georgian Houses

by
Donald Millar

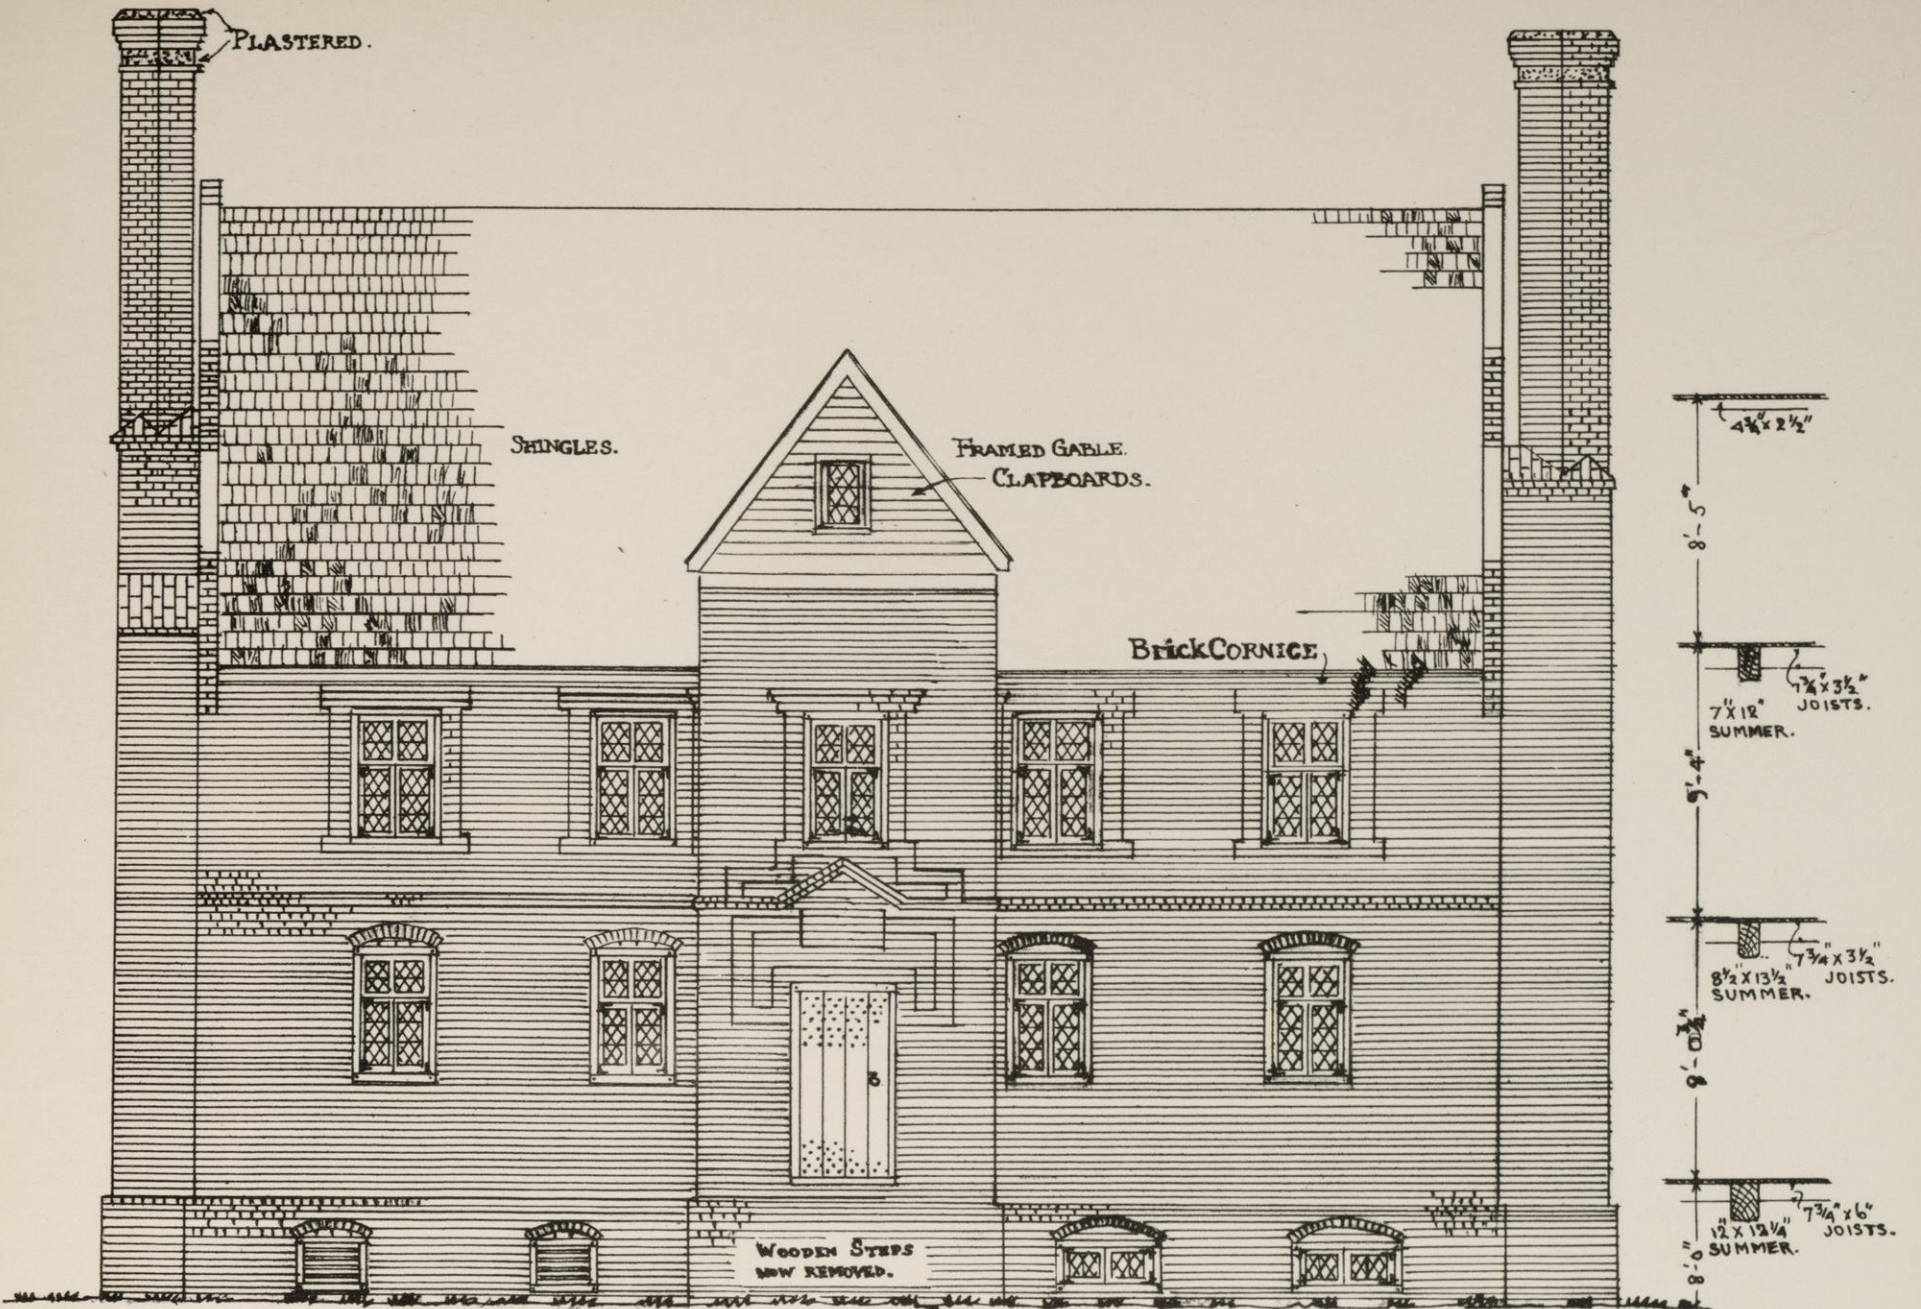
SOUTH OR FRONT ELEVATION - RESTORED.

Arthur Allen built this house about 1655. During Bacon's Rebellion in 1676 the rebels seized it and since then it has retained its present title. It is an house of Jacobean England showing characteristics of East Anglian brickwork in gables and chimneystacks. The projecting brick window trim is unusual. About 1854 a large house was added to the eastern end and alterations made which erased the moulded trim around the doorway, which has been restored from an old wood-engraving.

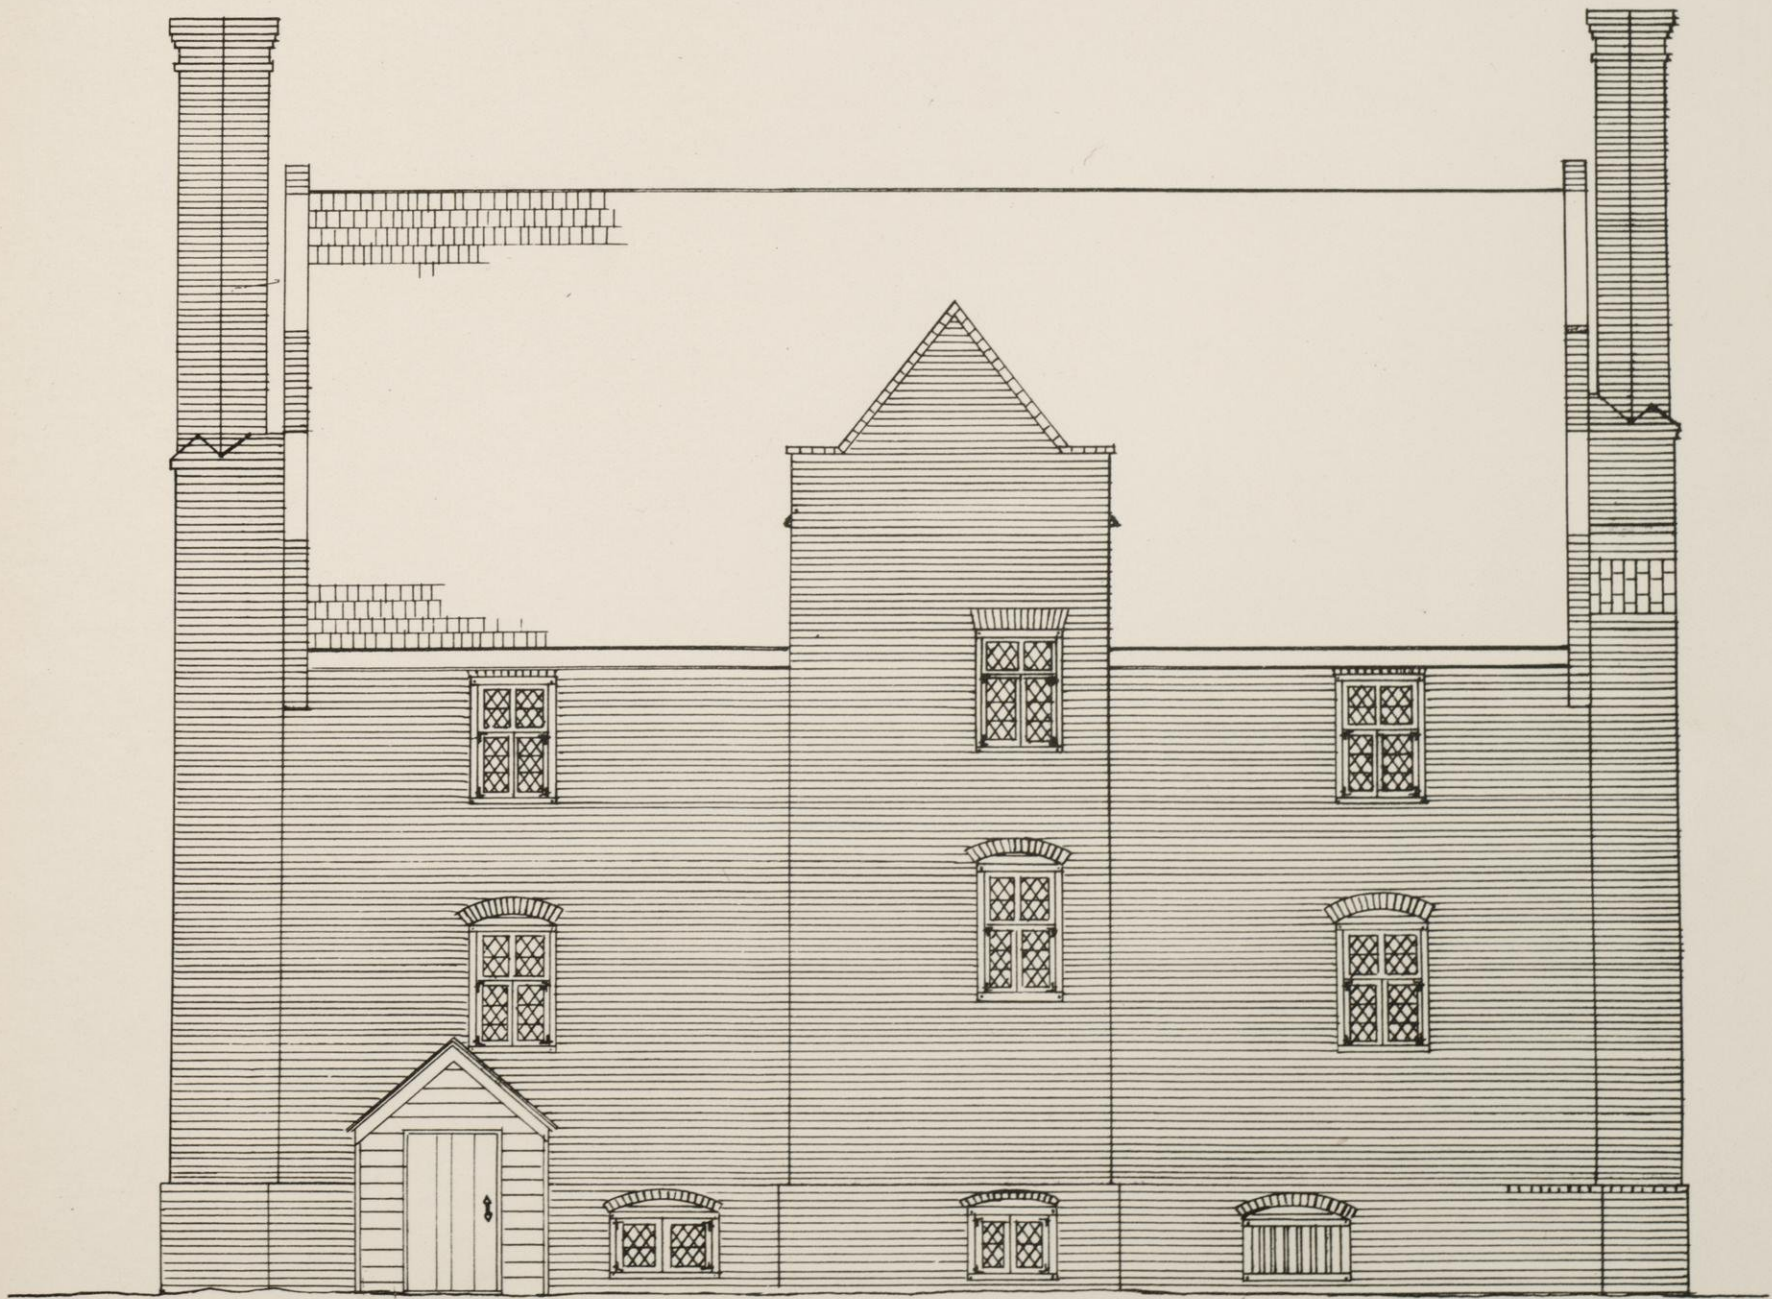
North Elevation.

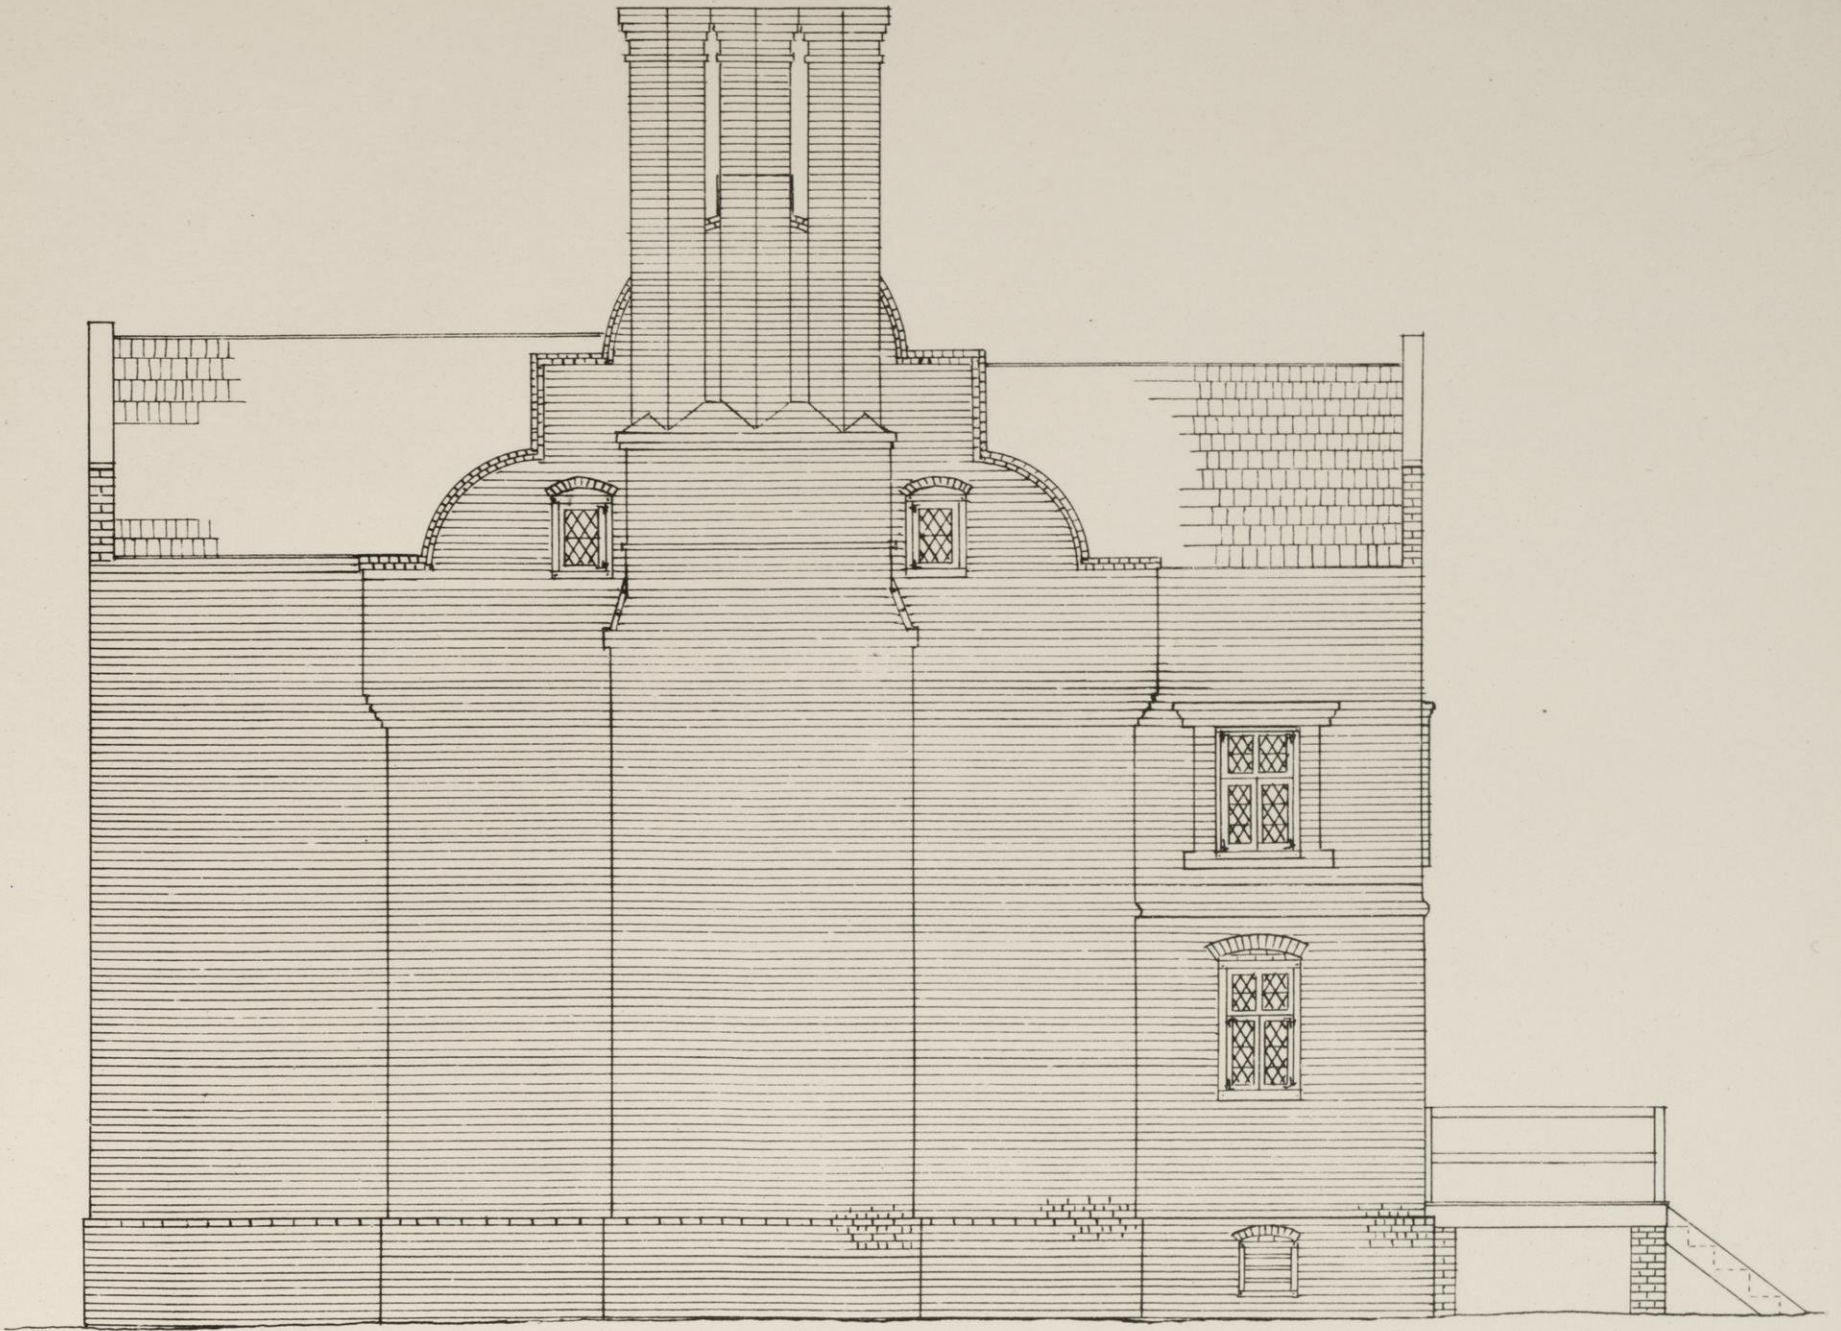
West Elevation.

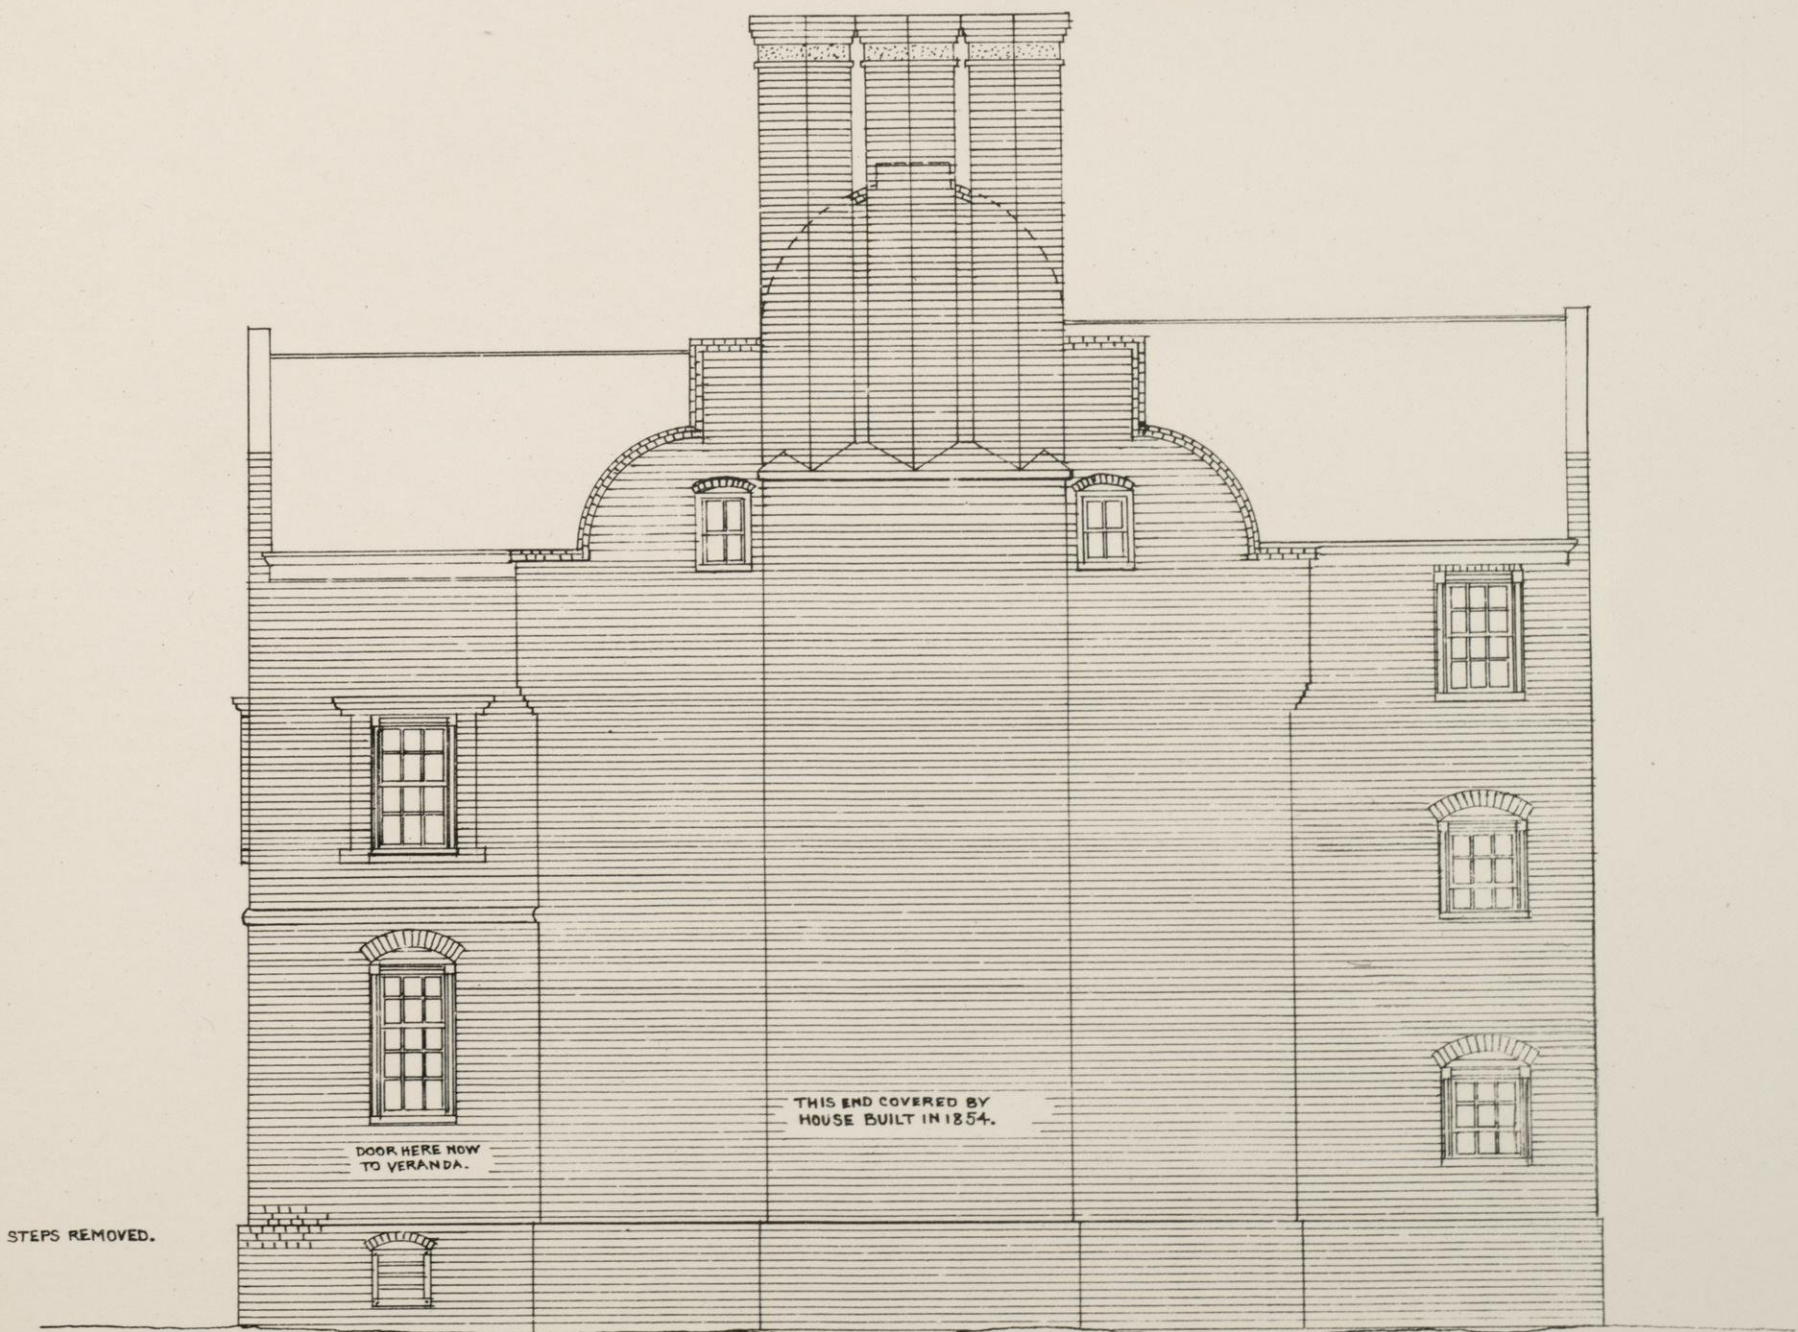
East Elevation.

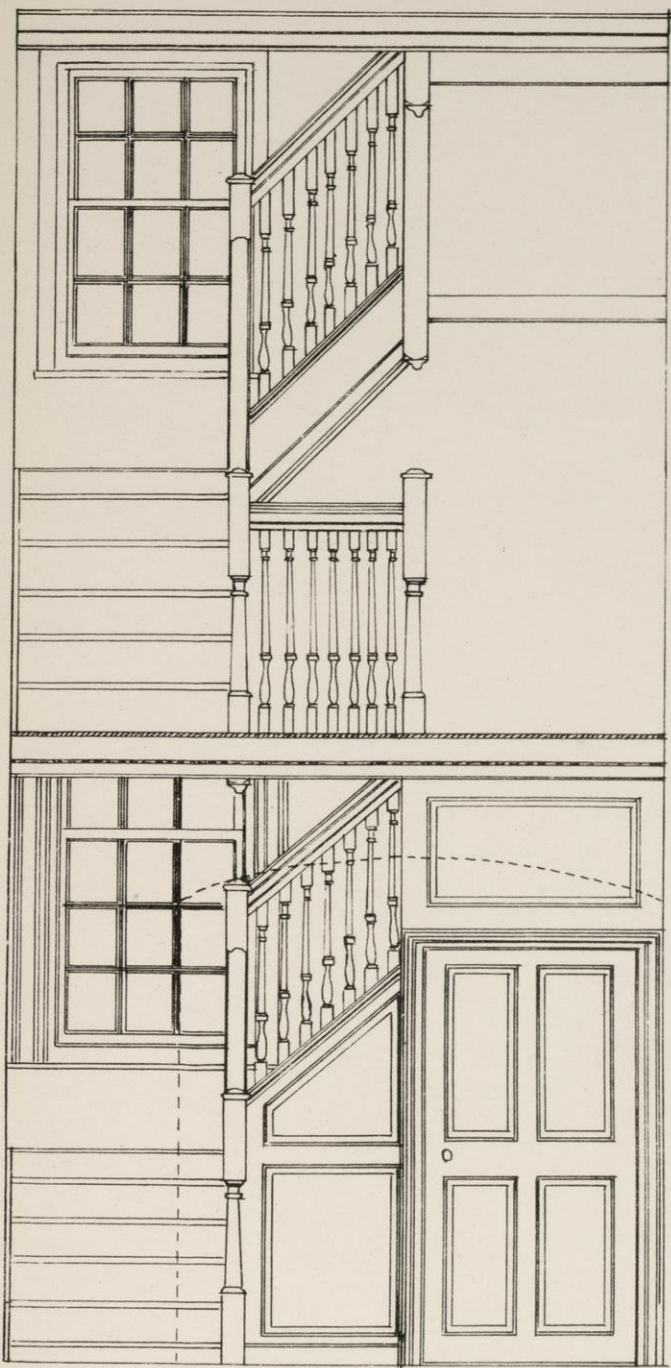
Stair- Showing Arch from Hall.

The stairs seem to date from the early Eighteenth Century, as does the panelling in the lower rooms. The construction is plainly shown in the drawings. A high brick wall once surrounded the house, which must have been useful for defence. The Dining-Room panelling is most effective with its small panels. Some details are crude, perhaps the work of unskilled negro labour.

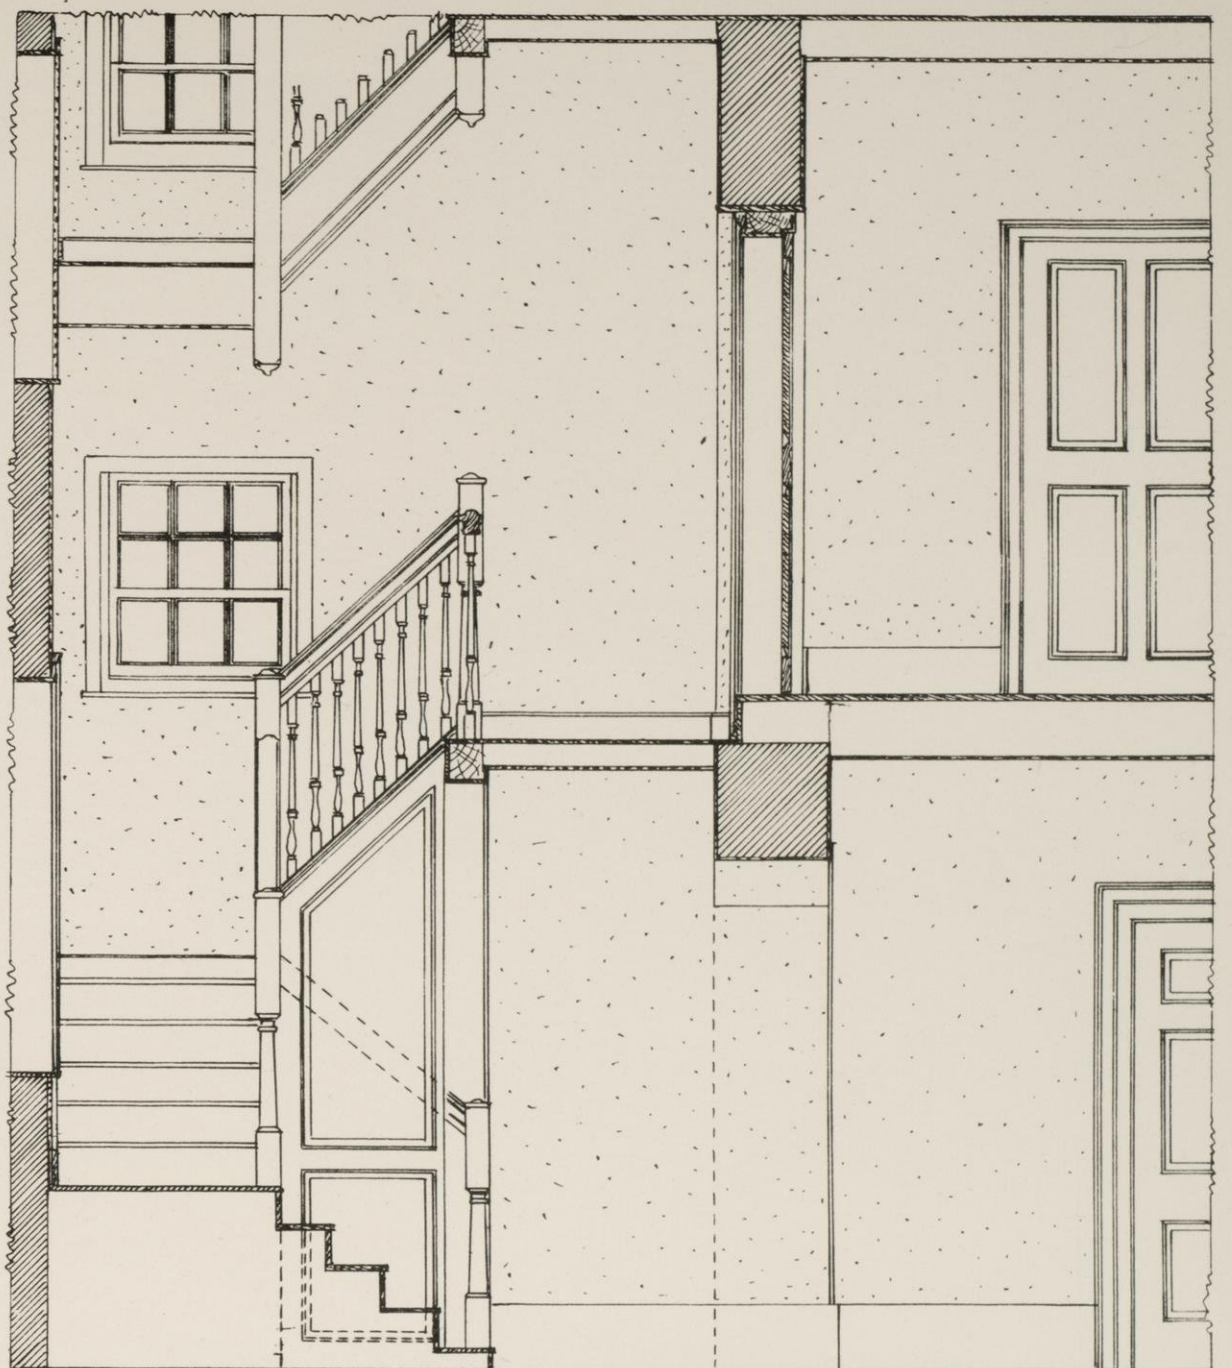
Section-Showing Stair and Arch.

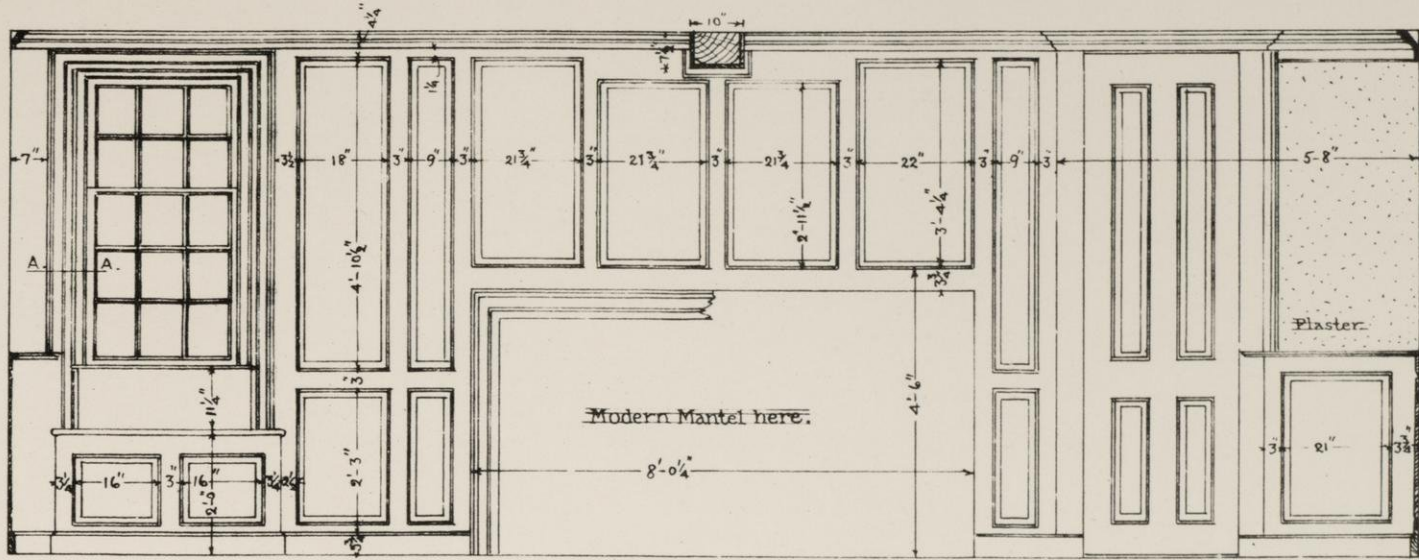
West Side of Parlour. Scale = 1/4" = 1'-0"

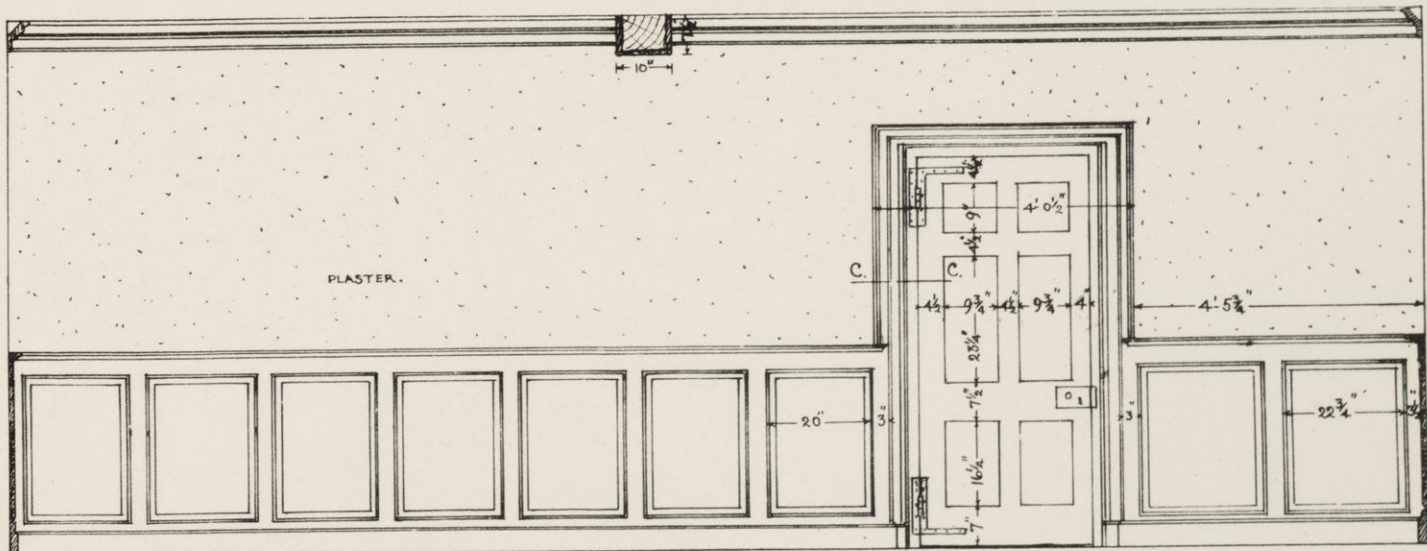
East Side of Parlour.

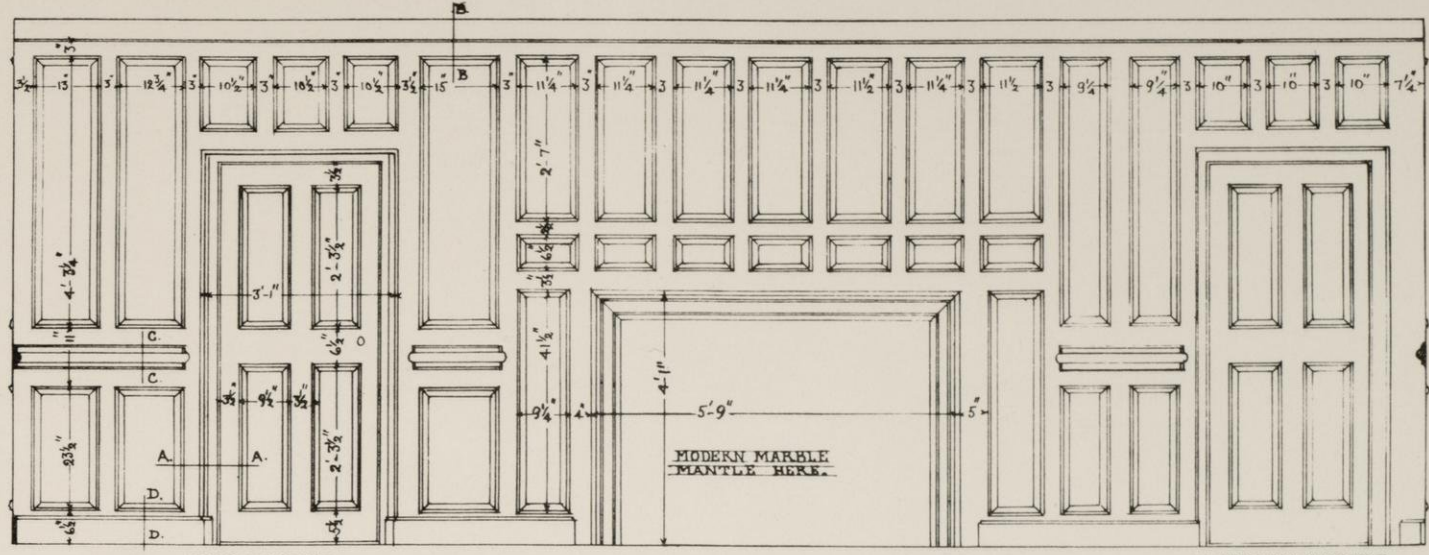
East Side of Dining Room - Panelling of about 1715.

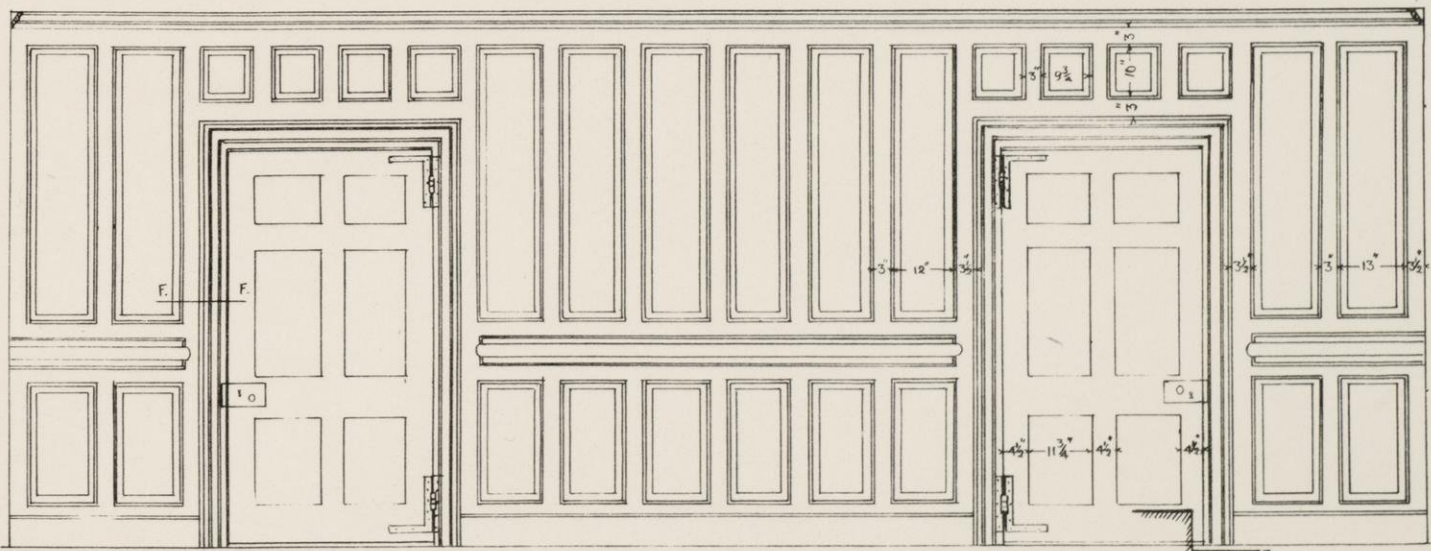
West Side of Dining Room. Scale: 1/2" = 1'-0"

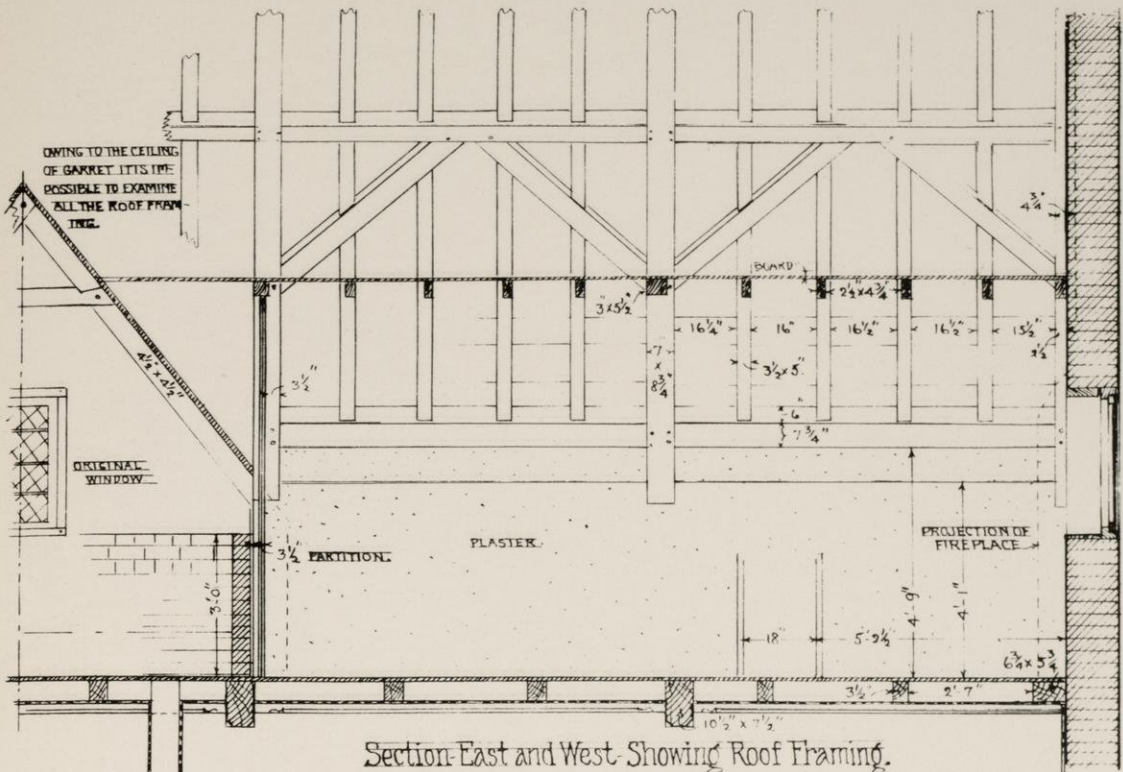
Section-East and West Showing Roof Framing.

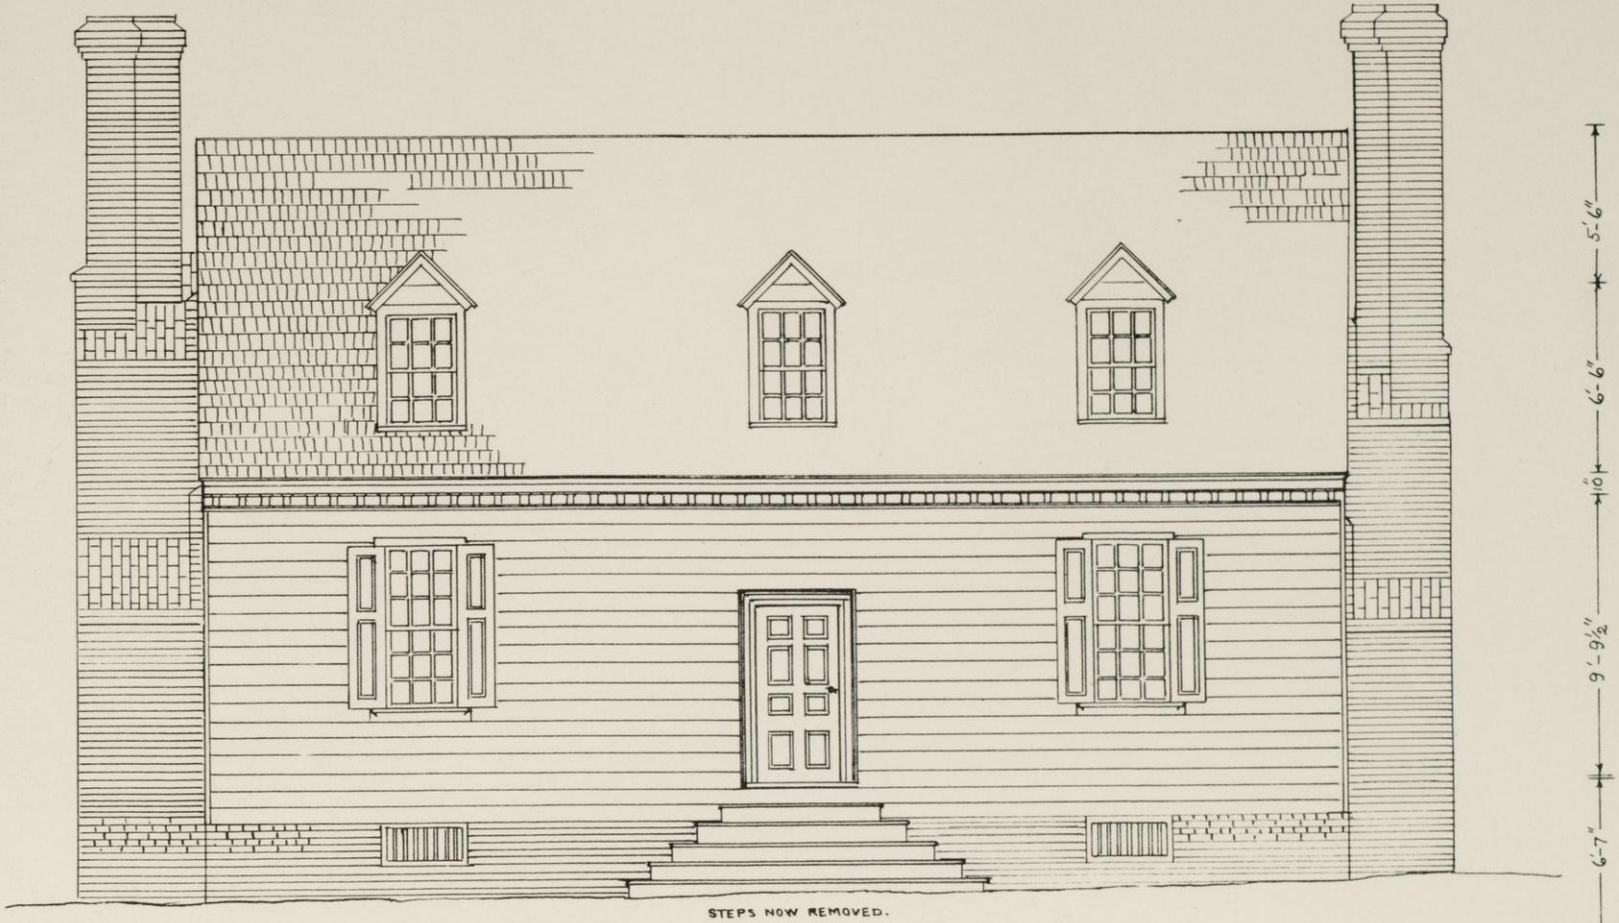
STEPS NOW REMOVED.

NORTH OR STREET ELEVATION.

This is a typical Virginia small house, set on a high brick foundation, with chambers under a sloping roof with narrow, well-proportioned dormers. The excellent construction of the brick chimneys should be noted. There was a typical Virginia porch added about 1820, now removed. The china-closet on the west end is casually supported on a post. The stair is good. Late mantels have destroyed the earlier fireplace surrounds, undoubtedly heavy bolection mouldings.

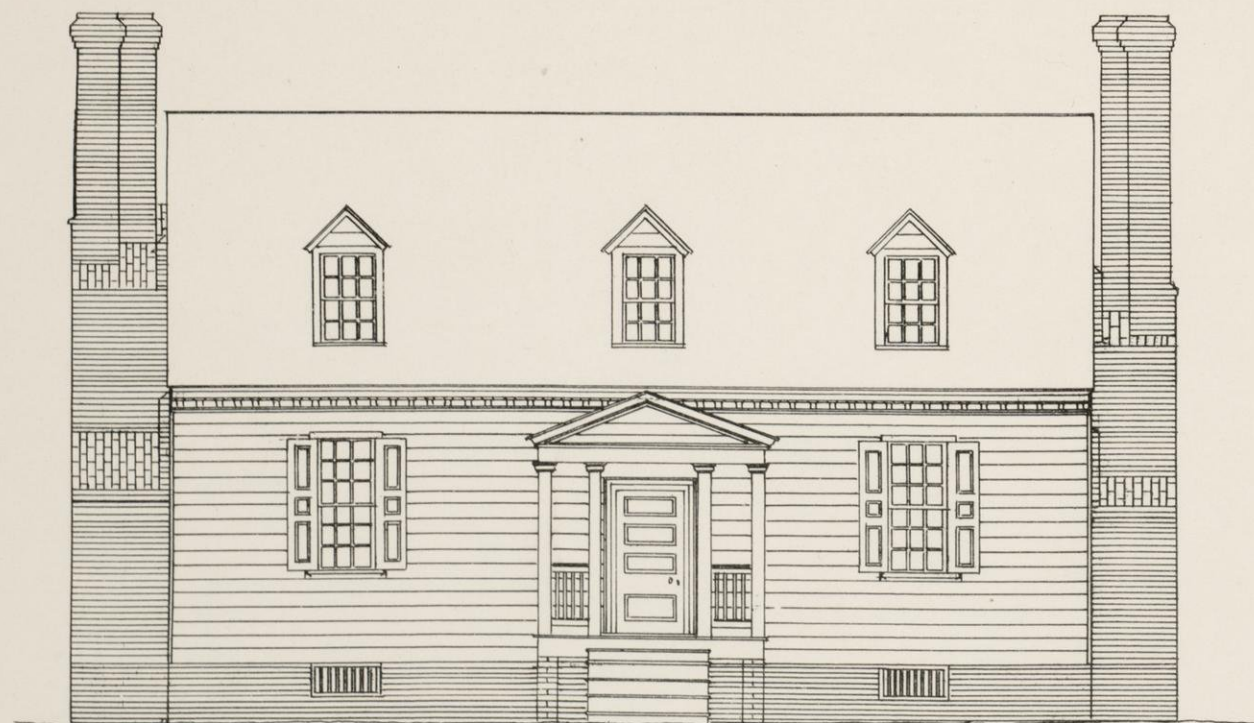
OLD STEPS NOW DESTROYED.
ONLY FILASTERS OF PORCH REMAIN.

NORTH OR STREET ELEVATION, ABOUT 1820.

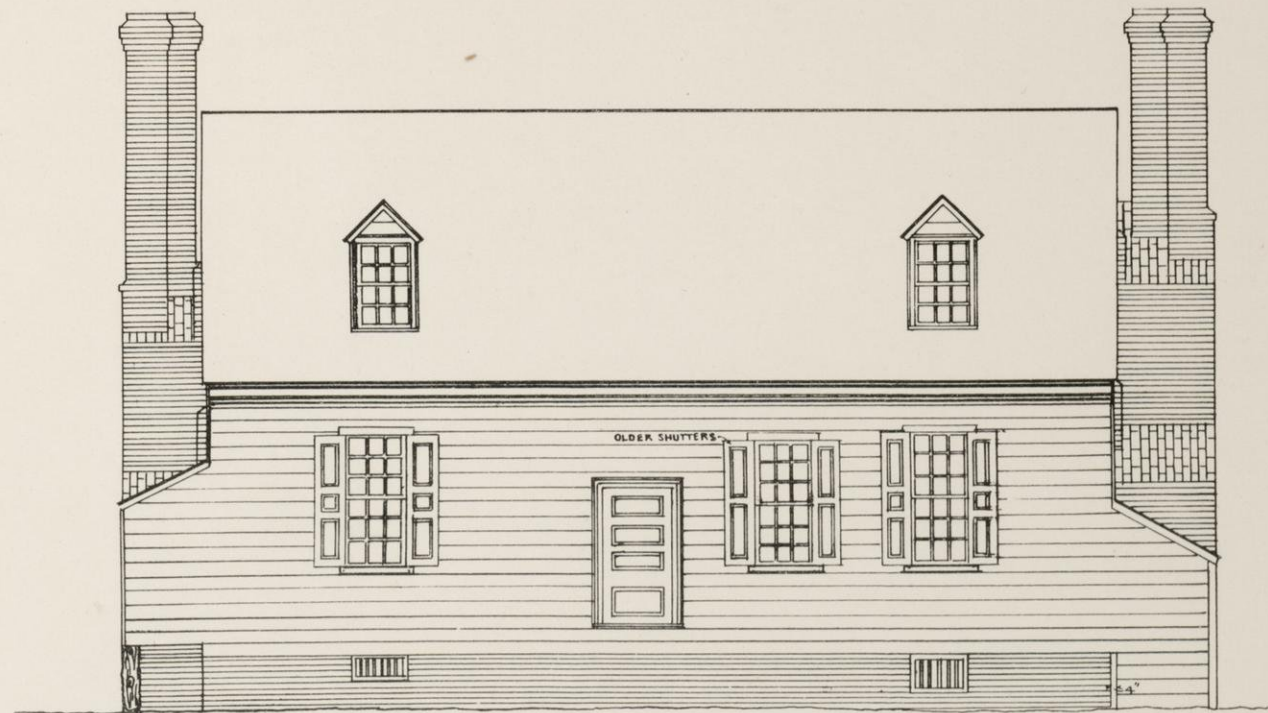
STEPS NOW DESTROYED.

SOUTH OR REAR ELEVATION.

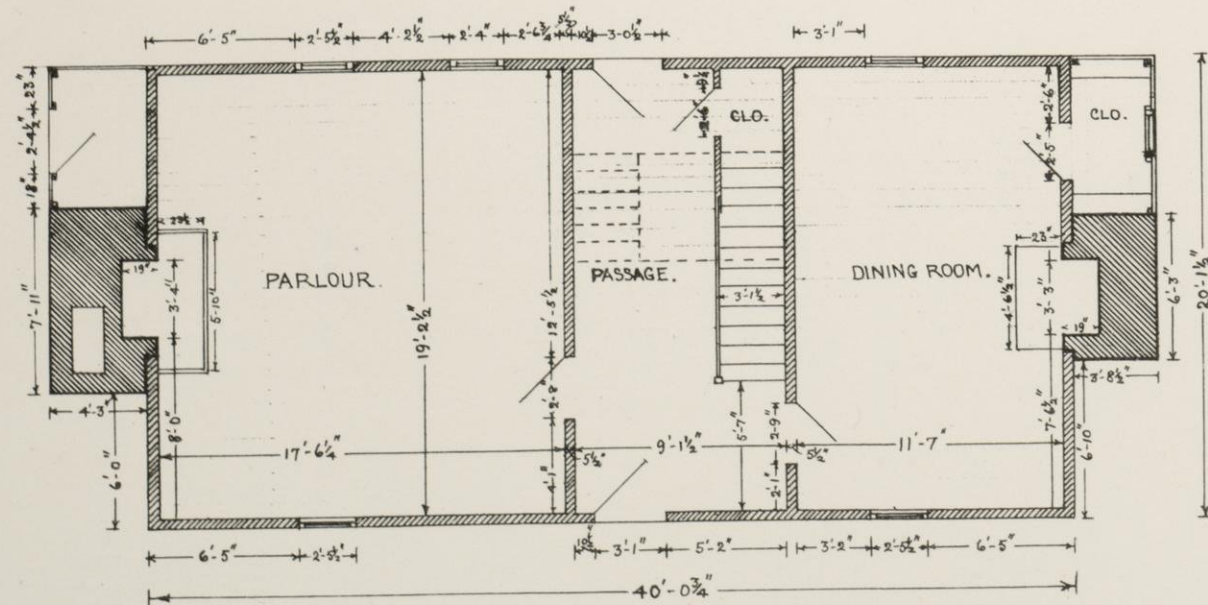
PLAN OF FIRST FLOOR.
