Measured drawings of some colonial and Georgian houses. Volume 3 1930

Measured Drawings
of
Some Colonial
and
Georgian Houses

by
Donald Millar

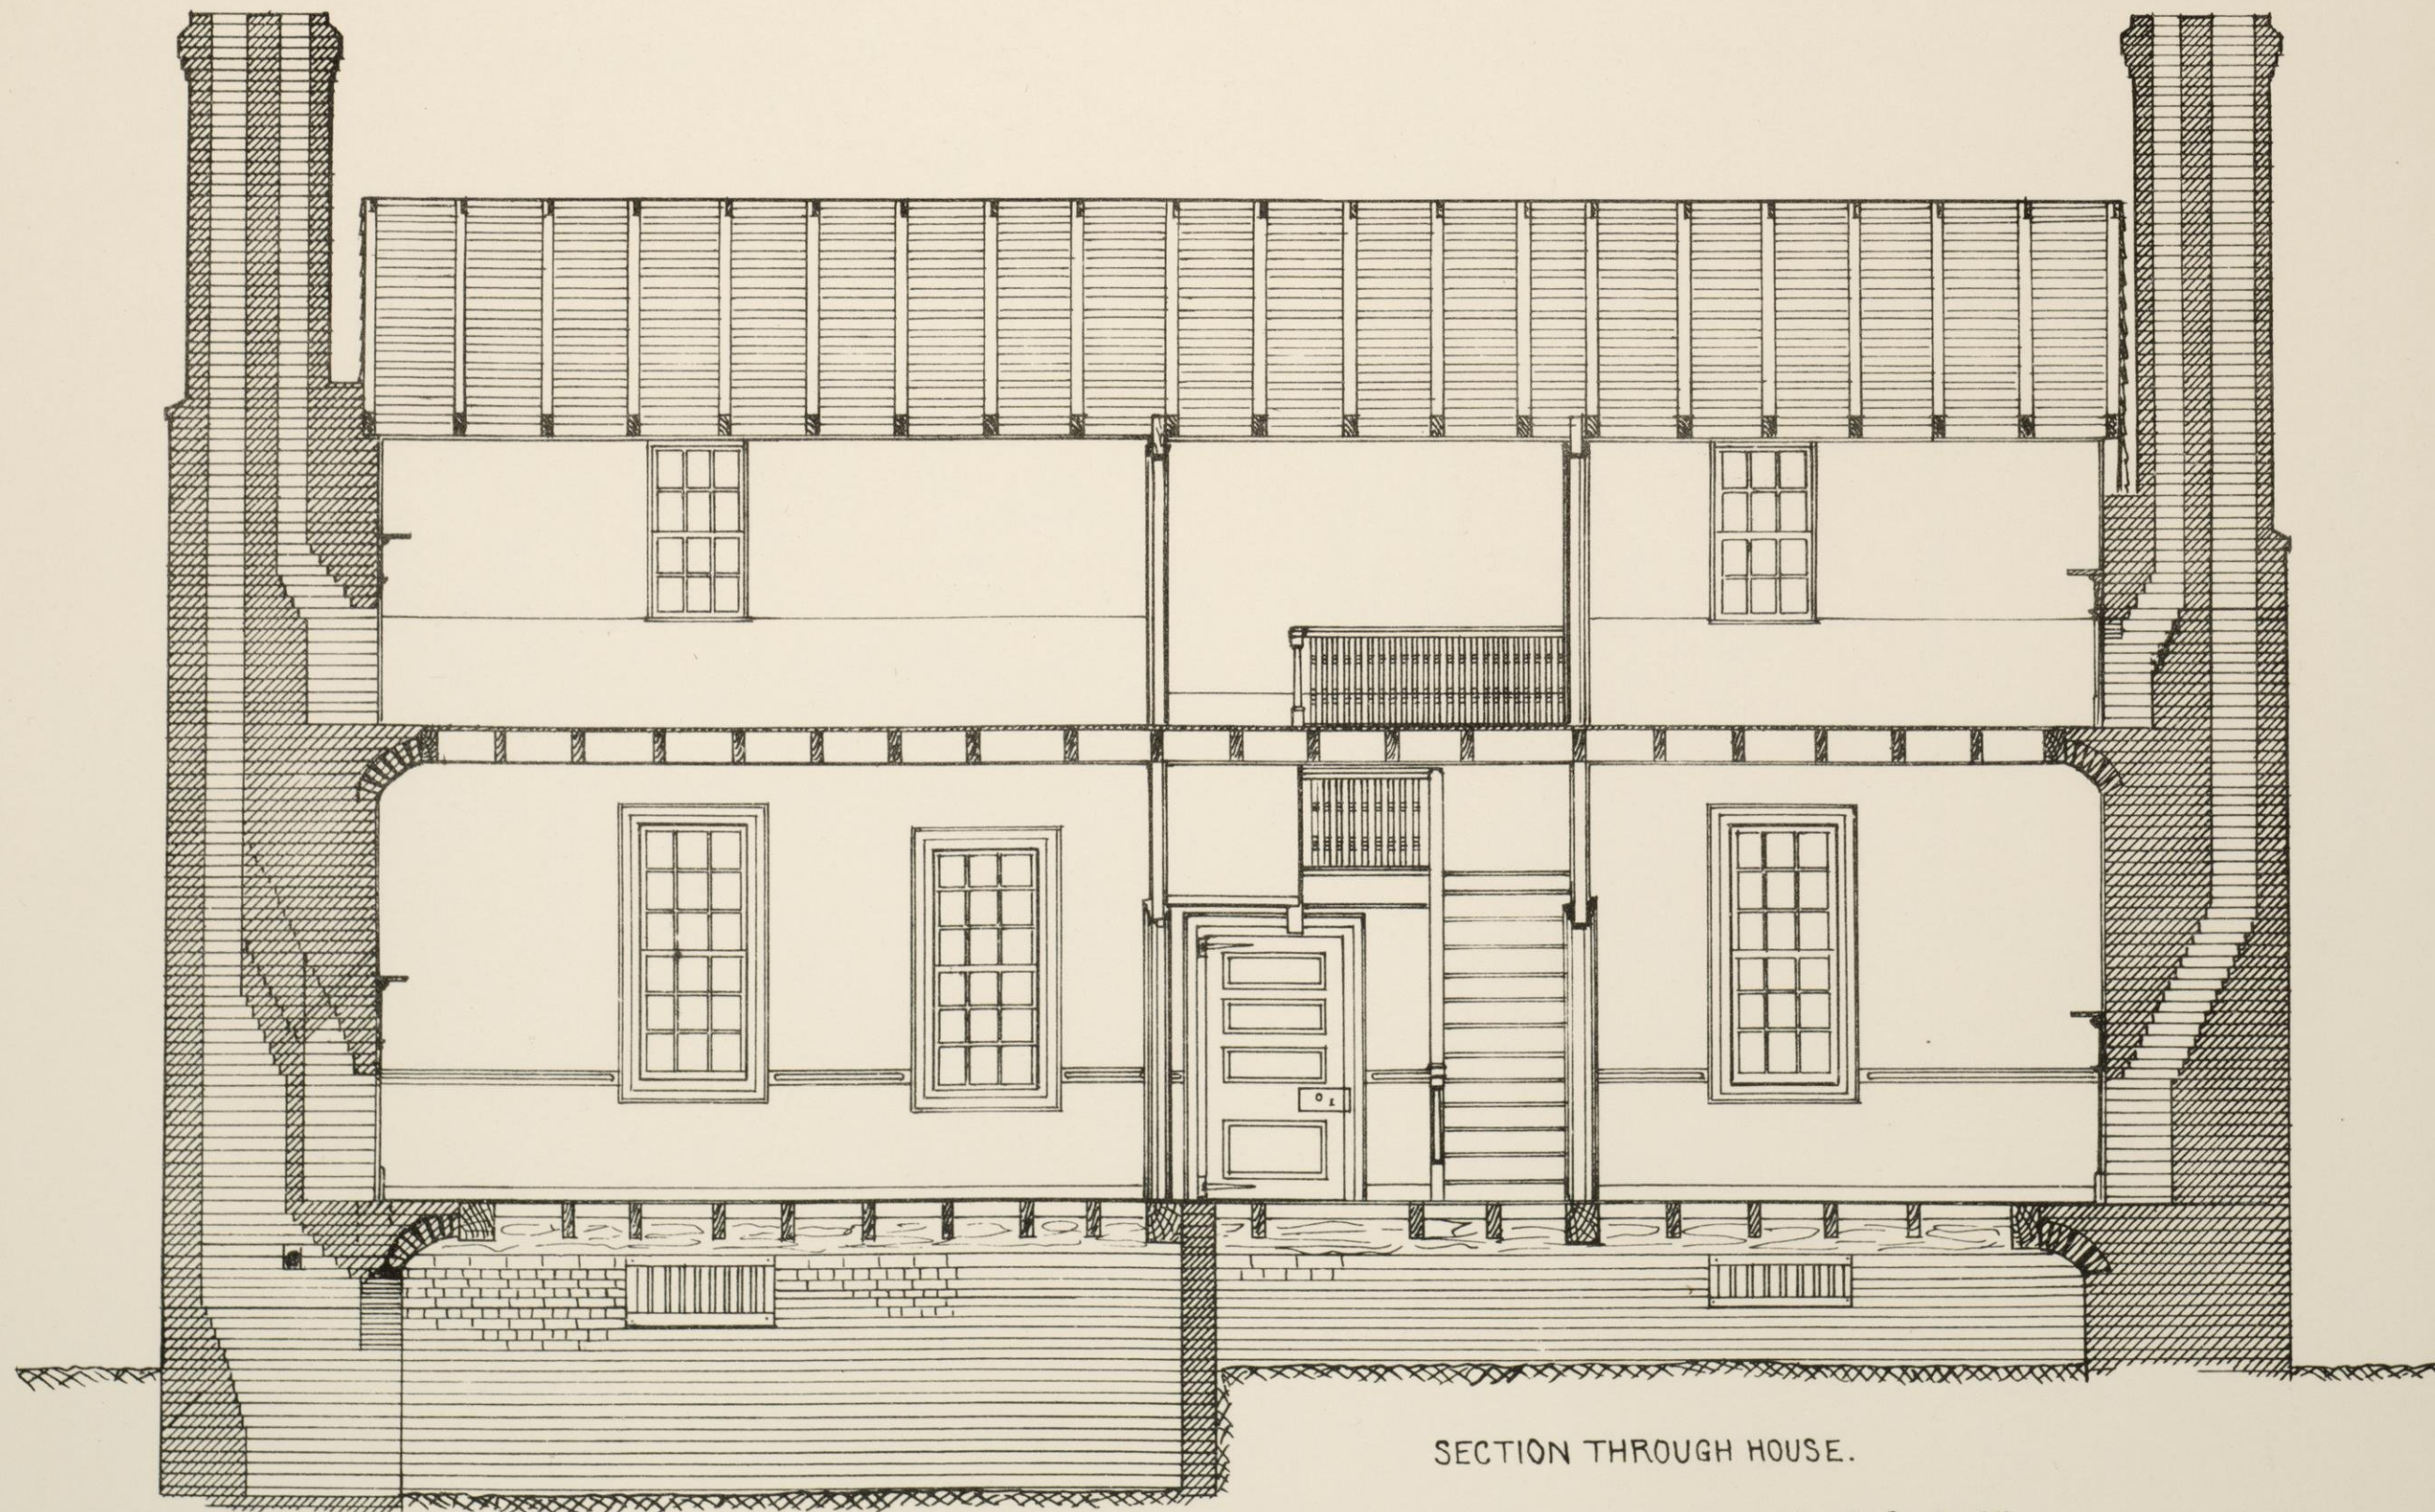
SECTION THROUGH HOUSE.

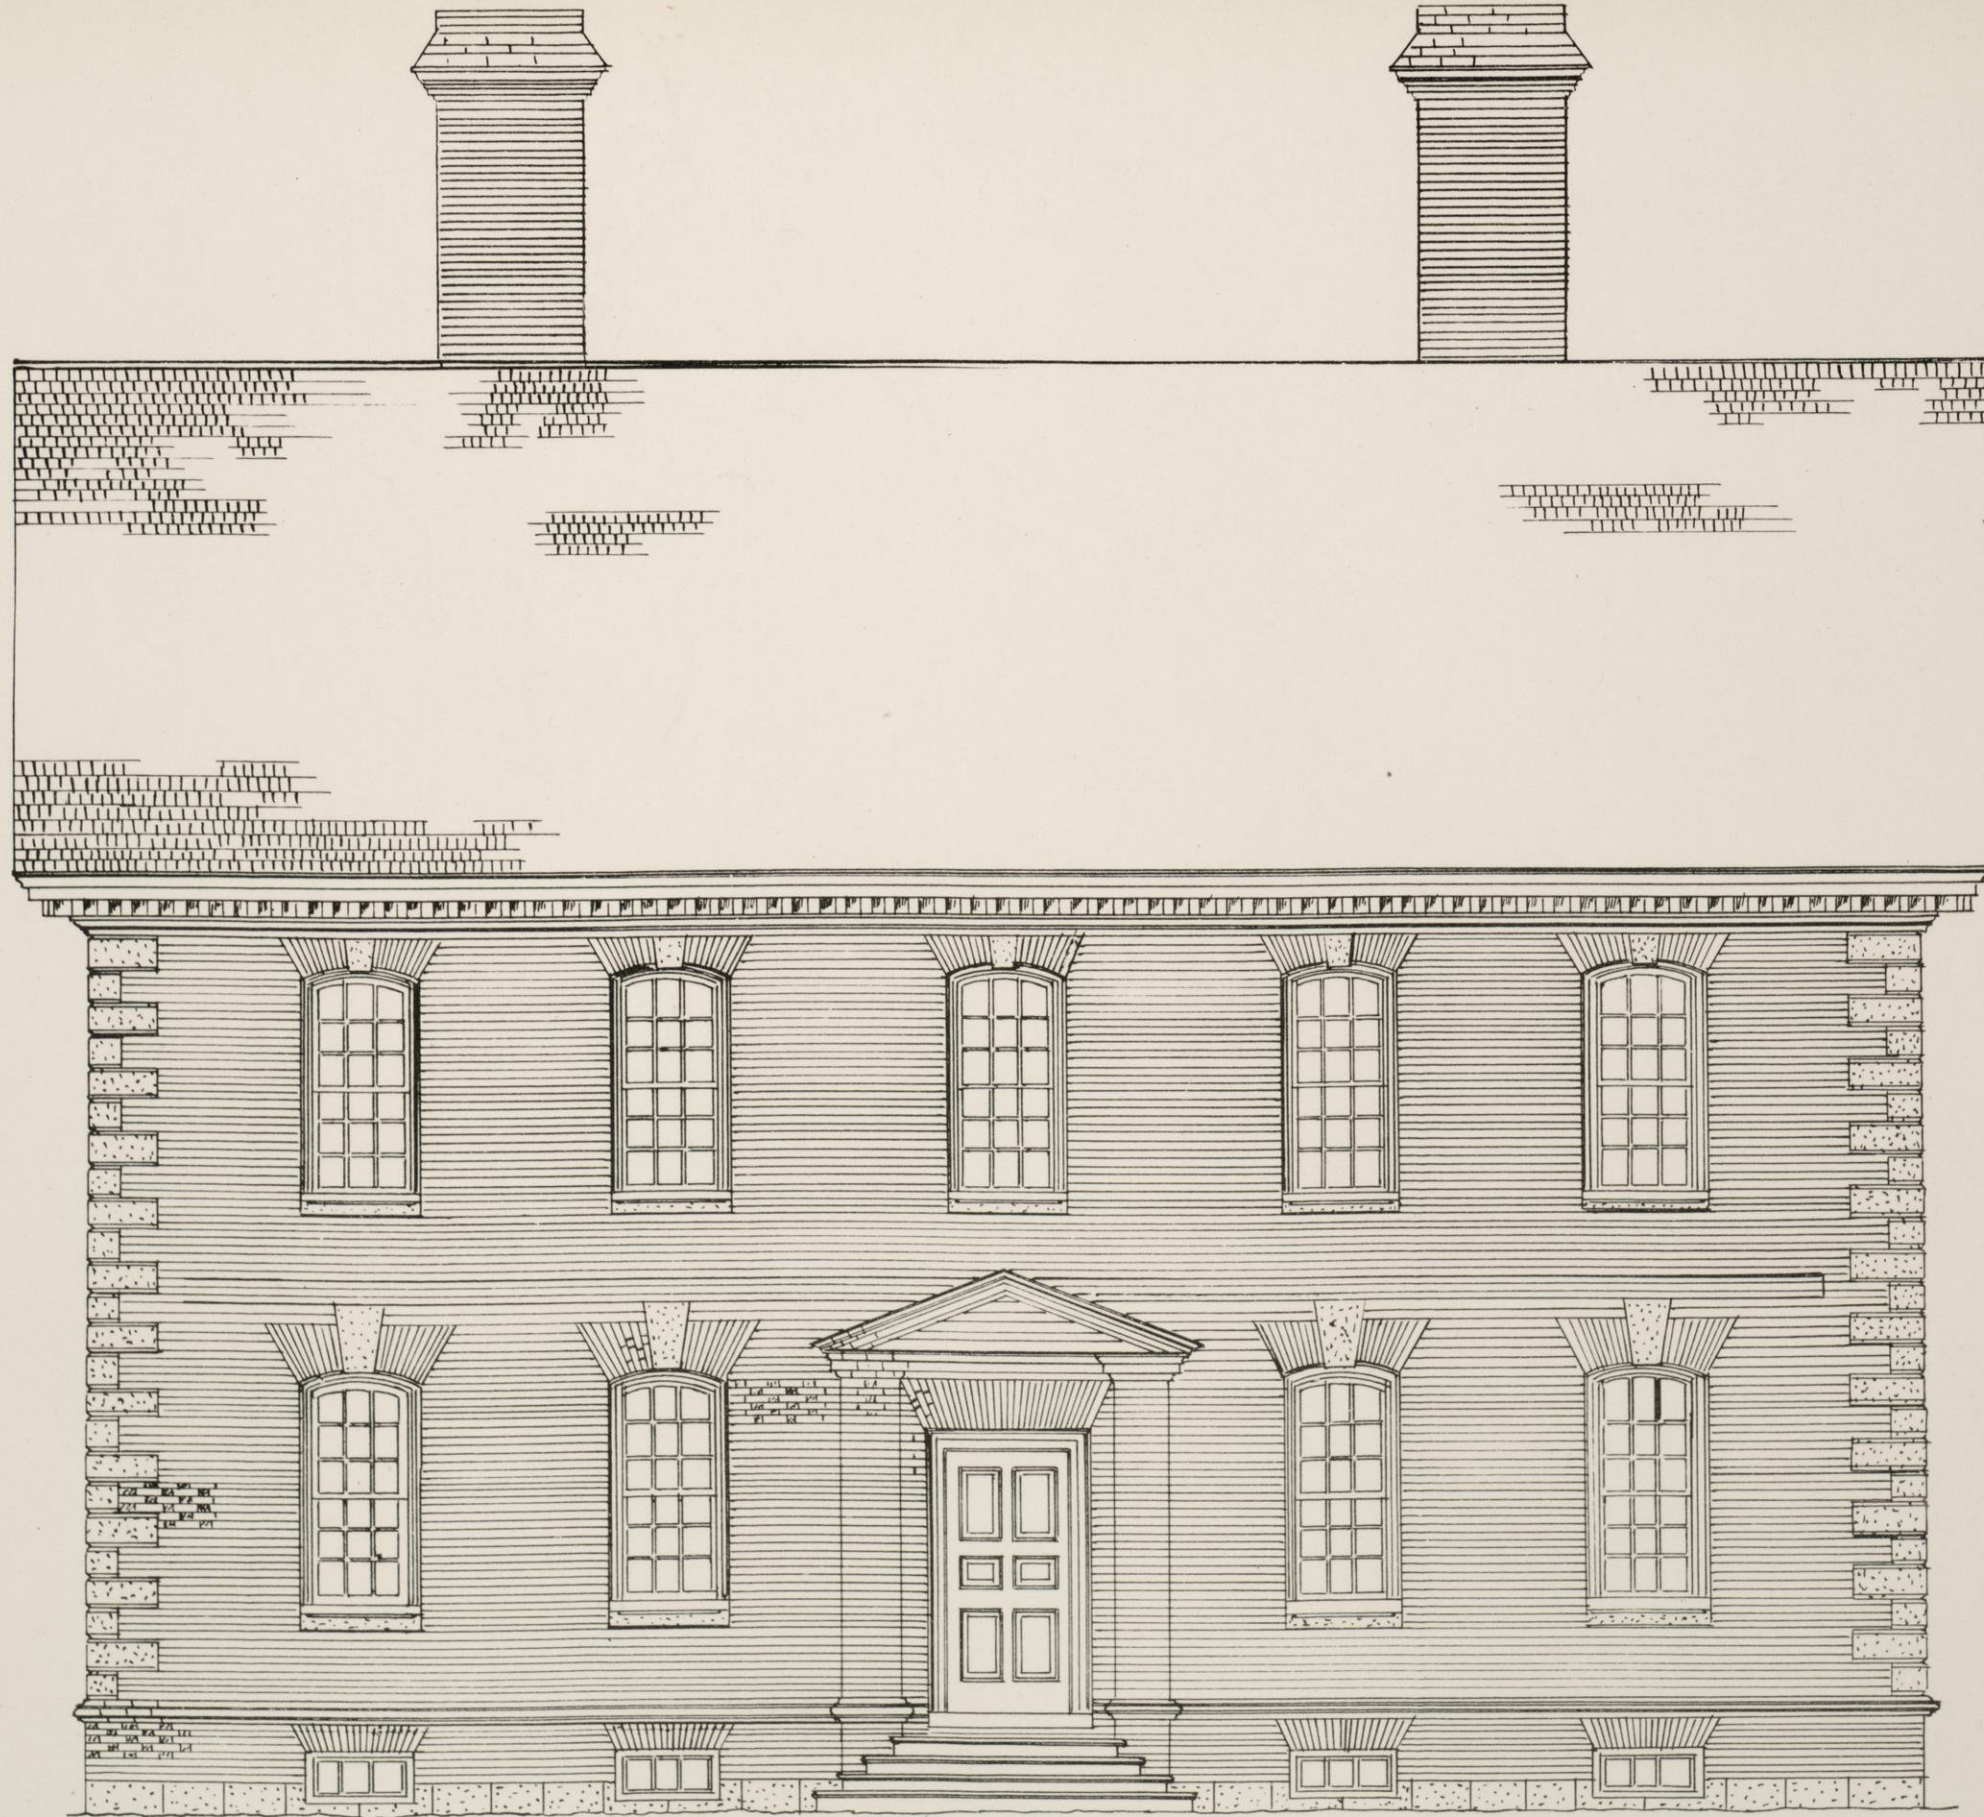
BUILT IN 1754 BY THOMAS NELSON,
GOVERNOR OF VIRGINIA.

THE NELSON HOUSE, YORKTOWN, VA.

This plate gives an accurate representation of the perfectly balanced facade of this, one of the finest houses of the Colonial period. It was built in 1754 by Thomas Nelson, Governor of Virginia. Moulded brick is used in the water table, chimneytops, and door-frame. The arched top of the windows is unusual but effective. The house has lately undergone a drastic "restoration."

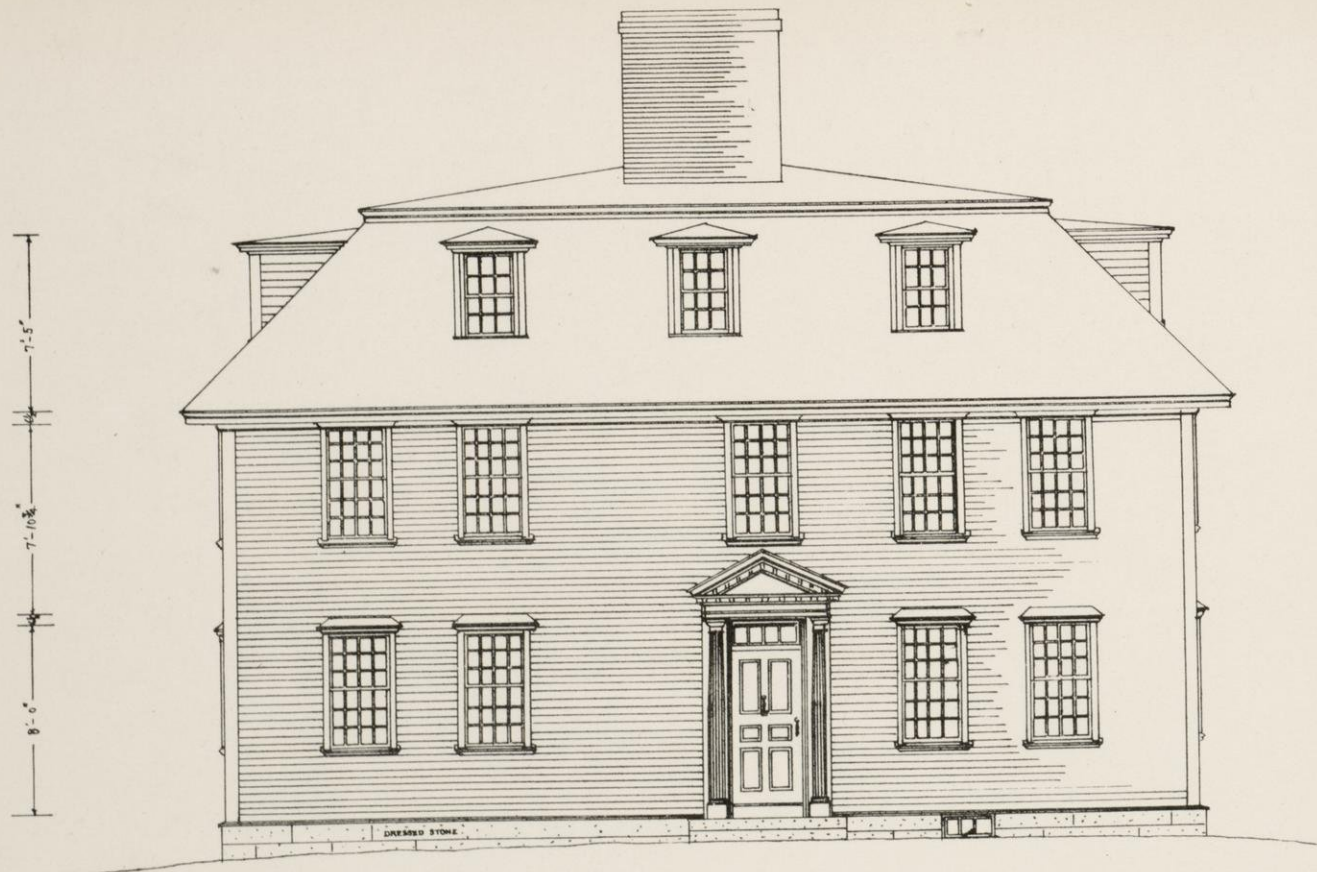
SOUTH ELEVATION

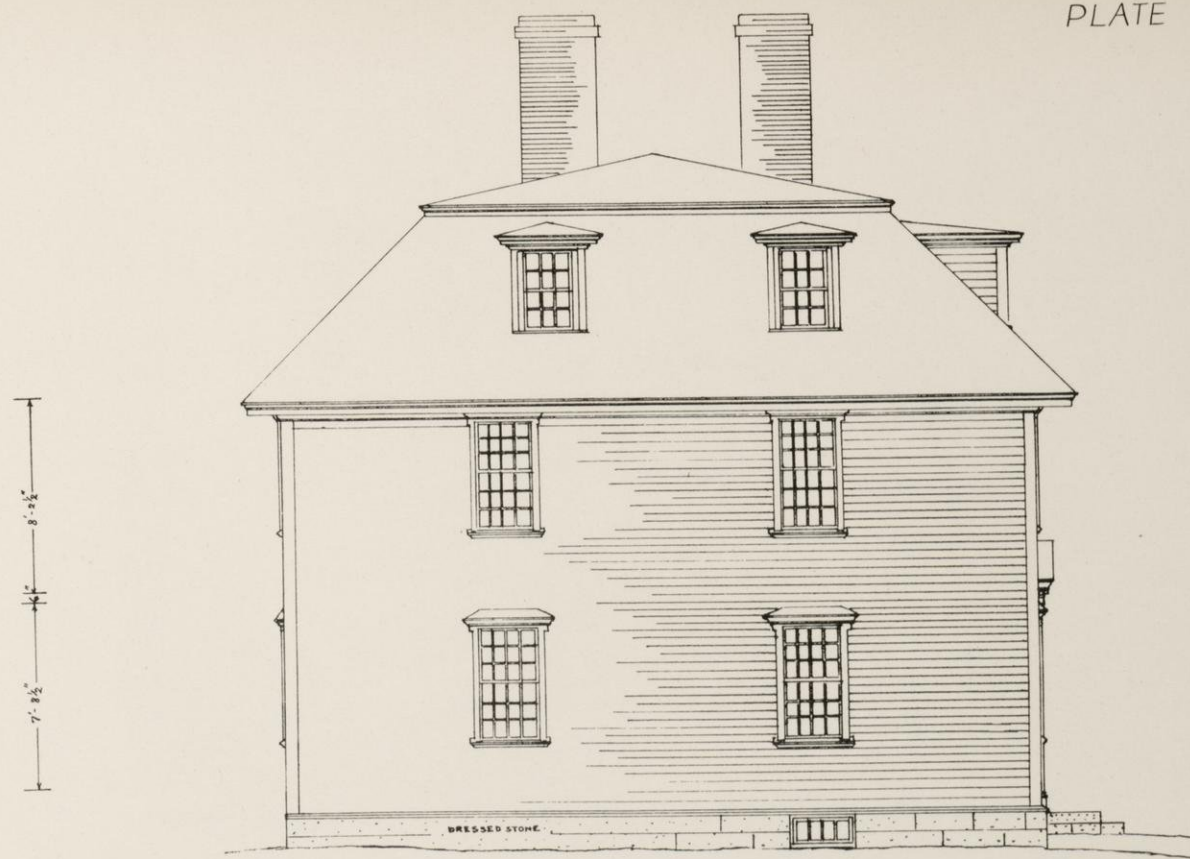
WEST ELEVATION.

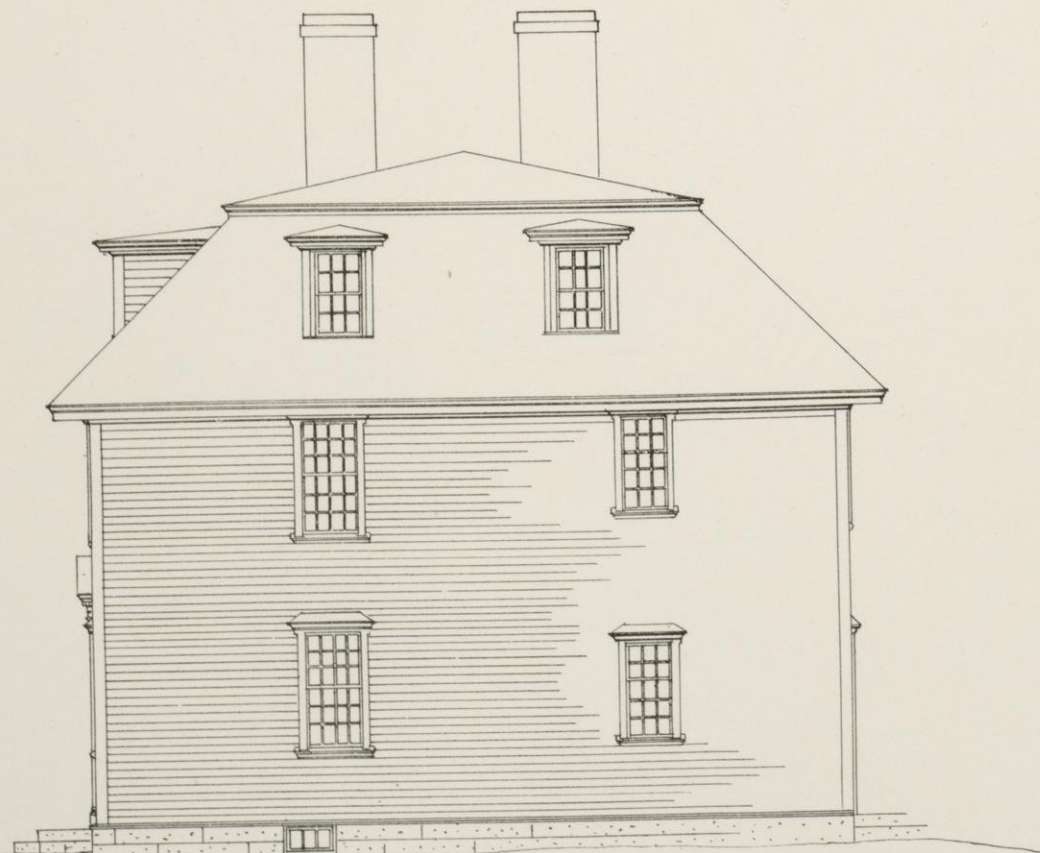
EAST ELEVATION

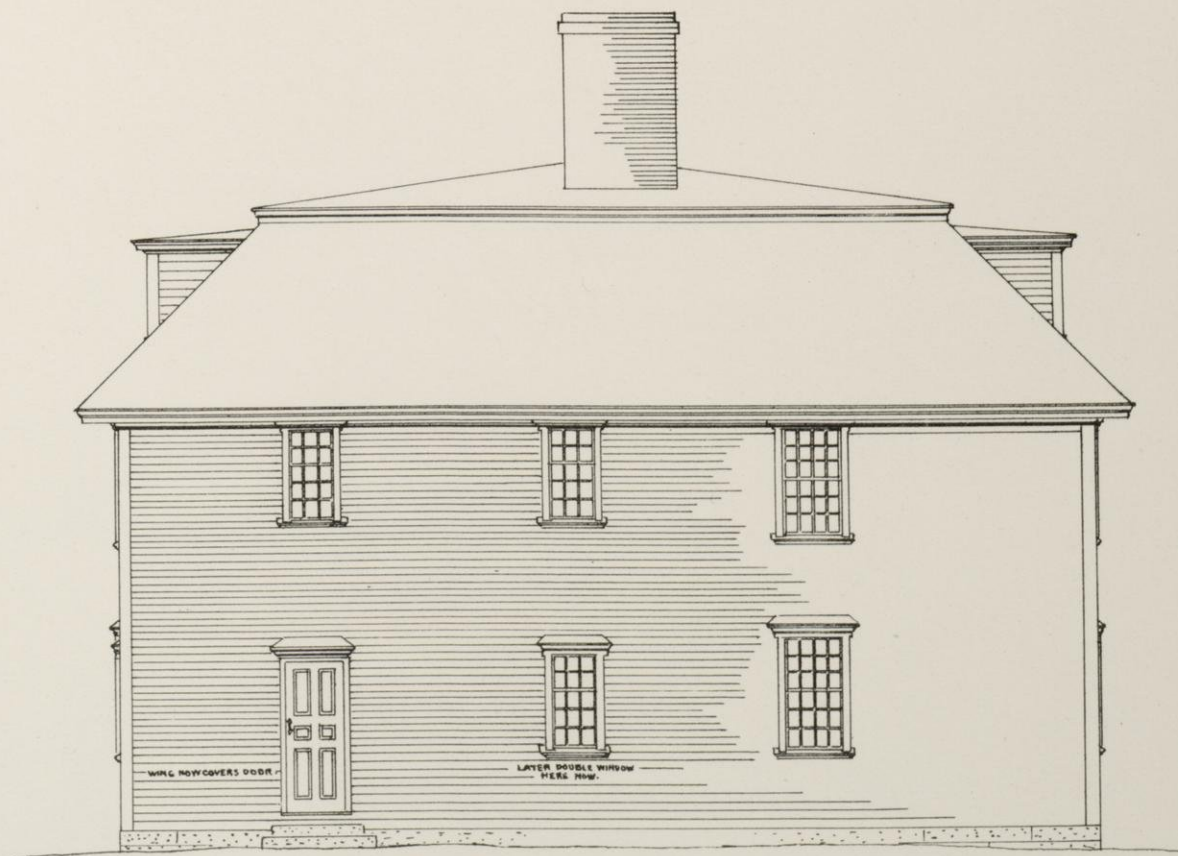
NORTH ELEVATION.

ORIGINAL (EASTERN) PART BUILT BY BENJAMIN MUZZY IN 1690.
 OPENED AS A TAVERN BY JOHN MUZZY IN 1714;
 RUN BY JOHN BUCKMAN FROM 1768 TO 1792, AND BY
 KUFUS MERRIAM FROM 1792 TO ABOUT 1847. ENLARGED ABOUT 1760.
 PURCHASED BY THE LEXINGTON HISTORICAL SOCIETY IN 1915.
 THE HOUSE IS SHOWN IN THESE DRAWINGS AS IT APPEARED DURING THE REVOLUTION.

The original house was the entry and east parlour with a leanto behind, built in 1690 by Benjamin Muzzy. It was opened as a tavern in 1714 and was the meeting-place of the "Minute-Men" on April 19, 1776. The long "tail" at the back has been omitted from the drawing, also a one-story wing running at an angle south-eastward. The original fireplace has been opened up. The present front door on the house is a "restoration," poor in detail. The one shown in the drawing has been designed from old photographs of the original, using old details. The West-Parlour Chamber has good detail and the fine old hinged partition has been removed. It should have been preserved. They were useful in tavern days to open two rooms for purposes of public balls, etc.

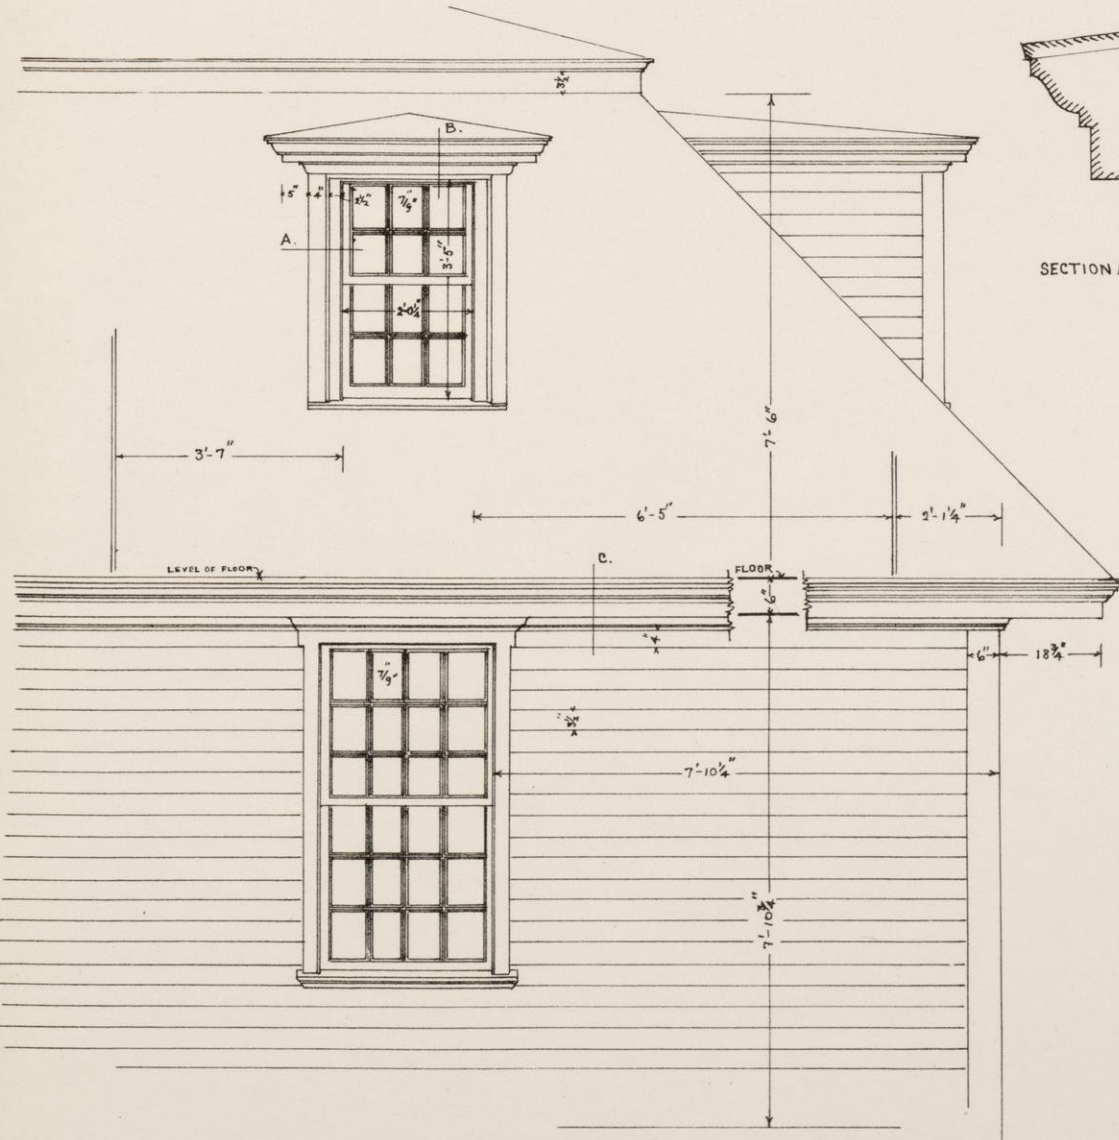
DETAIL OF WEST SIDE OF HOUSE - SHOWING DORMERS.

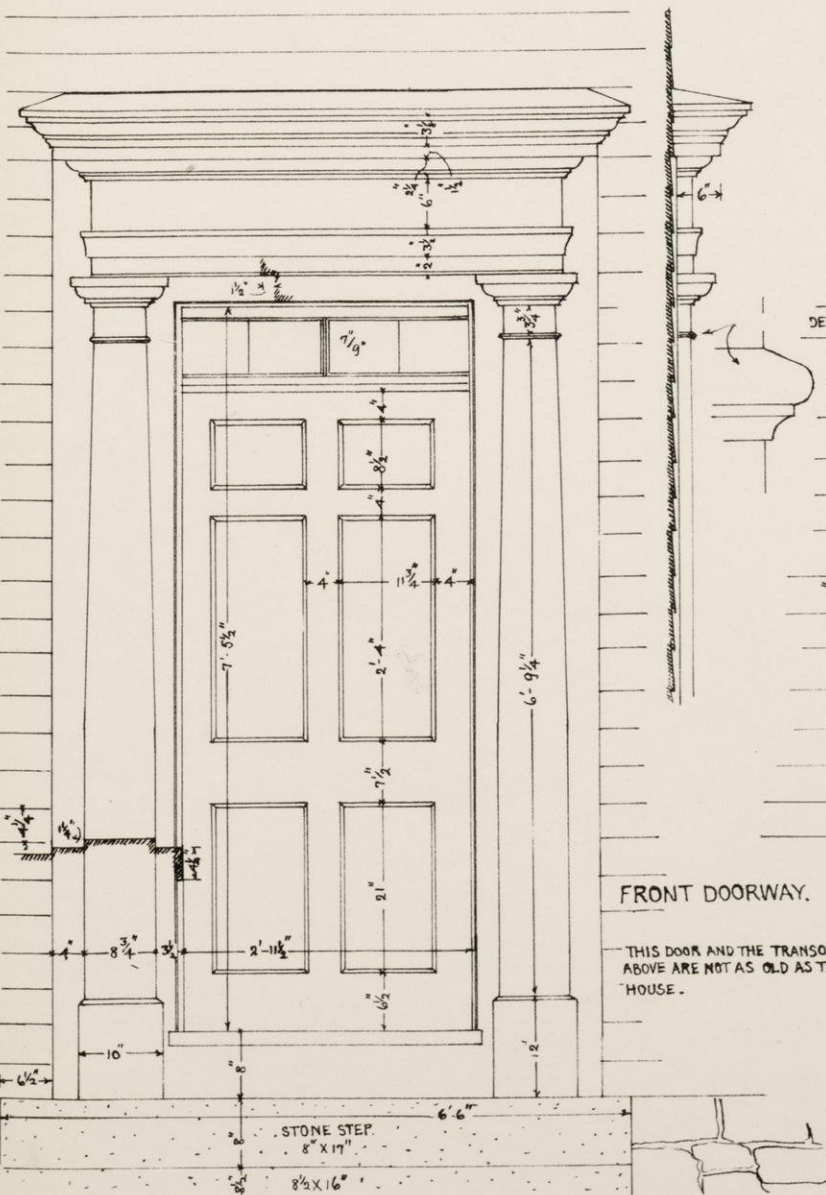
FRONT DOORWAY.

THIS DOOR AND THE TRANSOM ABOVE ARE NOT AS OLD AS THE HOUSE.

This house, the birthplace of Benjamin Thompson, the celebrated Count Rumford, was built about 1714. The stair is an unspoiled example of early work. The West Parlour has details of about 1800, no doubt masking work as interesting as the fine early panelling in the chamber above. The front doorway is later, with poor detail.

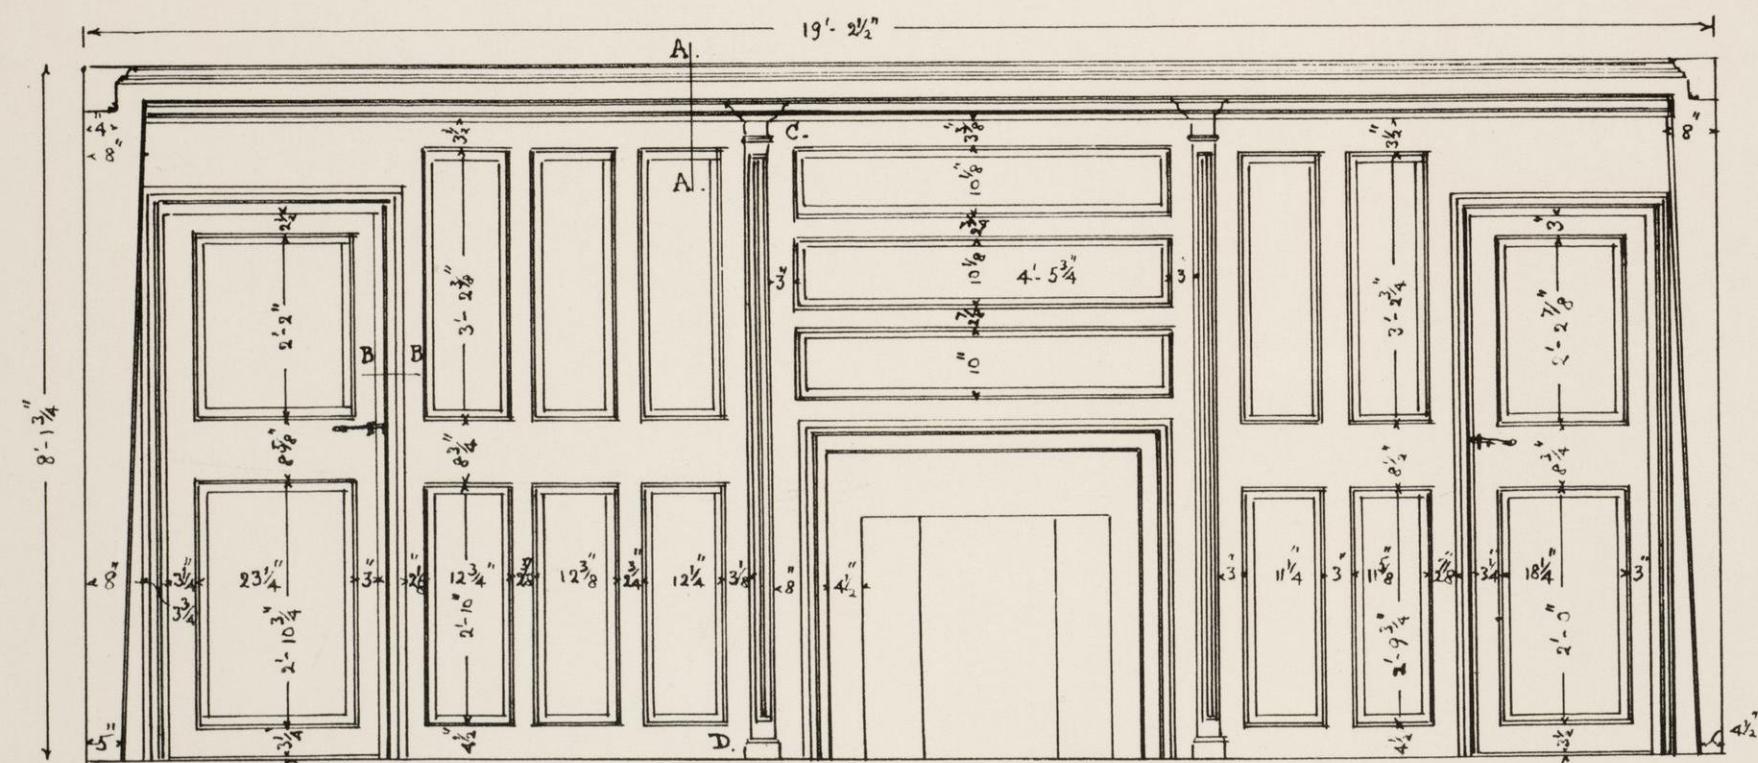
BUILT IN 1735.

PANELLING IN PARLOUR CHAMBER, BROWN HOUSE, CONCORD, MASS.

This is a well-balanced design and the corner-cupboard simple but charming.

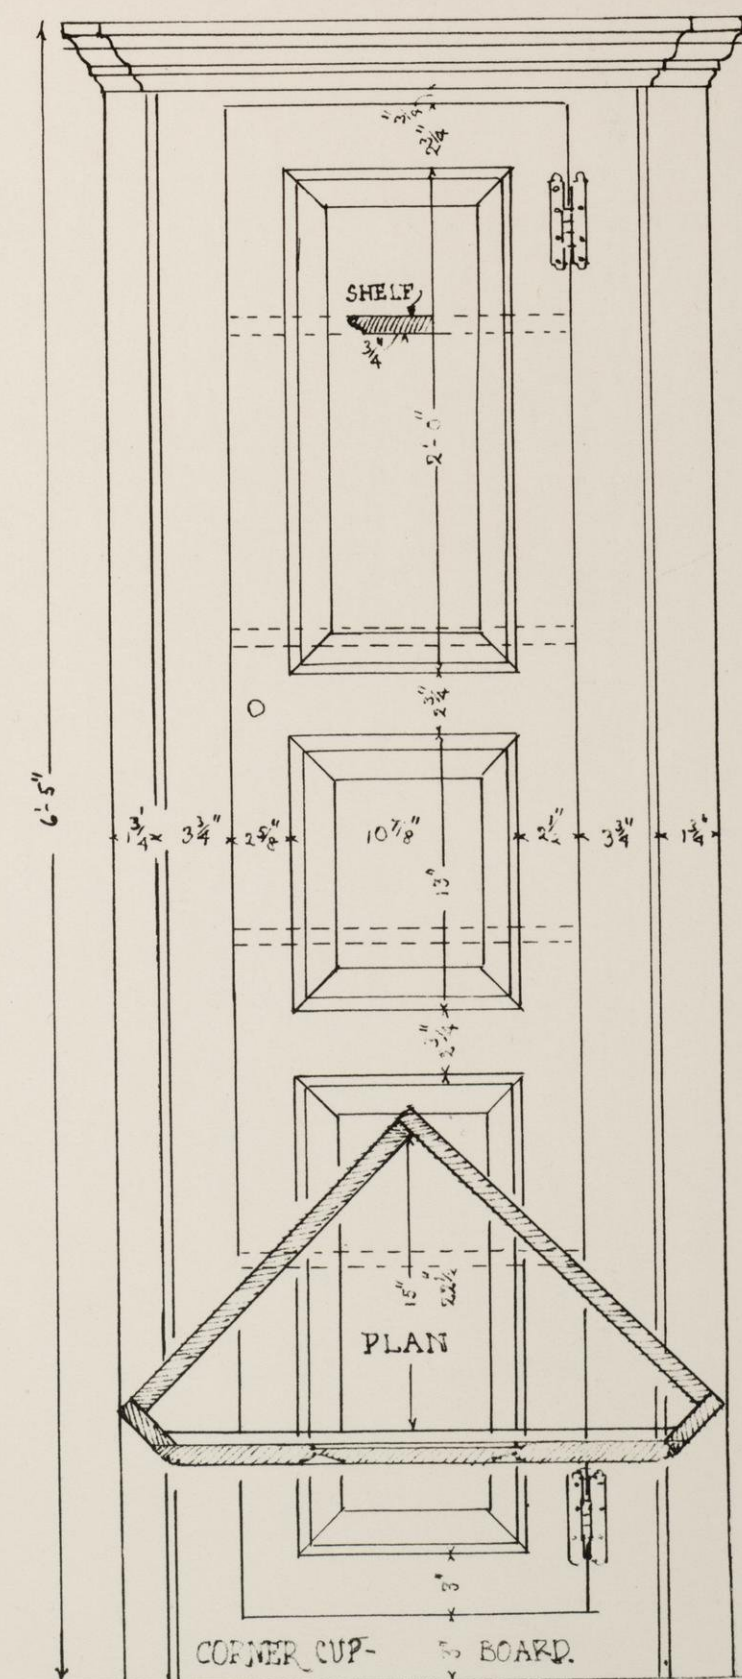
CORNER CUP- BOARD.

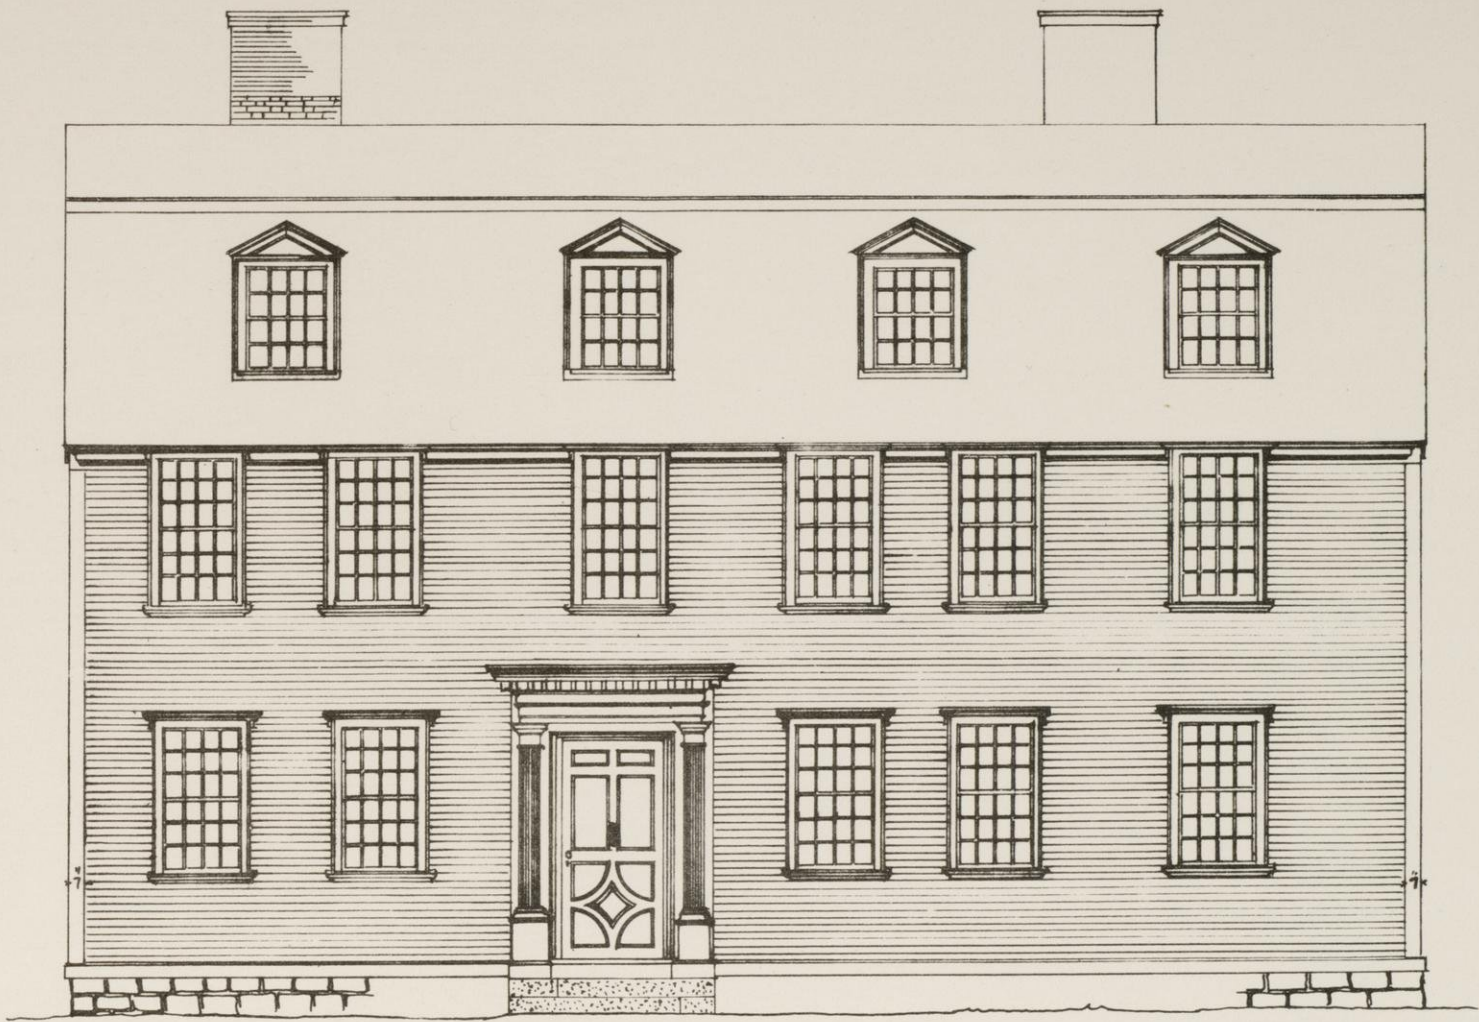
SOUTH FRONT ELEVATION.

This house was built about 1755-1765 by Capt. Edward Marrett. It originally stood on a corner, the east end facing on the other street. This large lower room has no old trim, and originally had in the end wall a door between two windows. Research proved it was a tailor-shop. The front doorway is well-done and the lower panels of the door form a charming design differing from the conventional finish. The stairhall and the staircase are the feature of the house. The Dining-Room with the chamber over it are the only rooms of interest, having good details. The closets on either side of the front door are a rare feature and most useful. The house has been removed and re-erected on the North Shore.

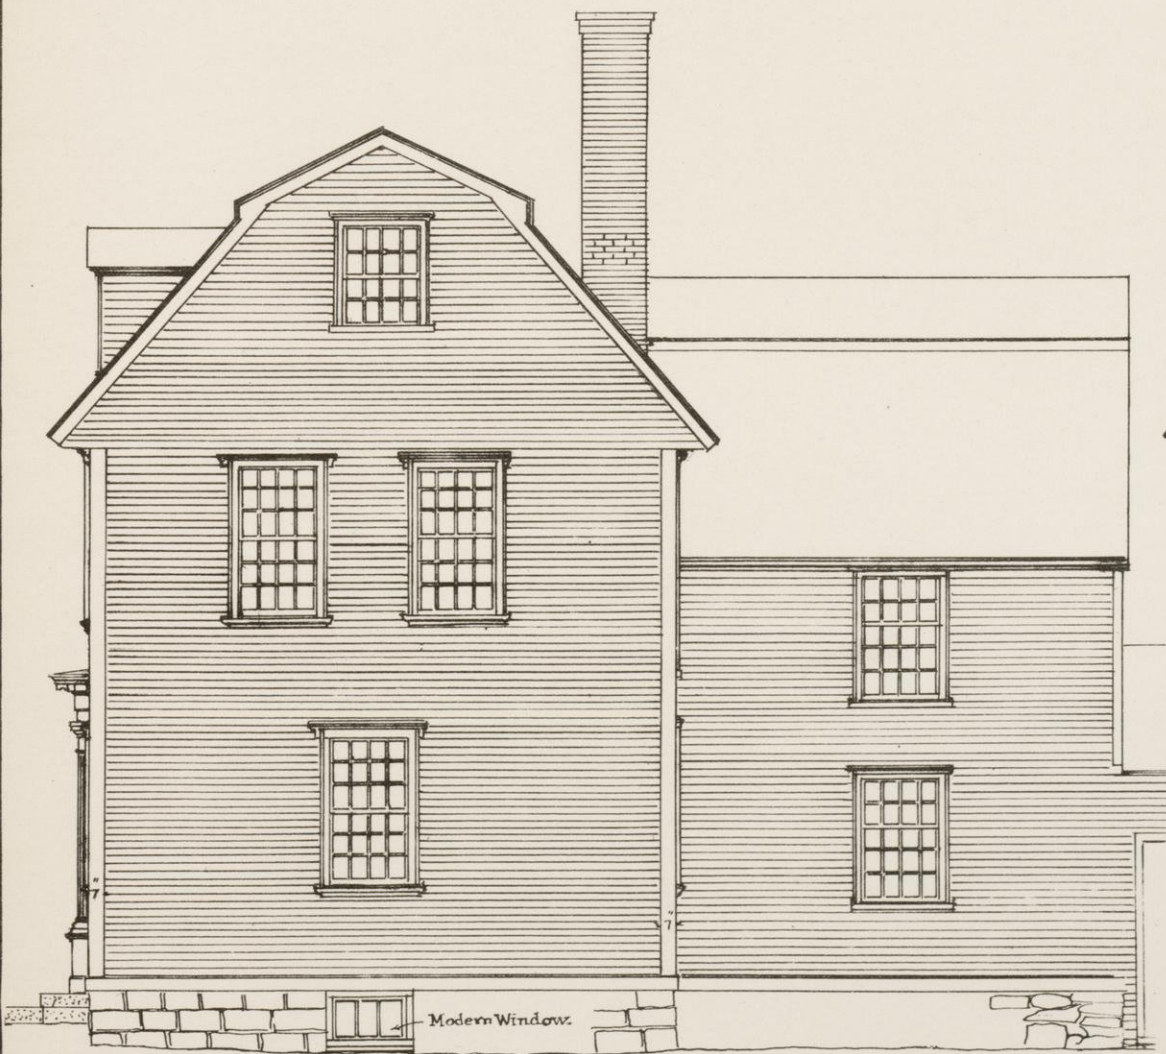
EAST ELEVATION -

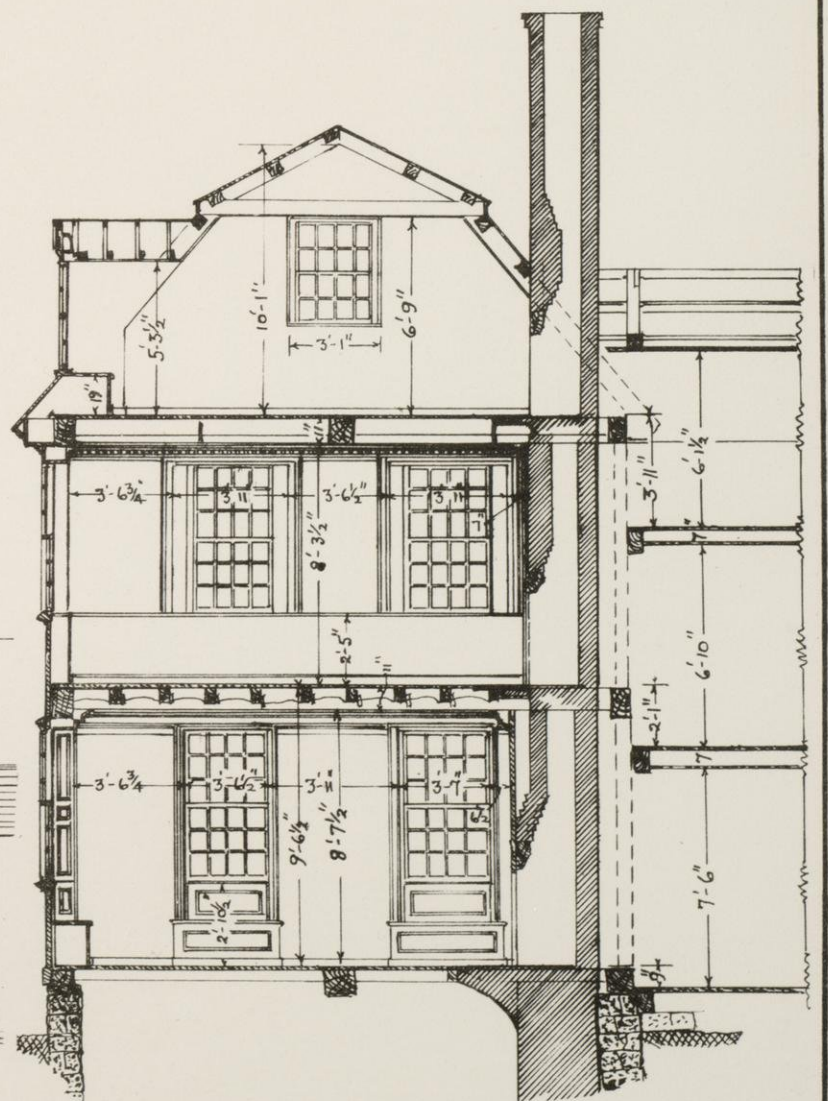
SECTION THROUGH WEST END.

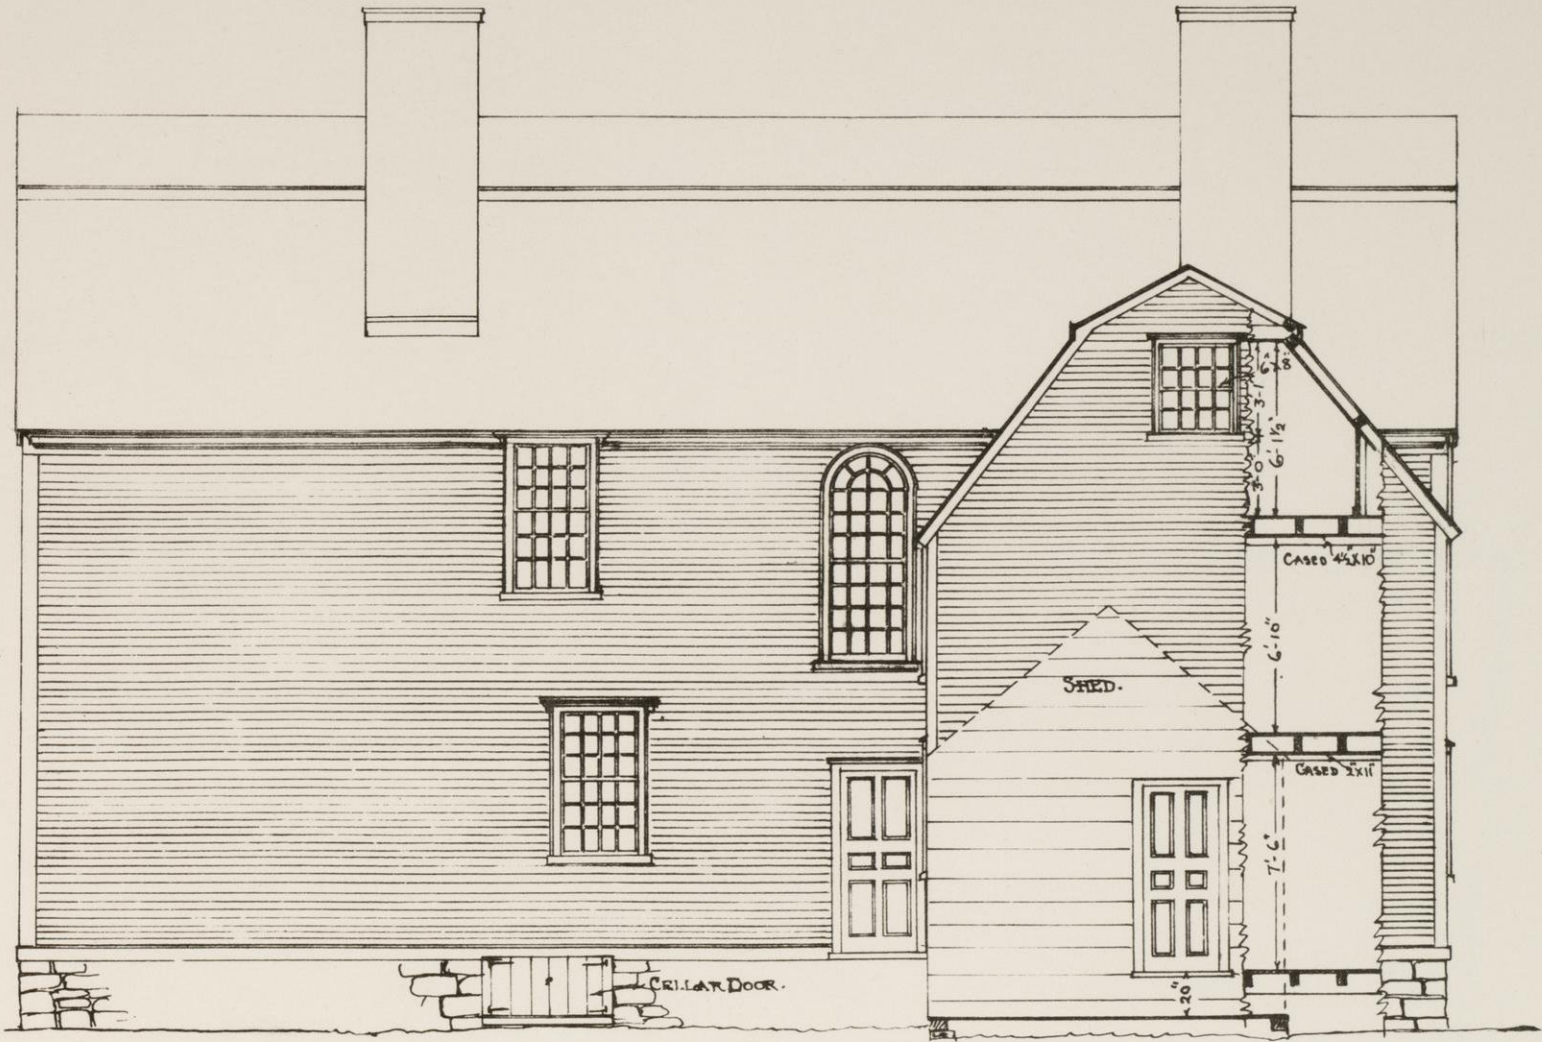
REAR OR NORTH ELEVATION.

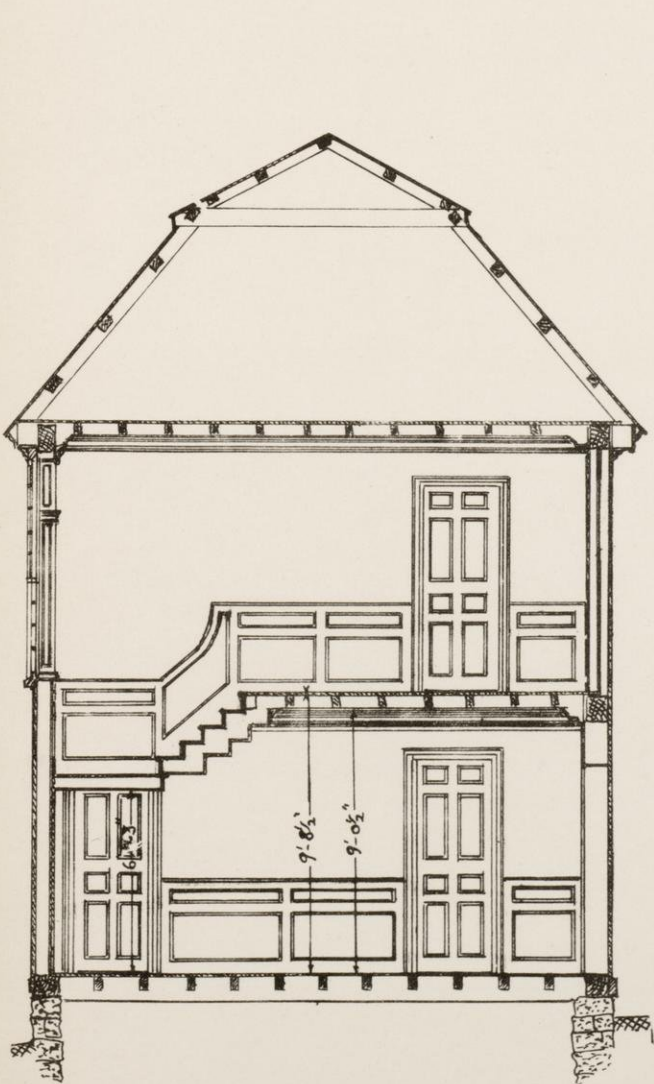
SECTION THROUGH HALL.
