Measured drawings of some colonial and Georgian houses. Volume 3 1930

Measured Drawings
of
Some Colonial
and
Georgian Houses

by
Donald Millar

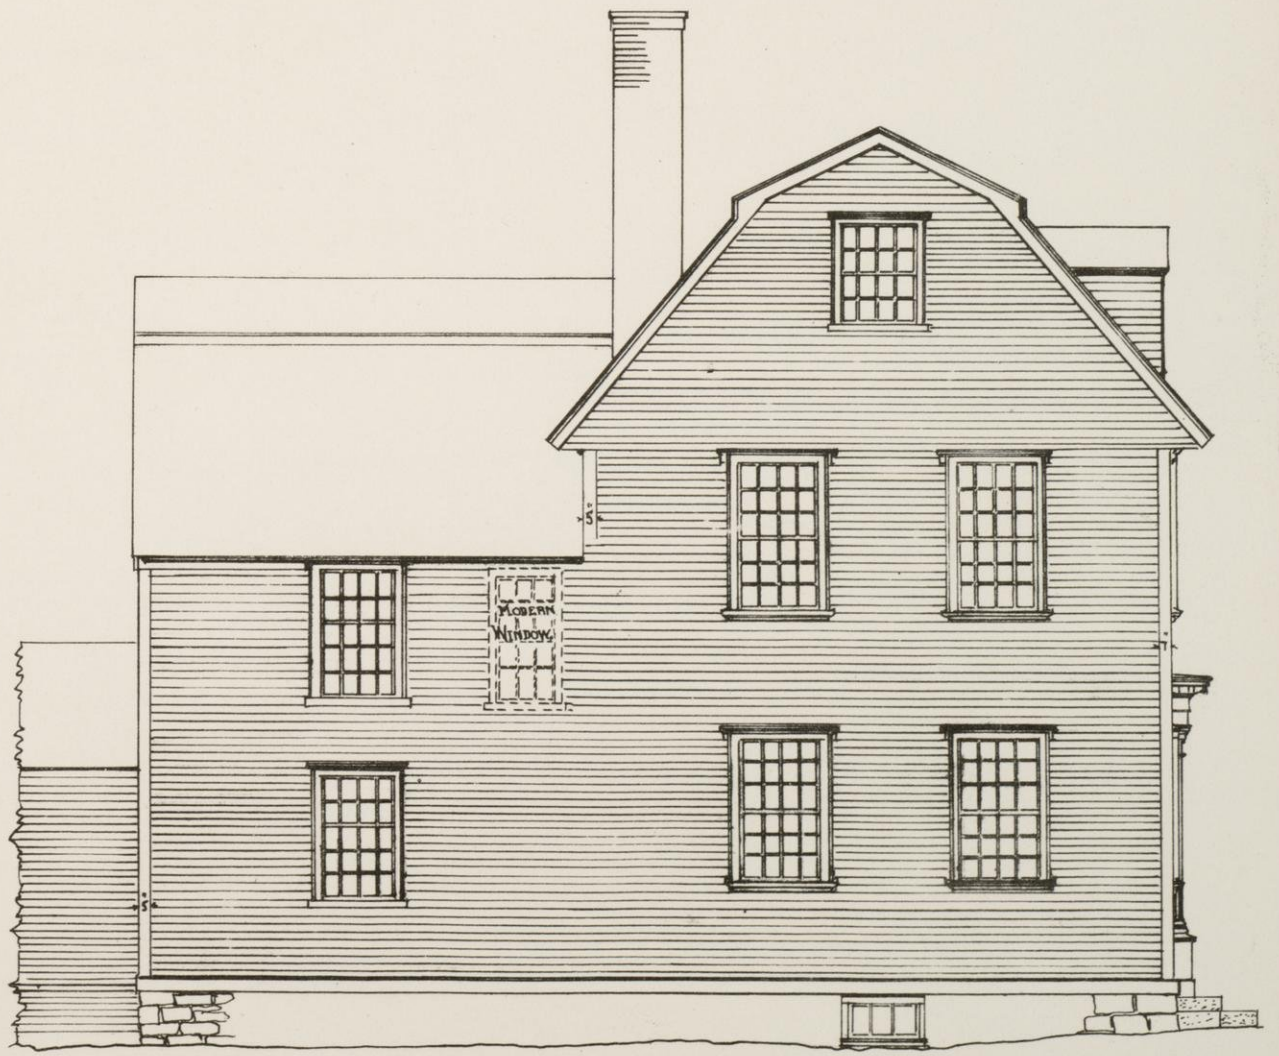
WEST END ELEVATION.

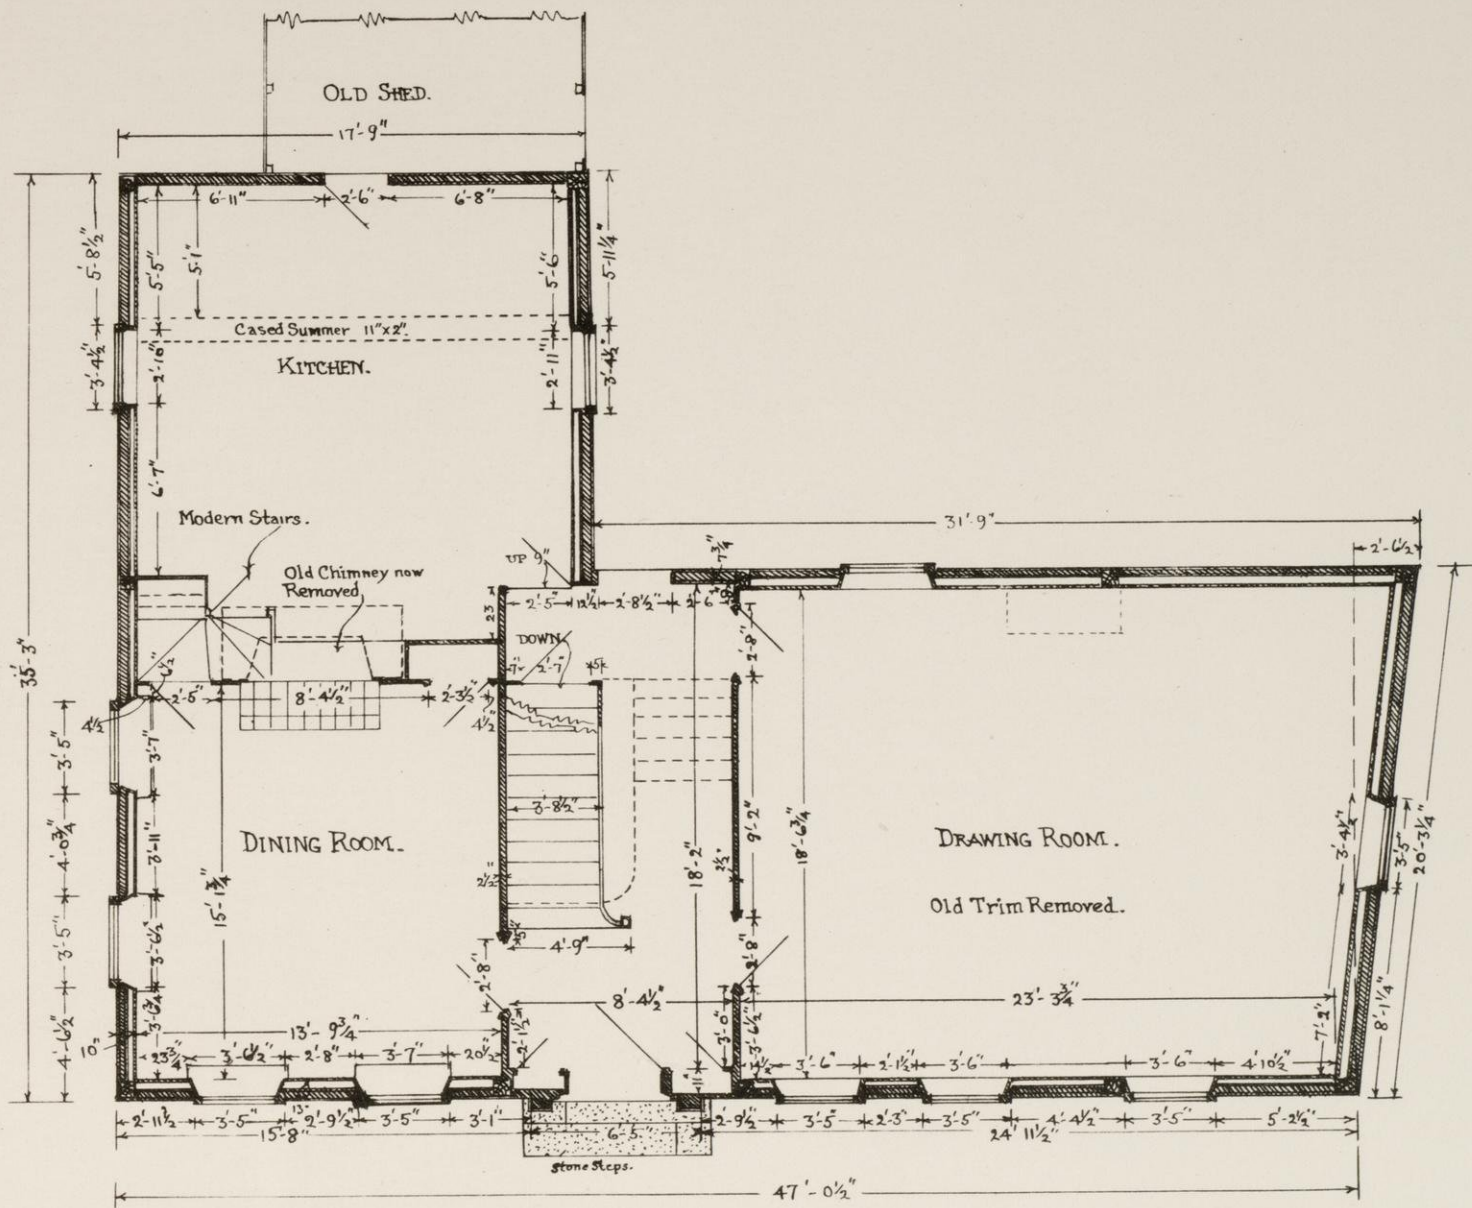
PLAN OF FIRST FLOOR.

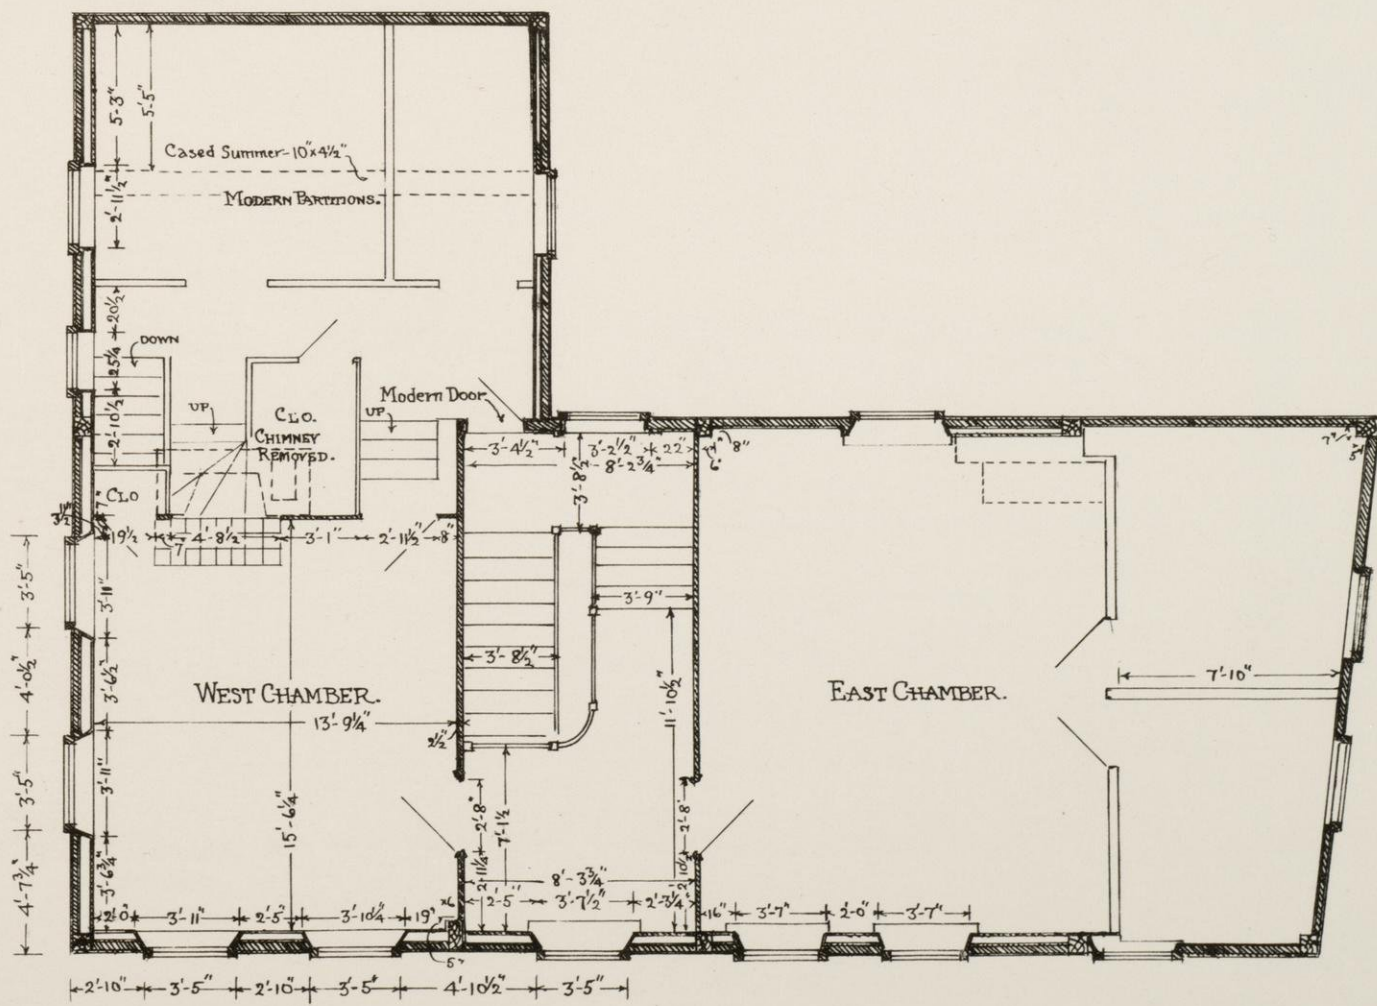
PLAN OF SECOND FLOOR.

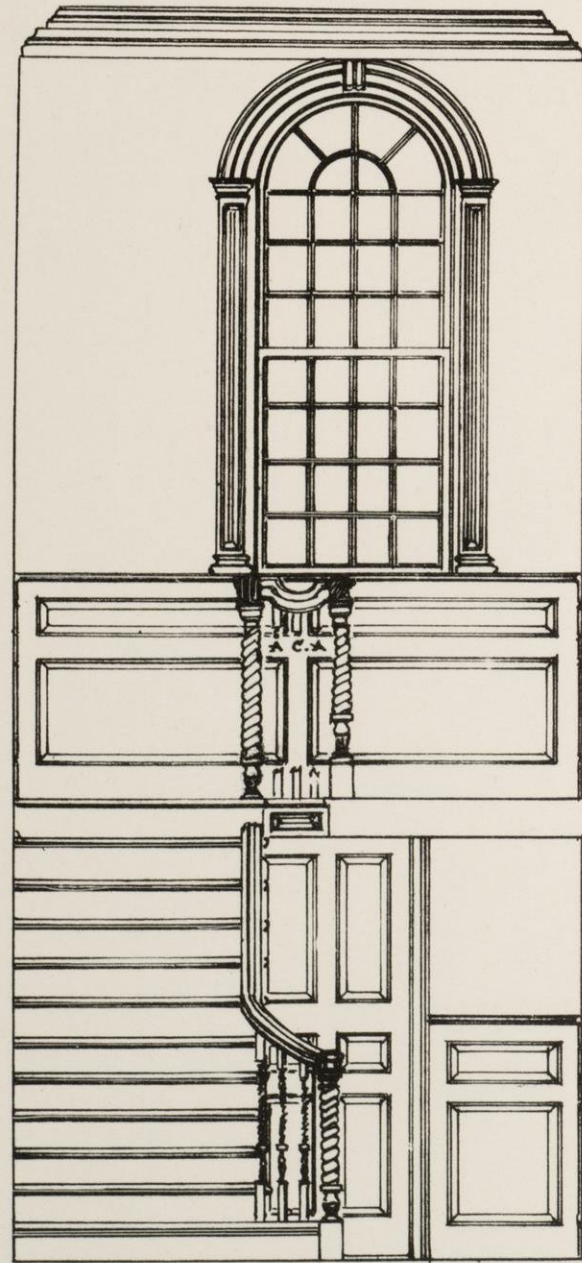
NORTH END OF HALL.

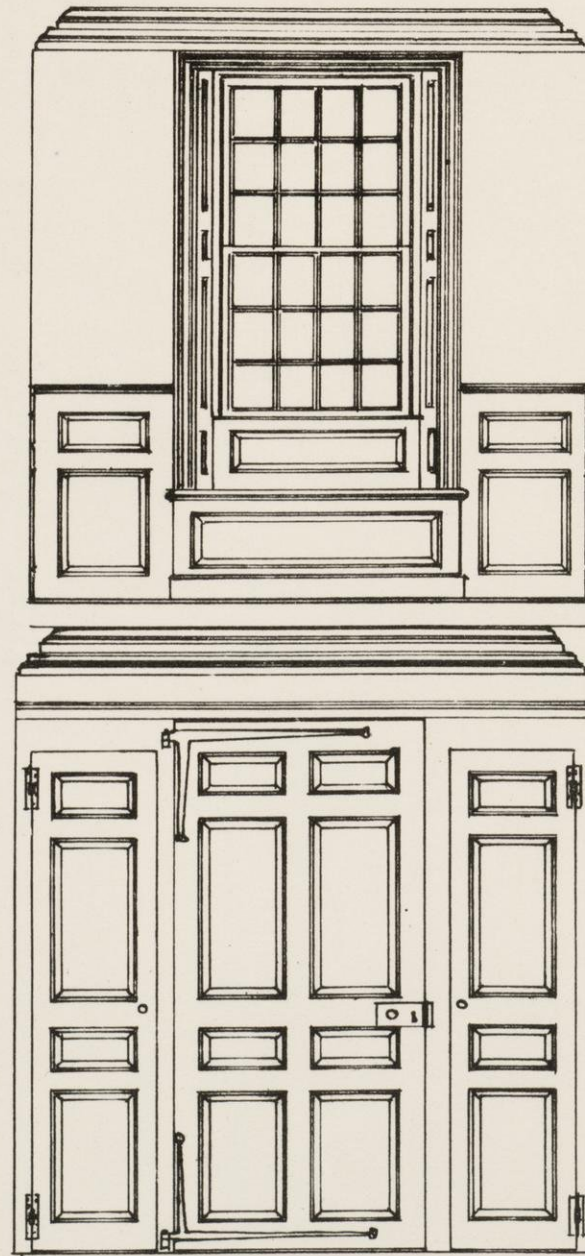
SOUTH END OF HALL.

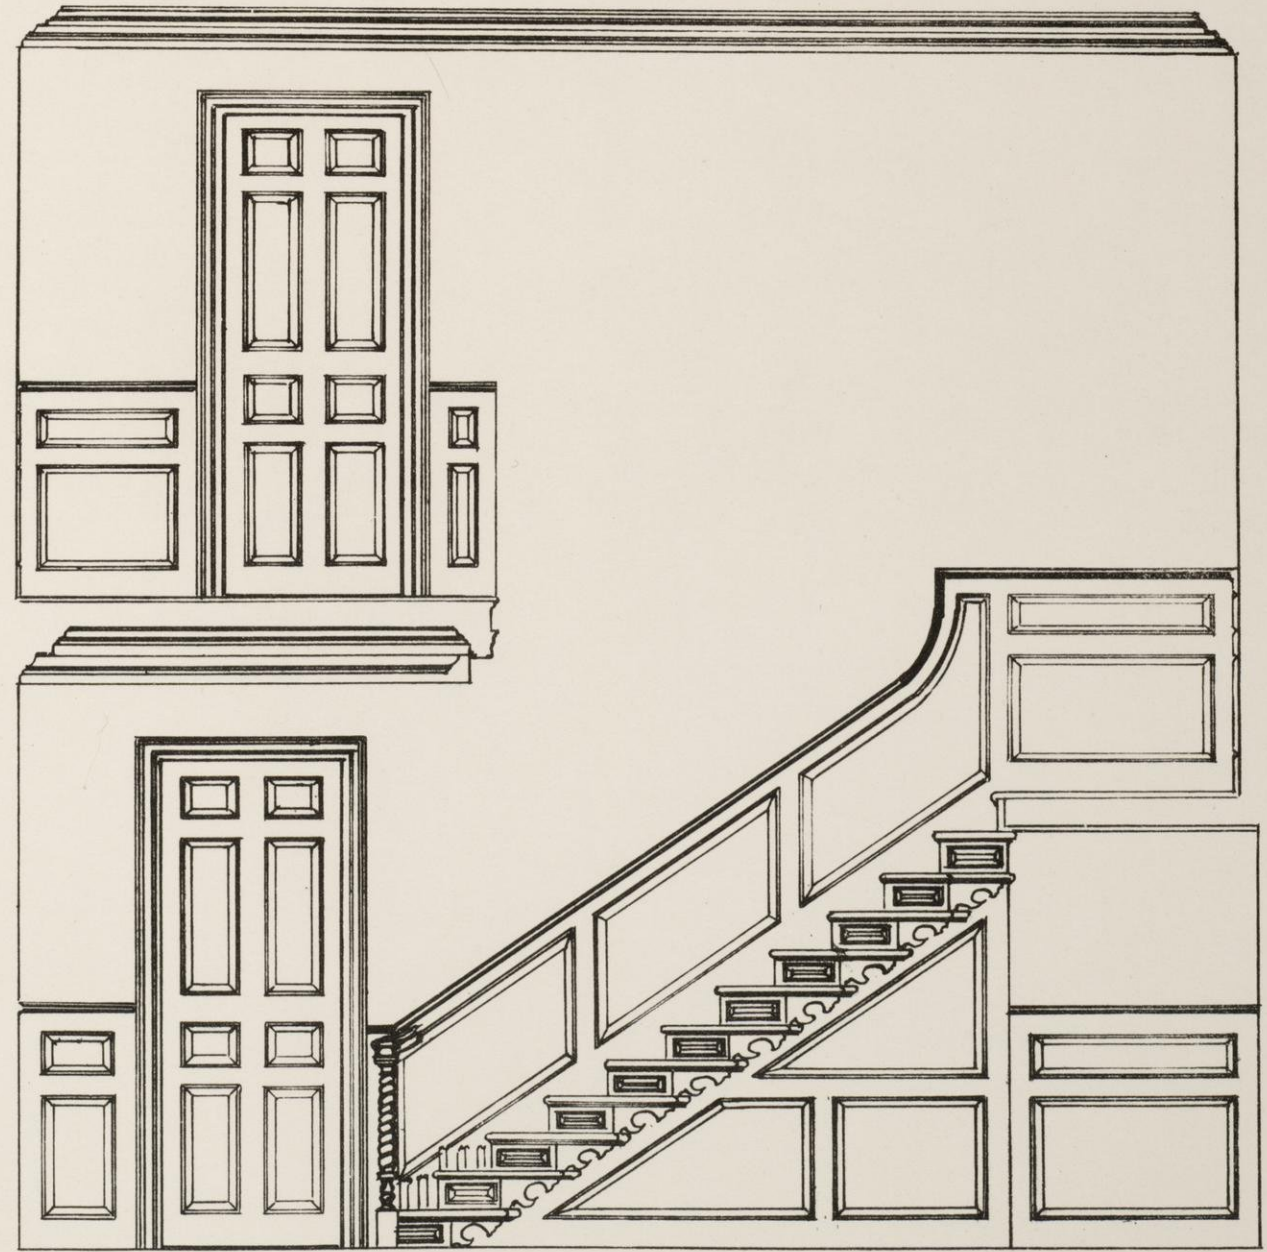
WEST SIDE OF HALL. (BALUSTERS SHOWN ON PLATE 9)

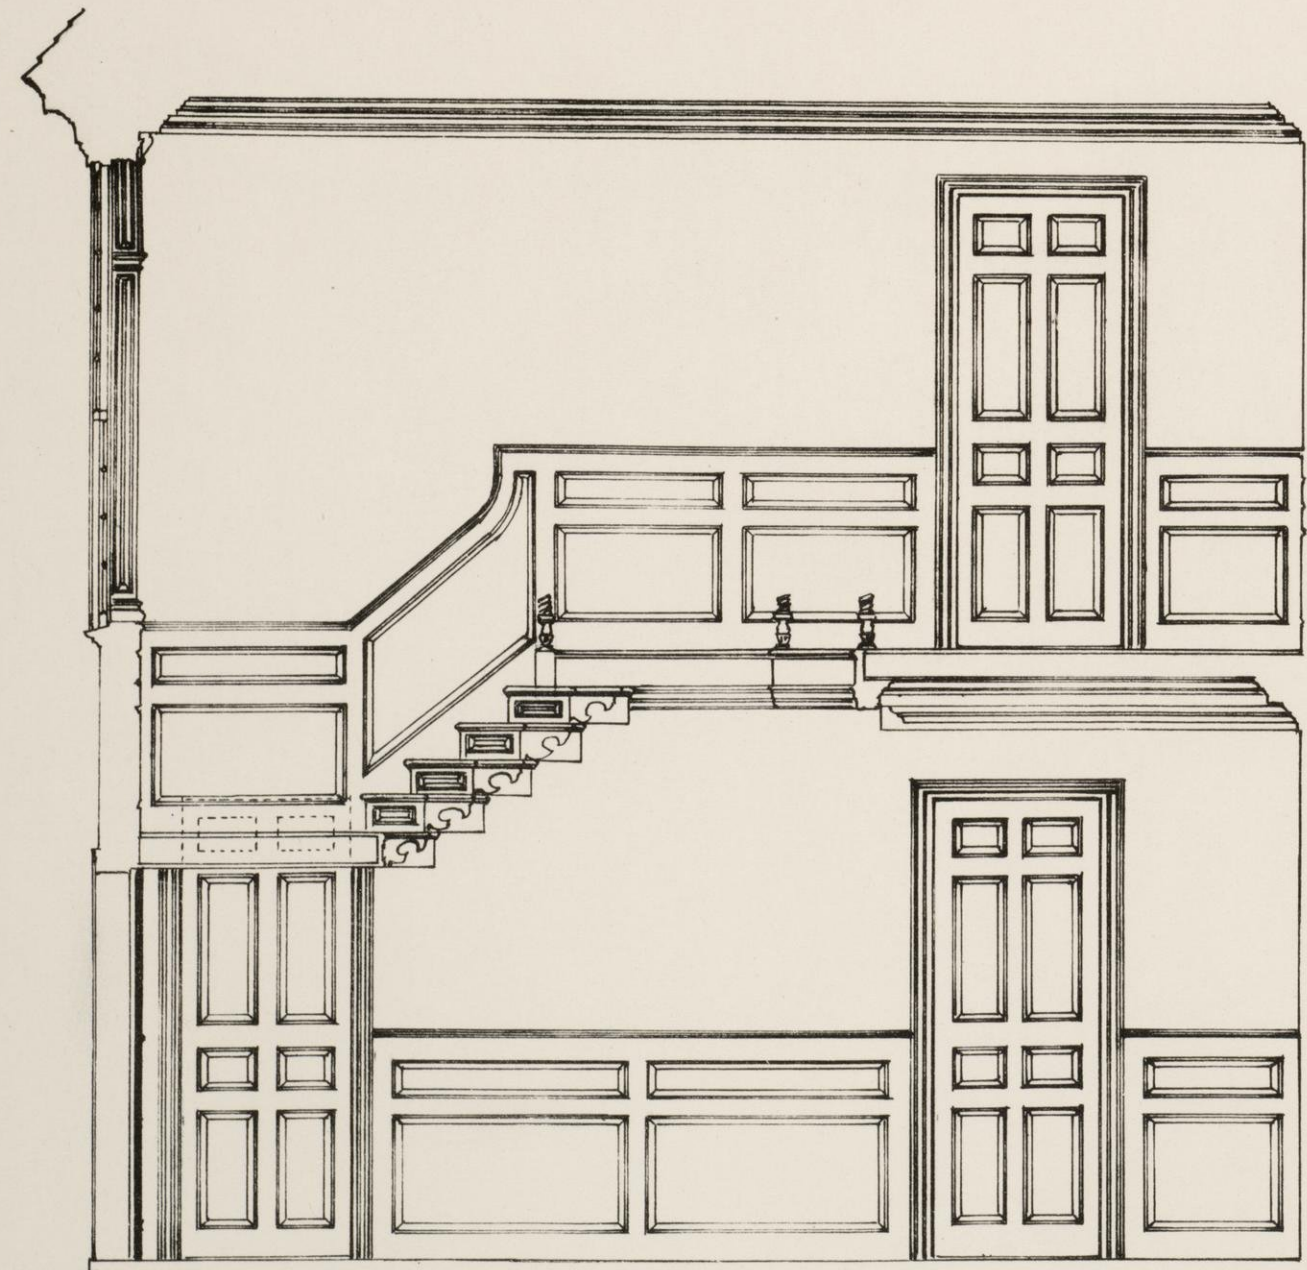
EAST SIDE OF HALL.

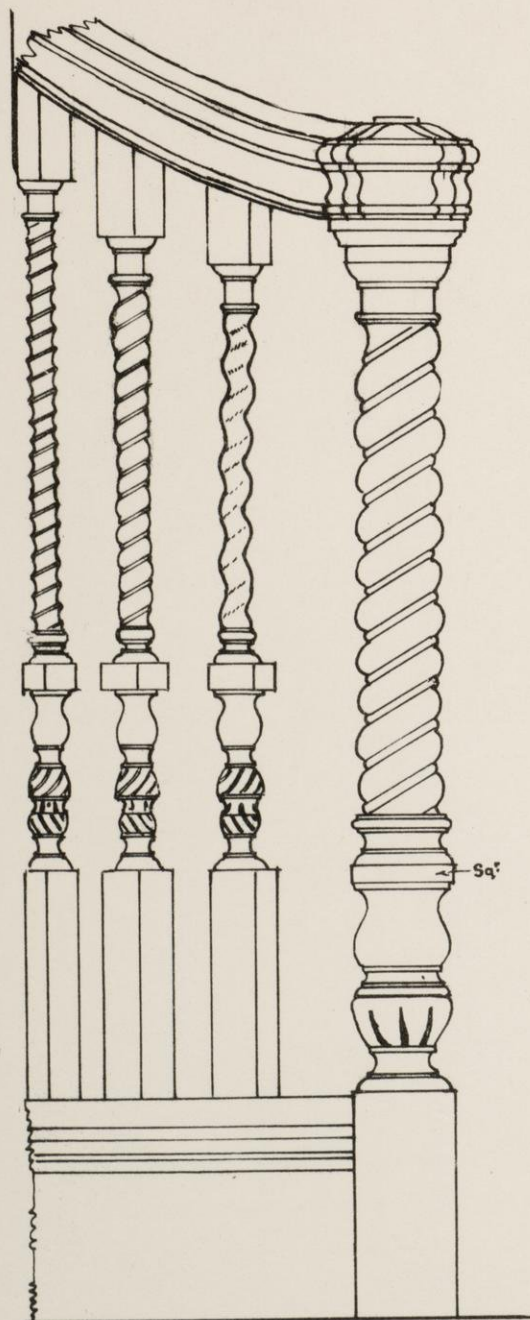
NEWEL (RESTORED.)

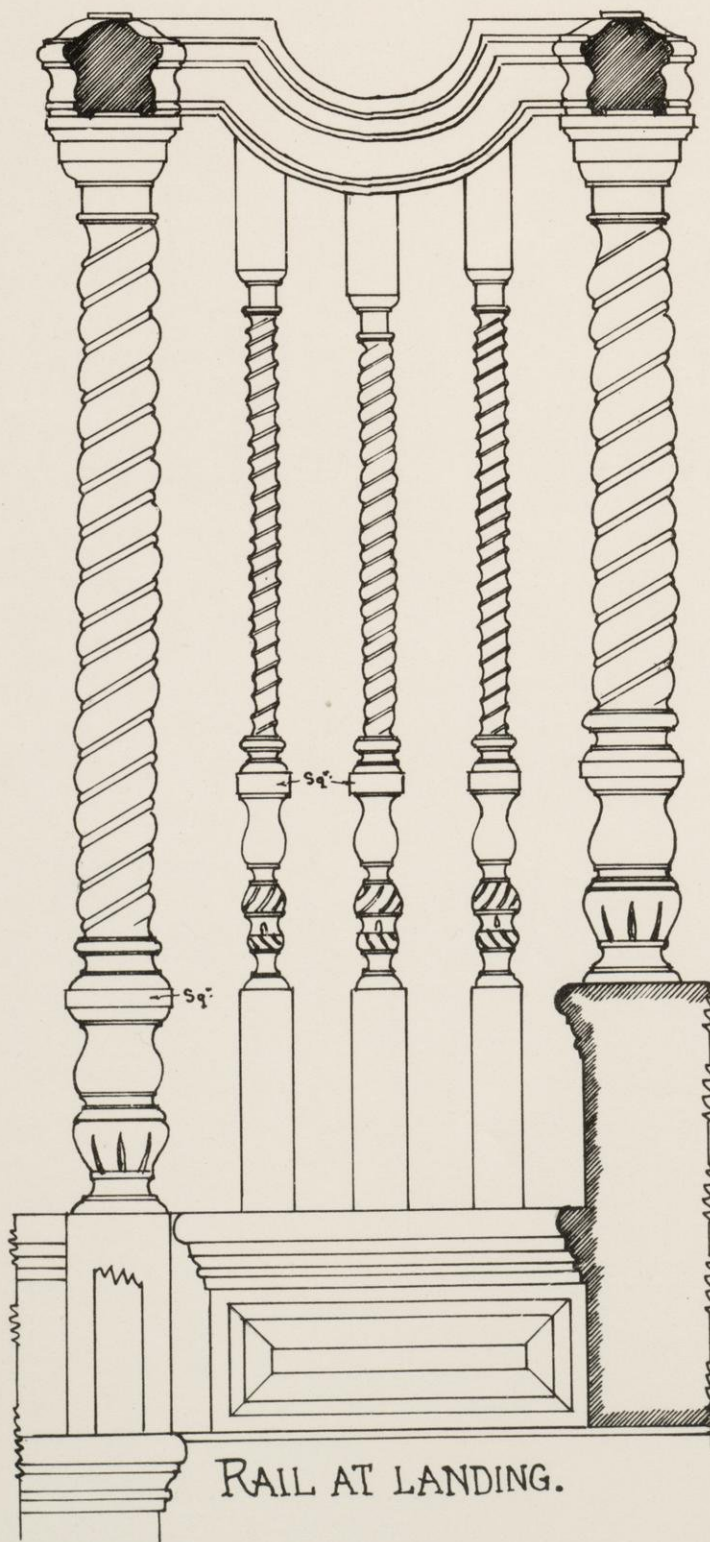
RAIL AT LANDING.

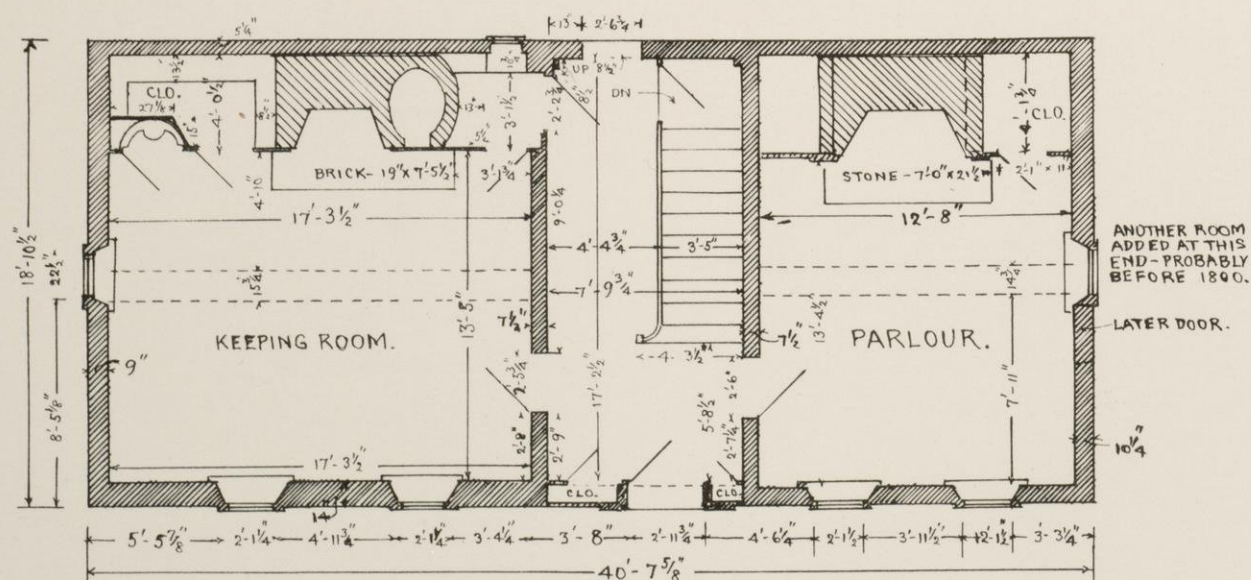
PLAN OF FIRST FLOOR.

The peculiar framing of the entry and west rooms indicates that this house as it now stands is an enlargement of an older house. The present work dates from about 1725. Another room has been added at an early date at the east end, making the house very long for its height. The panelling in the "Keeping-Room" (as the living room used to be called) and the stair-hall are well done. Beside the door are two closets like those in the Marrett House in Cambridge—the only two instances known to the author. The details of the stairs are interesting and the front doorway has a fine curved and broken pediment. The pilasters are gone and the frame much mutilated. The cellar stair shows a very old construction and the gable end shows that this is evidently a house framed without studs for walls, but covered with boards, nailed vertically from plate to sill, as is shown in the plates.

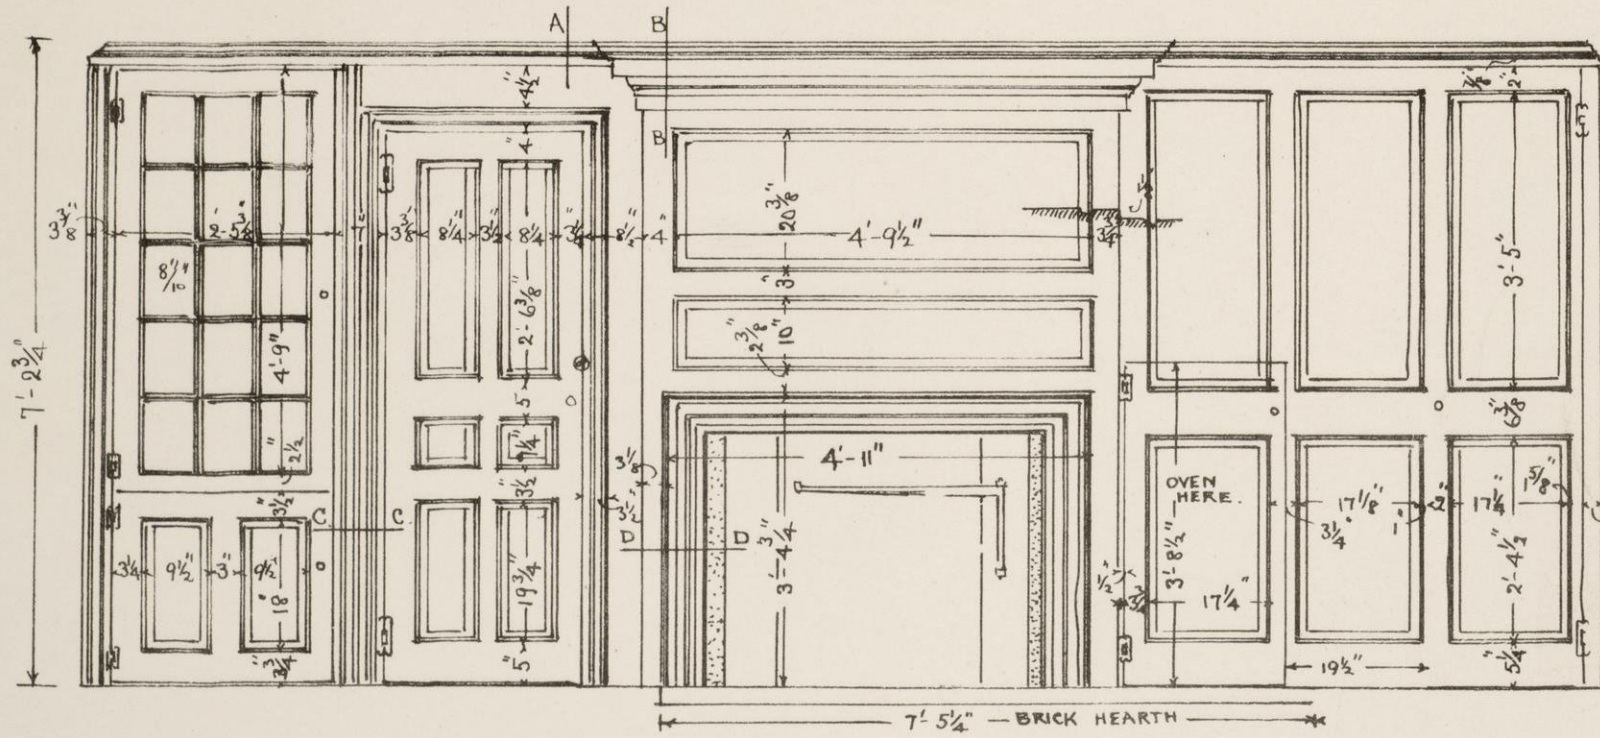
NORTH SIDE OF KEEPING-ROOM.
17'-1 1/2"

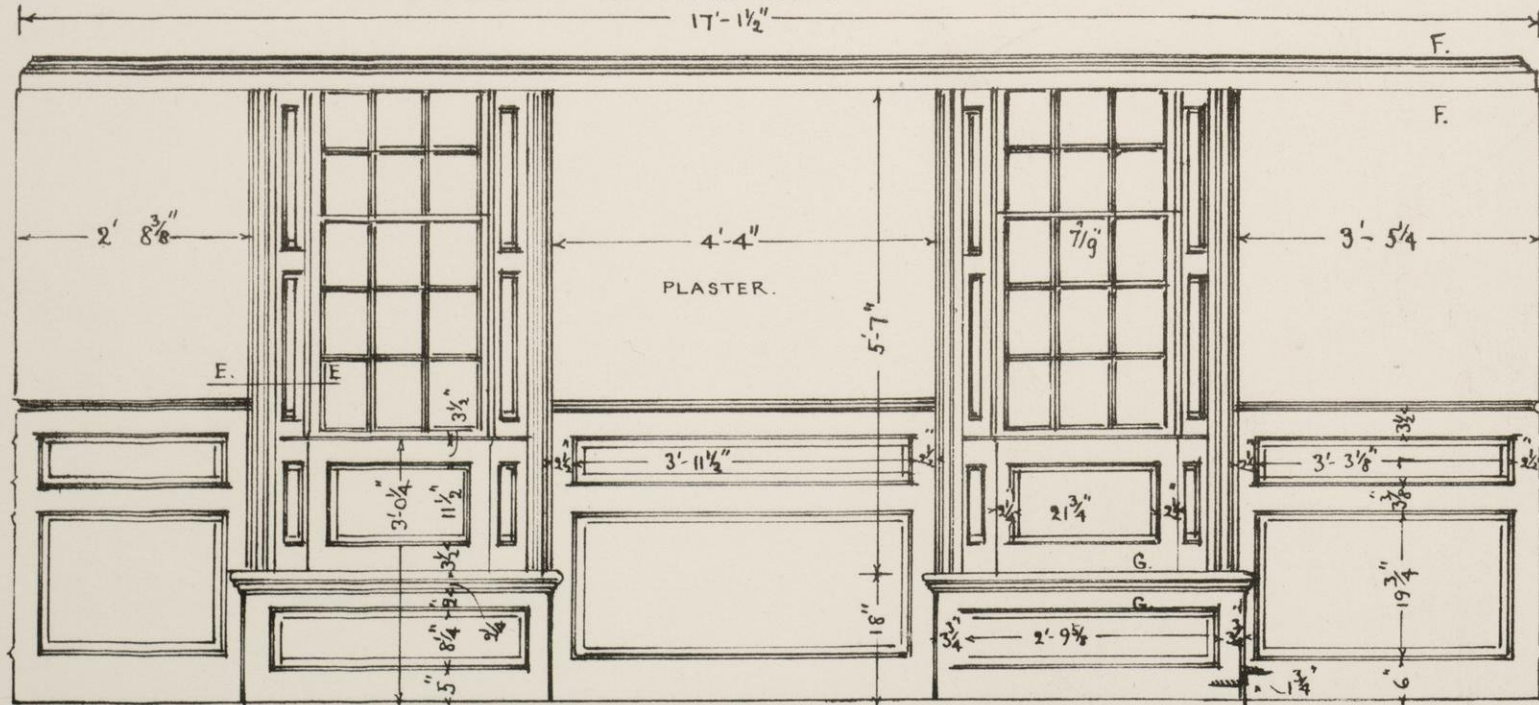
SOUTH SIDE OF KEEPING-ROOM.

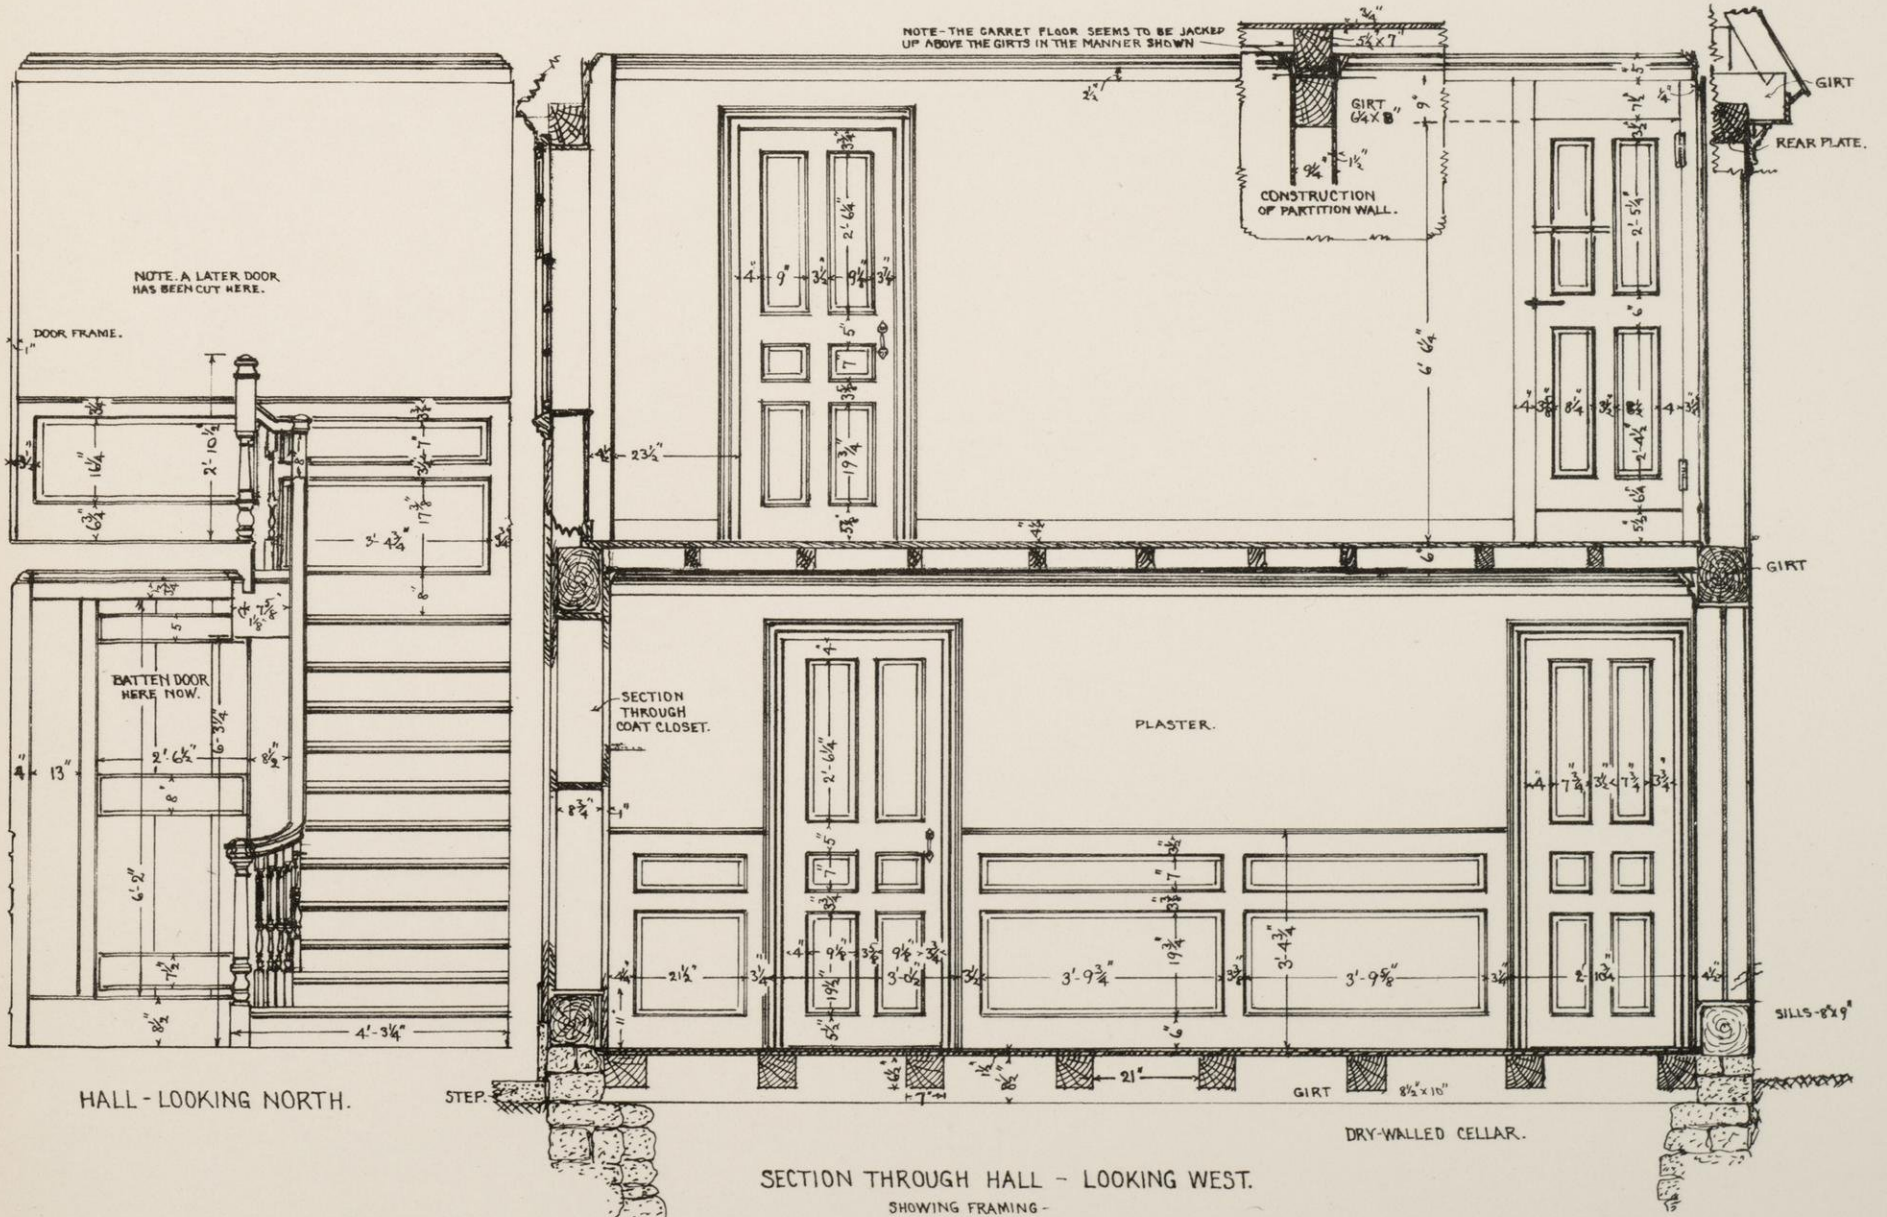
NOTE. IT IS EVIDENT FROM THE FRAMING THAT THE WALL AND KEEPING-ROOM FORMED AN OLDER HOUSE. ABOUT WHICH THE PRESENT WORK WAS BUILT ABOUT 1720-1730.

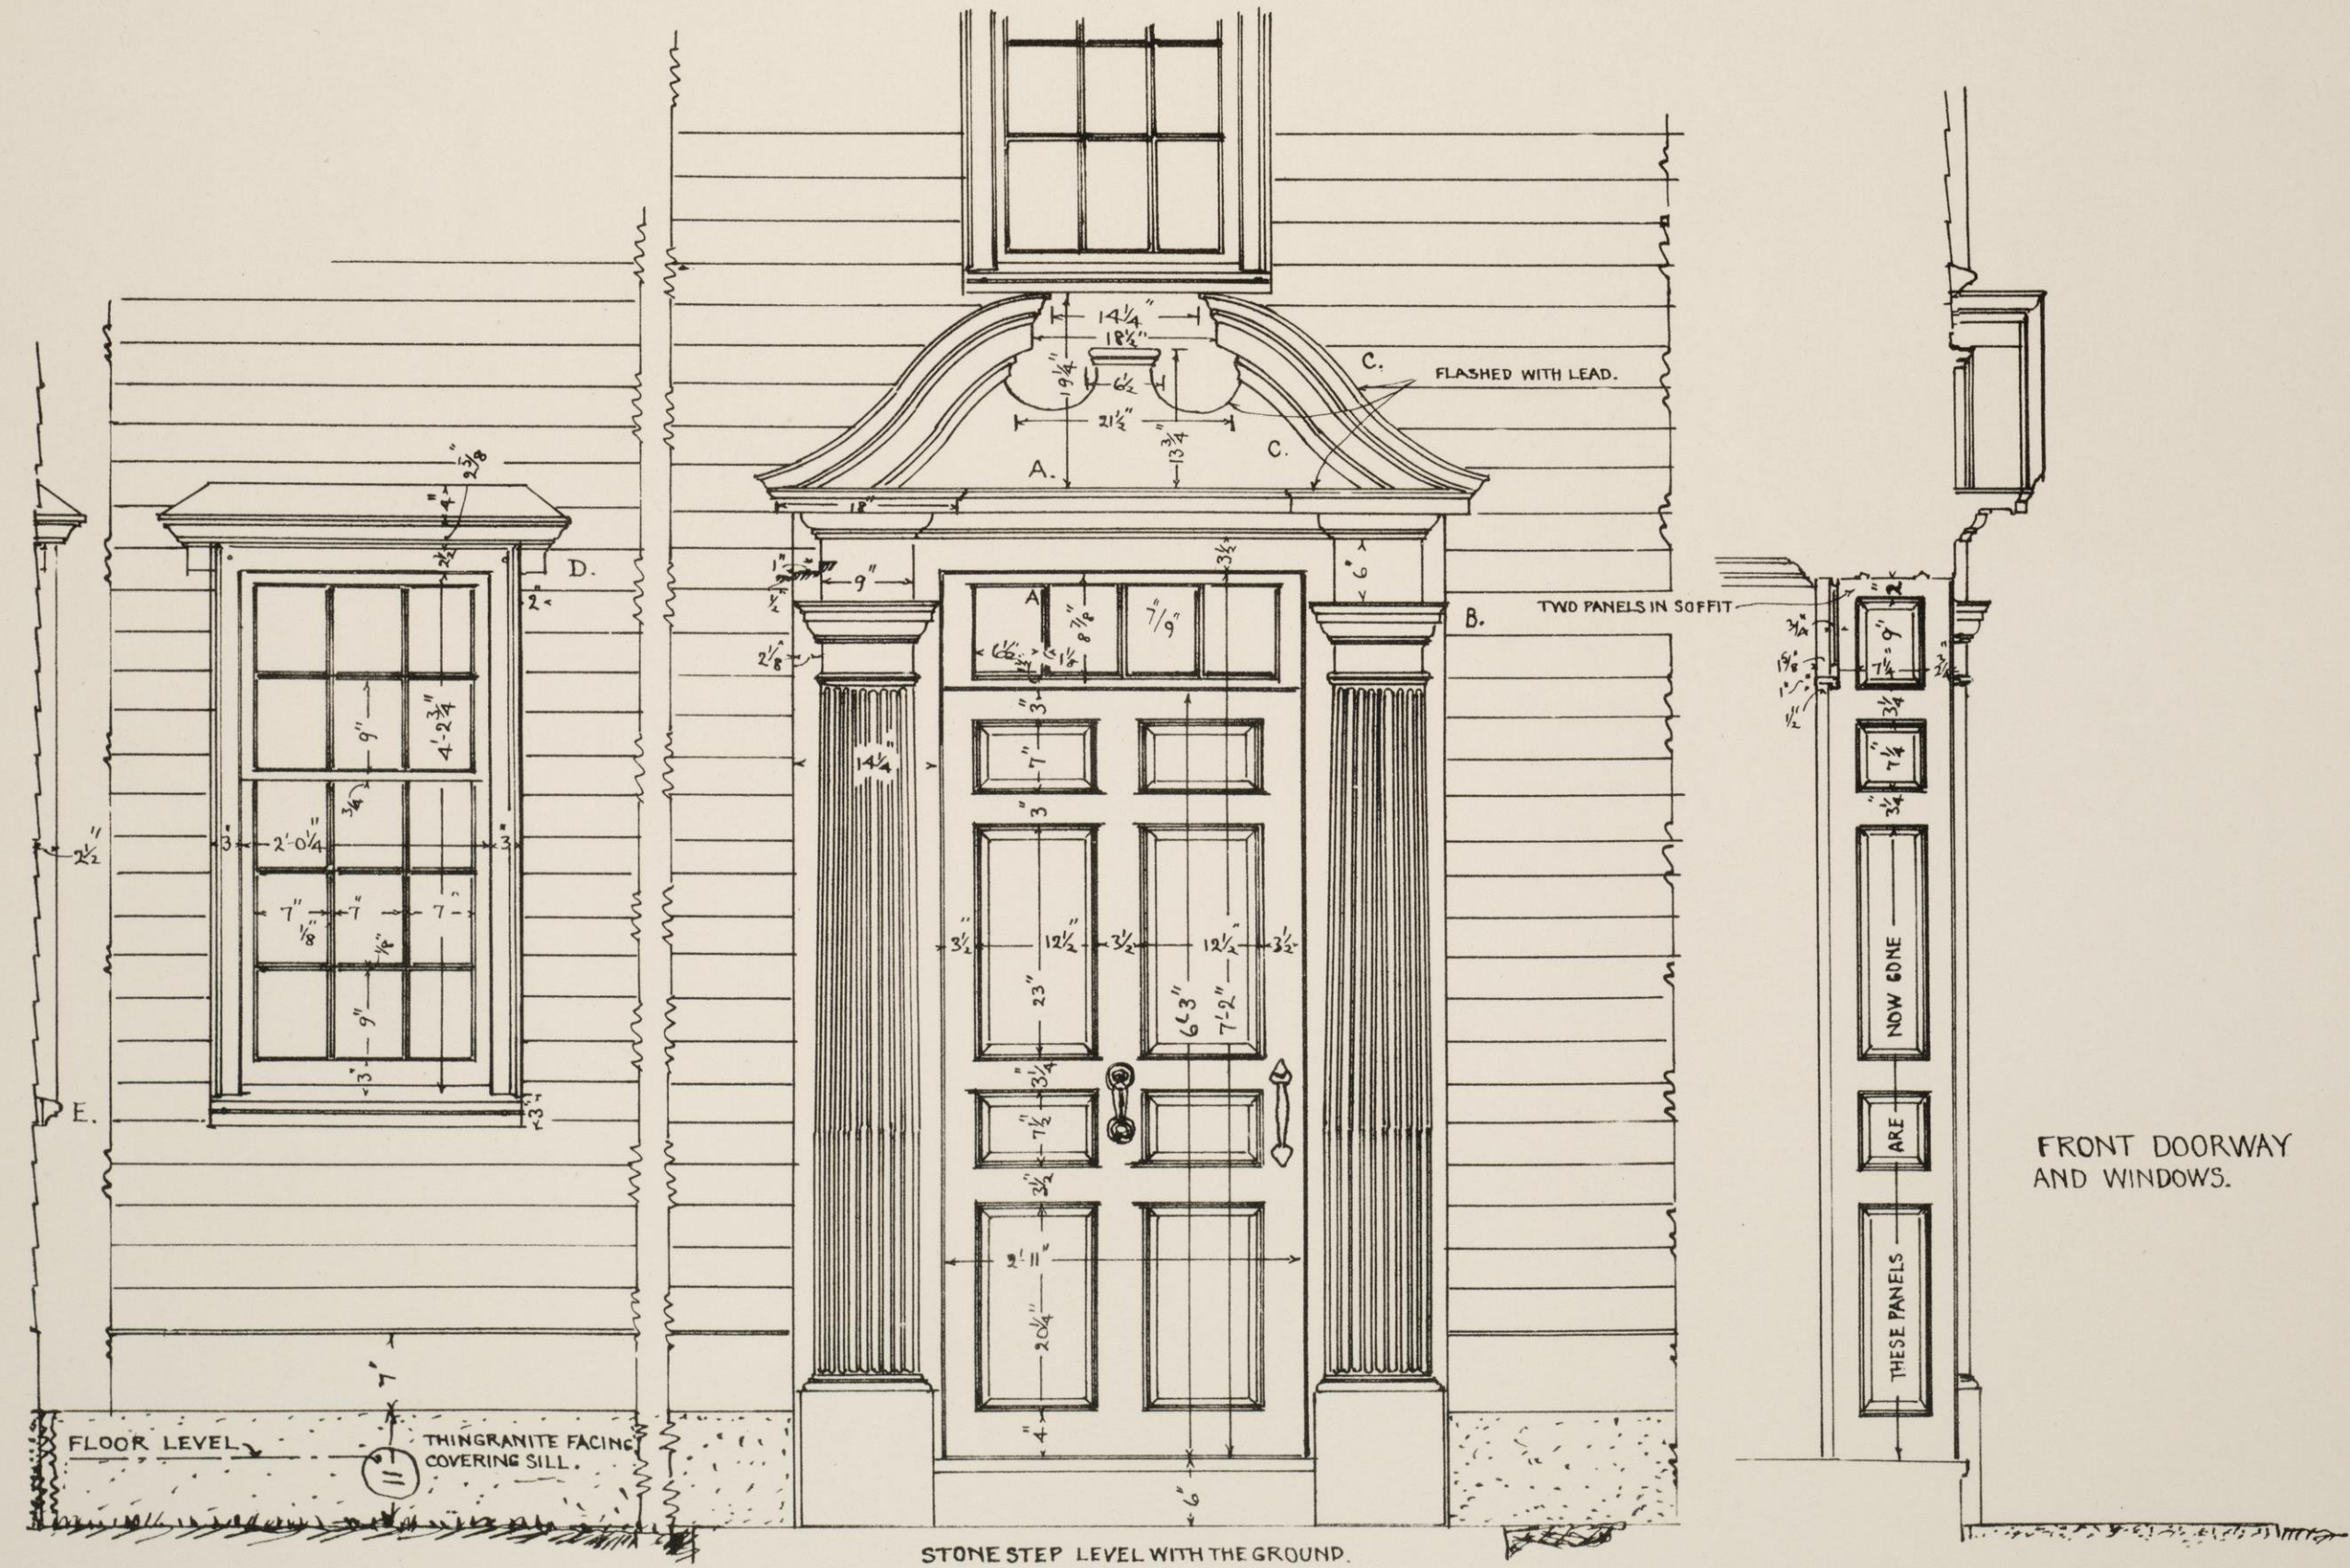
PANELLING IN EAST CHAMBER -

NOTE - THE HEIGHT OF THIS ROOM VARIES - 7'-8 1/2" ON THE NORTH SIDE - 7'-7 1/4" ON SOUTH. NO CORNICE AROUND ROOM. WINDOWS AS IN WEST CHAMBER.
