RESTORING THE RECREATIONAL POTENTIAL OF SMALL IMPOUNDMENTS

The Marion Millpond Experience

*An Inland Lake Renewal
and Management Demonstration
Project Report*

Technical Bulletin No. 71
DEPARTMENT OF NATURAL RESOURCES
Madison, Wisconsin

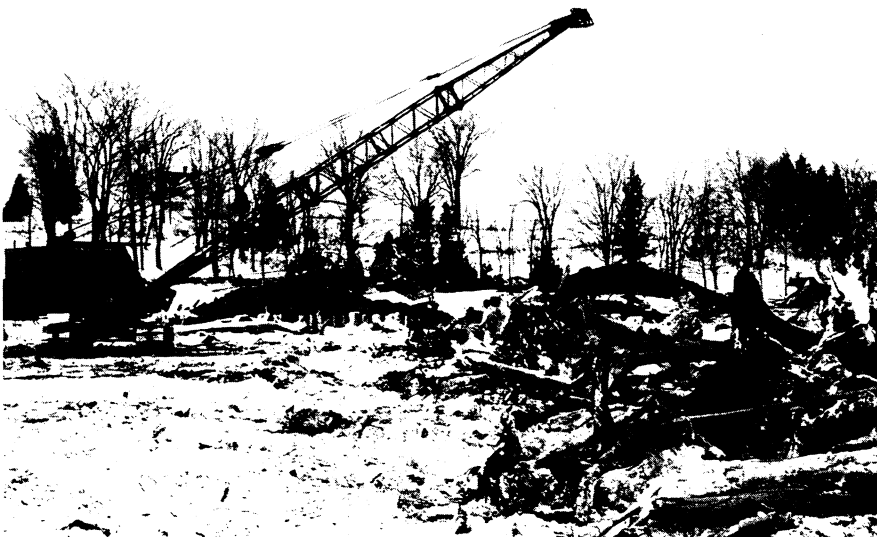
FIGURE 7

Winter stump removal.

During the 1969-1970 winter, roads were frozen-in on the pond bottom. This enabled contracted heavy equipment to work on the pond bottom proper. Deeply embedded logs and stumps were removed by a drag line, wind-rowed by a front-end loader, and moved off the pond bottom by truck. (Fig. 7). The large volumes of stumps and debris were trucked to a disposal area. (In spite of a great deal of thought, no salvage value was found for this wood – largely cedar and

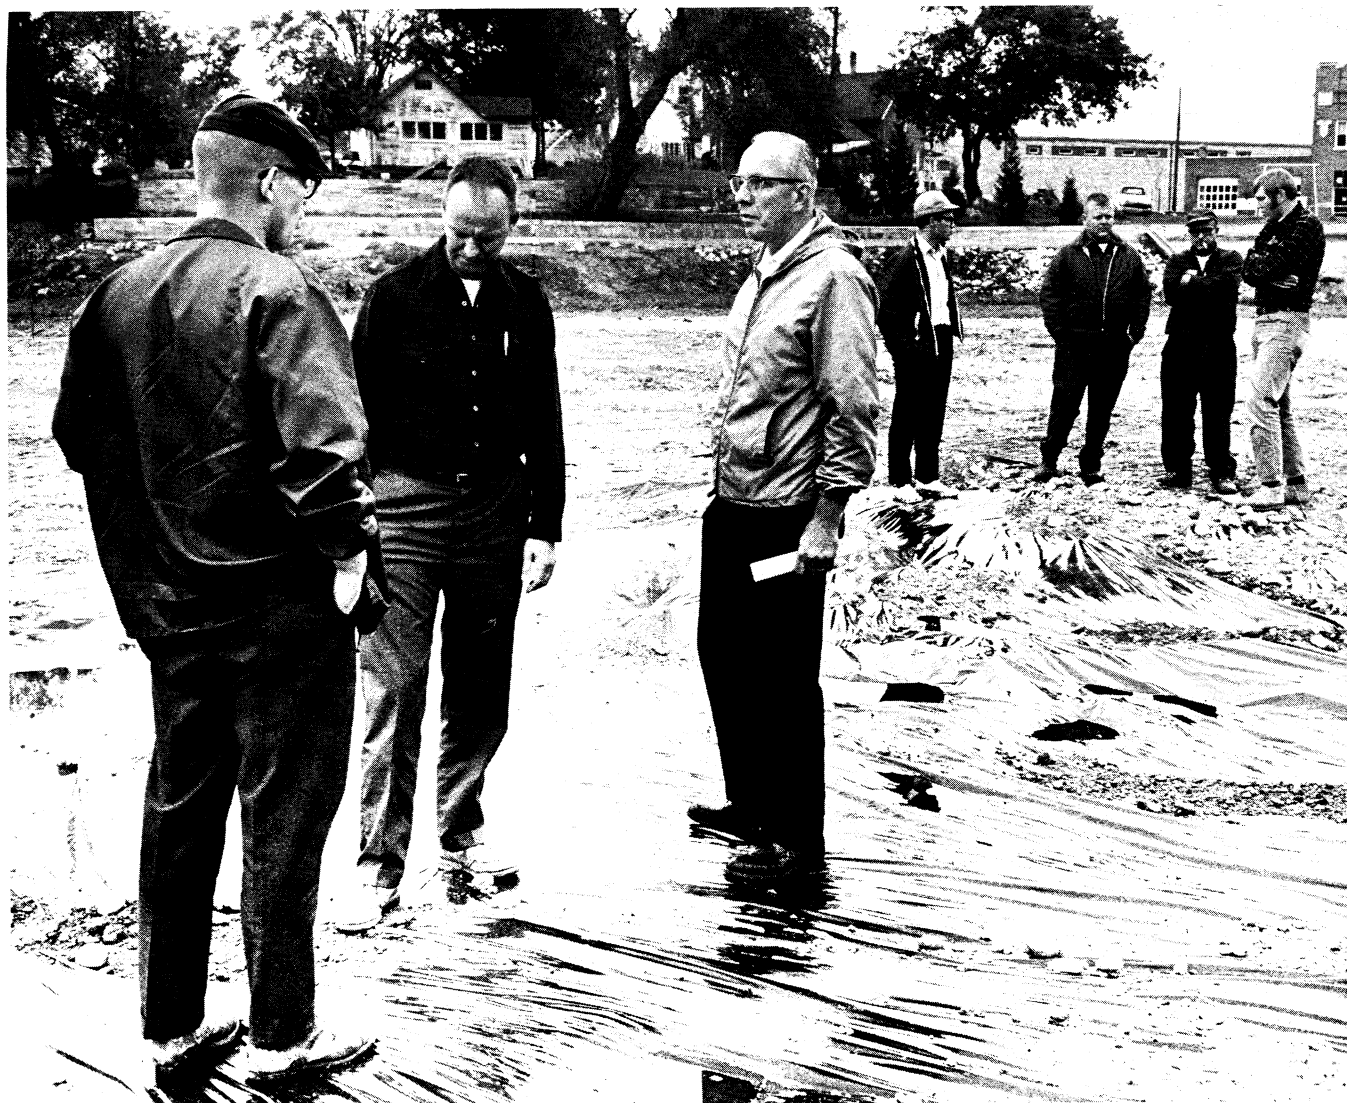
FIGURE 8

Plastic sheeting anchored in place prior to covering.

The plastic sheeting was applied in the winter, when frozen ground and ice cover allowed machinery to be used for transporting and spreading sheeting and anchoring materials. Sheeting was laid down by a team of workers, and anchored temporarily with rocks (Fig. 8). The sheeting was perforated to permit gases from the underlying sediments to escape. From 3-6 inches of sand, gravel or "pit-run" sand and gravel was then spread over the sheeting by means of a front-end

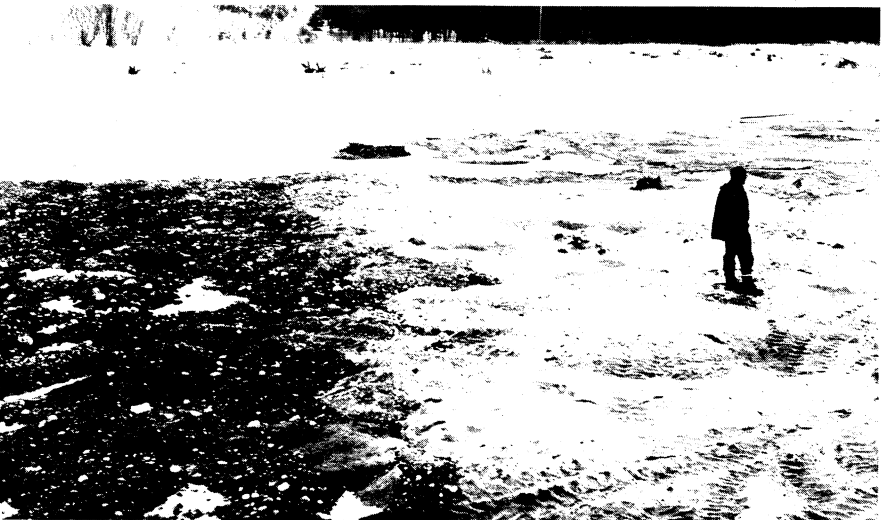
FIGURE 11
Gravel and sand covering over cleared areas.

Other areas of the pond were covered only with sand or gravel for comparative purposes (Fig. 11). The location, description and evaluation of the treated areas are reported in Appendix C and Figure 12.

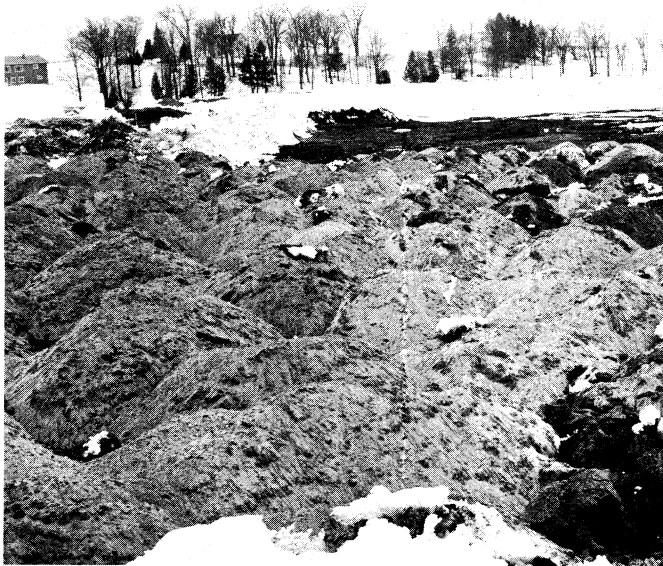
FIGURE 13
Construction of the Lion's Point Beach.

Lion's Point (see Figure 5) was selected for construction of a public swimming beach and boat dock. This area had been acquired in 1968 by the Marion Lion's Club for this purpose. A beach area was chosen that would be swept clean by waves generated by prevailing westerly winds. Plastic sheeting was distributed over the bot-

tom, and covered with sand, which was then spread to a 1:8 grade (Figs. 13 and 14). A boat dock was built north of the new beach and picnic tables and other facilities were installed.*

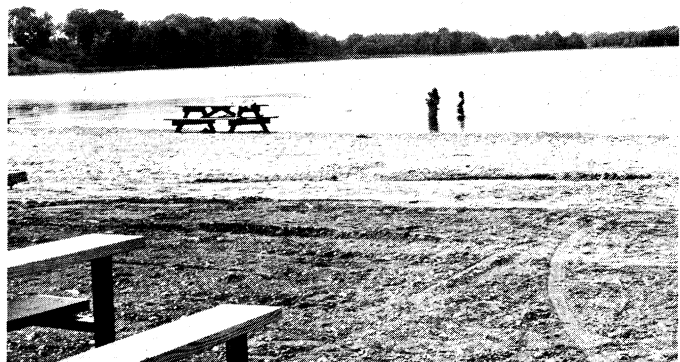
FIGURE 14
Lion's Point Beach – after construction.

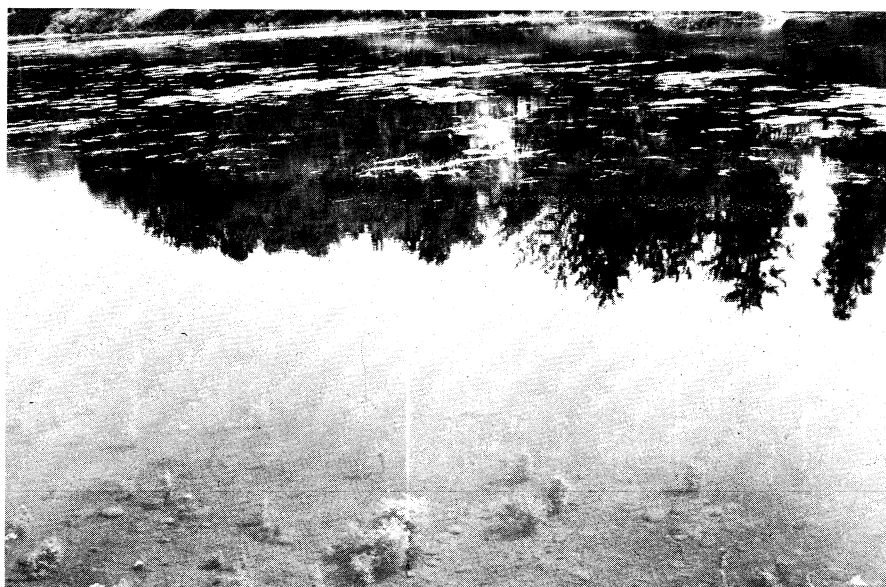
FIGURE 15

Plant growth in treated areas (foreground) vs. untreated areas during the second year after treatment.

Based upon this two-year comparison, treated areas generally exhibited less plant growth than untreated areas (Fig. 15). Data for 1972 indicate that the areas that were blanketed with sheeting and sand or gravel had substantially less growth than those areas which were only dredged or dredged and sandblanketed; an exception to this occurred where dredging was done to a depth exceeding the photic zone (Treatment 9, see Appendix C). Treated areas have a different vegetation than the control areas. Macrophytic algae of the genus *Chara* form the majority of the plant growth in the treated areas. In contrast, rooted angiosperm macrophytes constitute most of the plant growth in control areas. The shallow-water treated areas had a high biomass of filamentous algae in 1971. Production of this algae dropped off markedly from 1971 to 1972, although small amounts were present clinging to plant tops and shoreline areas. The decrease in filamentous algae was expected, in view of competition from the higher biomasses of other plants in 1972.

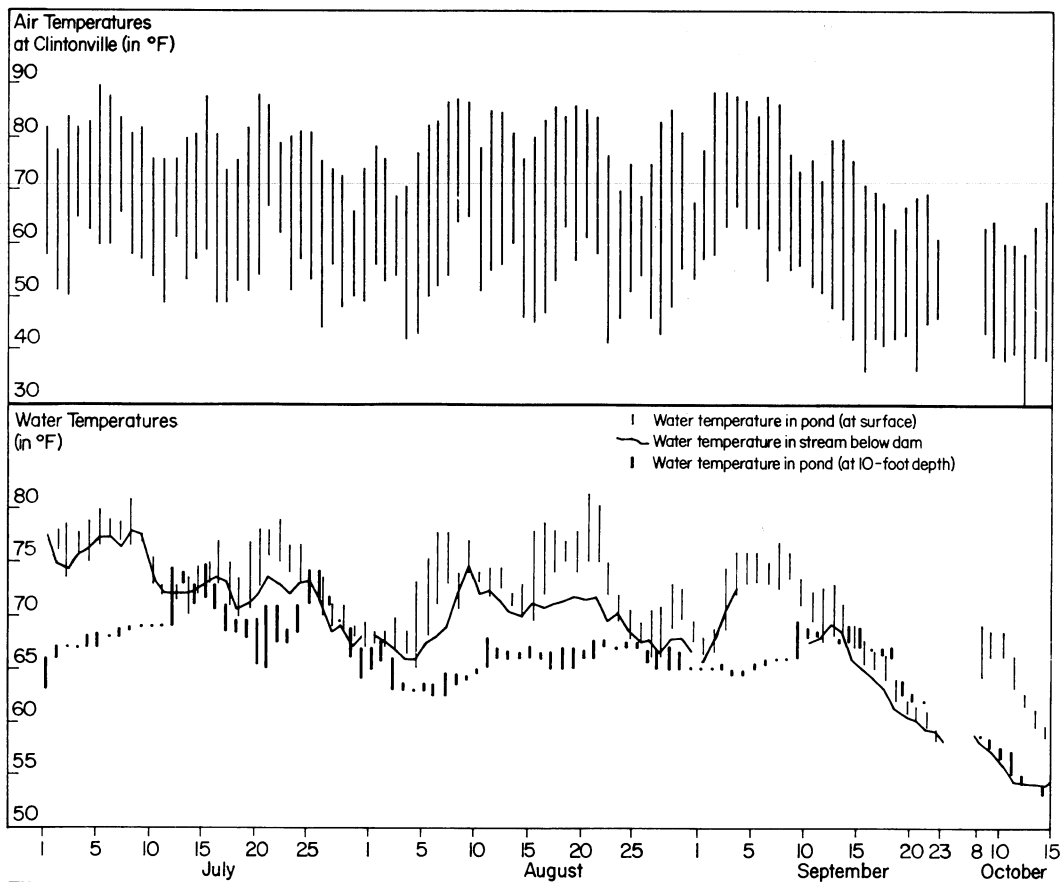
FIGURE 16

Water temperatures above and below the Marion dam and air temperatures, 1 July–15 October 1971.

During the summer period, water from the pond bottom was occasionally passed through the wasteway. Unfortunately, no record of the dates or volumes is available. From the temperature records, it appears that deep water withdrawal took place around 15 and 26 July 1971.

Temperatures that inhibit trout are in the high 70's (77-80 F). Bottom temperatures in Marion Pond never reached these levels, but surface temperatures exceeded 80 F on at least three days and would have likely been lethal to trout. Bottom temperatures were generally about 10 F cooler than surface temperatures and exhibited less variation in range. Based on the Marion data, the continuous bottom draw of water from some millponds may be beneficial to trout in downstream waters.
