Plover Area Nitrate Study 1986

Fred Bailey Water Supply Manager Wisconsin Rapids Area North Central District Wis. Department of Natural Resources

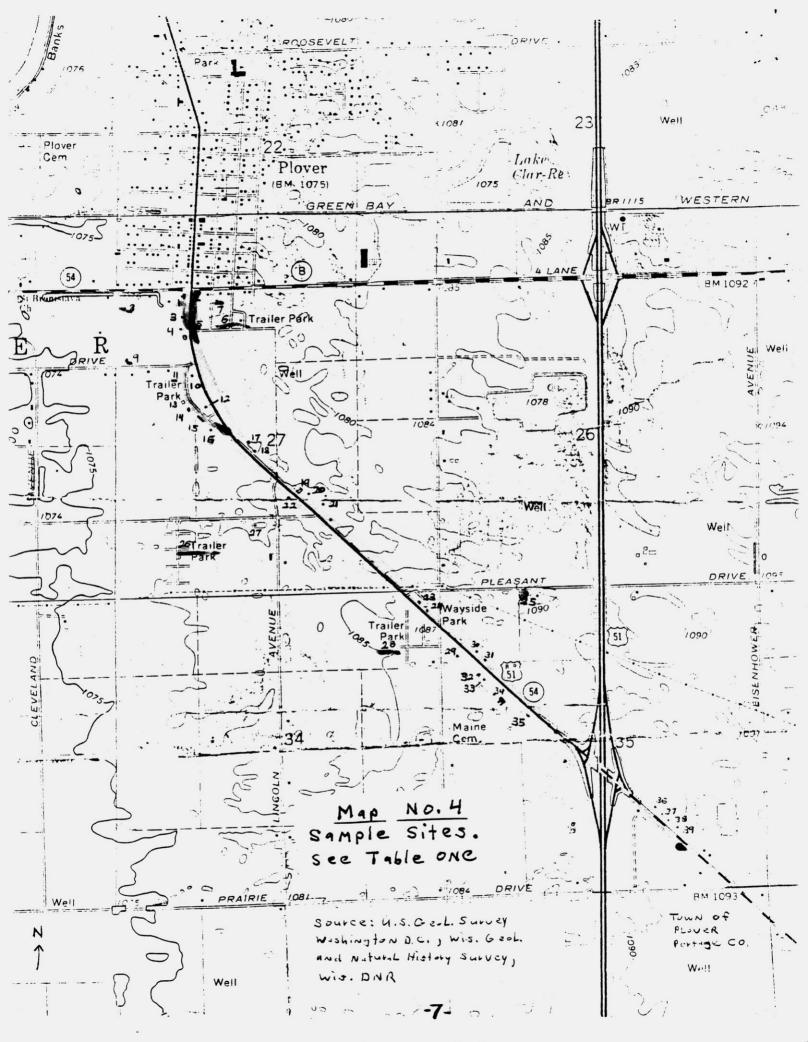
Table One

Name	e and Map Number - See map #4	Well Type	Well Depth	Sample Date	N-NO ₃ in ppm
1.	Plover Bait & Sporting	Unk.	Unk.	8/08/86	11.0
2.	Standard Station	Drilled	60	8/08/86	6.0

20.	George Peper	Driven	46	7/15/86	13.9

From looking at table one, you can see most of the area wells had an elevated nitrate nitrogen content in their water. Thirty one of the fifty five wells sampled showed an elevated nitrate content above eight parts per million (ppm). There were a number of wells with nine to ten ppm nitrate and these might easily exceed the health limit of 10 ppm under certain conditions. Twenty two of the wells sampled were actually above the 10 ppm health limit for nitrate and four of these wells were above 20 ppm. The highest value reported being 27 ppm nitrate nitrogen.

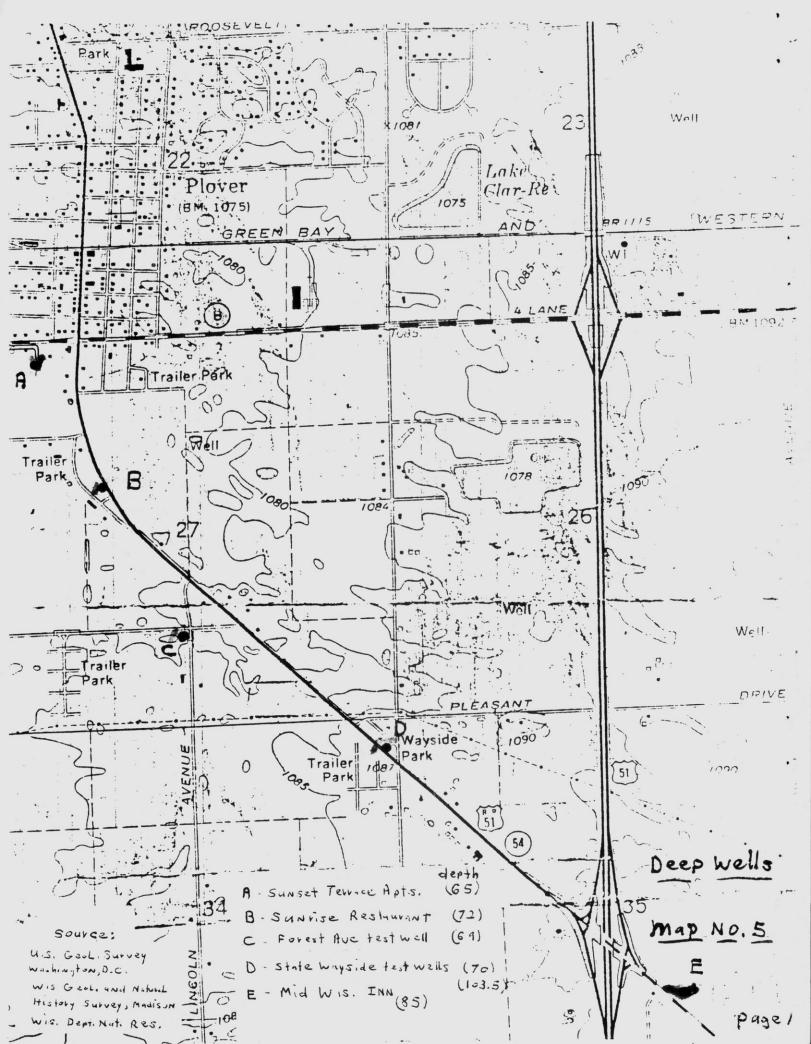
The wayside itself is an interesting study area. It is literally surrounded by irrigated agriculture yet the 23 foot deep handpump tested

out at only 7.7 ppm nitrate. In looking across the potato field one can see that. Tom Cordy owns a 40 acre parcel nearby and it is likely some of the recharge for this well is coming from this wooded forty. It does appear this wayside handpump could be easily affected by local farming practices such as usage of fertilizers and pesticides. I discussed this concern with the State Highway Department and they may switch to the 103 foot deep steel test well for their water.
