# **Memorial Union, University of Wisconsin-Madison: historic structure report.**

Uihlein/Wilson et al.

Historic Structure Report

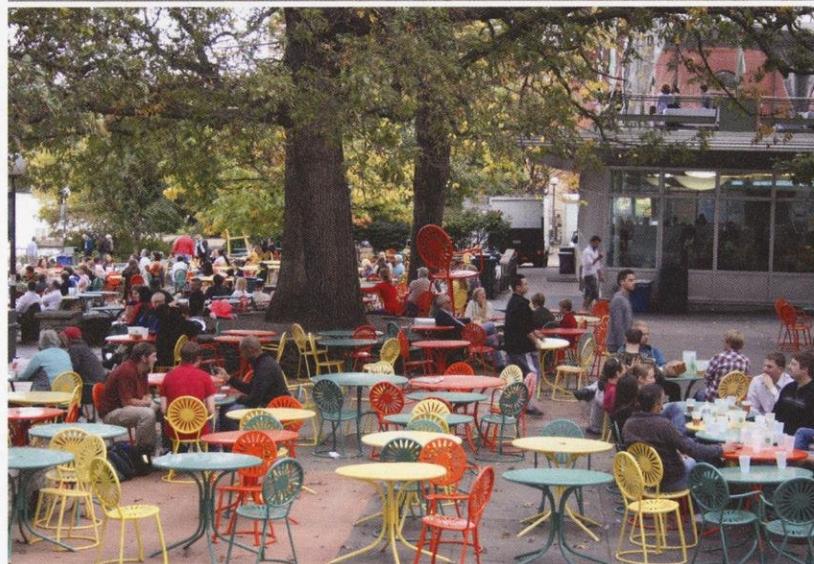
Image, top: View of the east area of the upper Terrace and the temporary accessible ramp.

Image, bottom: Main Terrace area under the canopy of large oak trees.

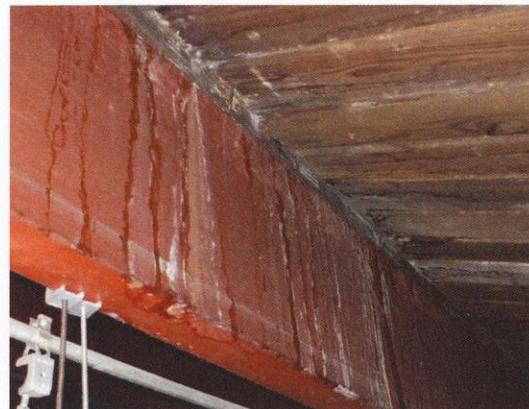
The attic had several areas of past water leaks through the roof. (Image 4) The clay tile roof was just replaced earlier in the year. The water staining seen in the attic is therefore assumed to have been repaired or occurred during the roof replacement. The attic shall routinely be monitored for leaks and any leaks found should be repaired to prevent the deterioration to the structural and other building systems.

- Image: Water stains on wood deck boards and steel beam in central core attic.

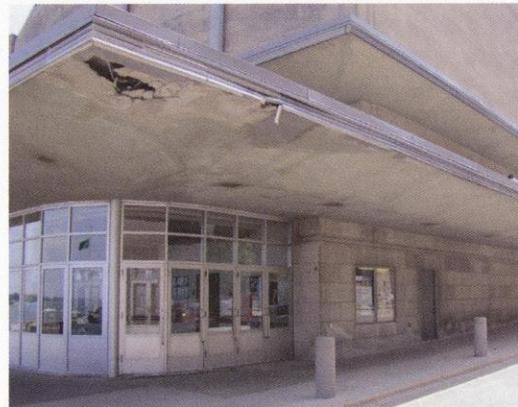
The most severe damage to the Theater wing is caused by trucks running into the canopy on the west elevation. It appears that this occurs fairly frequently due to the canopy being

slightly lower than the modern delivery trucks. The most severe damage was made to the northwest corner where a truck has broken the soffit and appears to have ripped off and bent the bottom flange of the steel beam. A truck also hit the southern end of the canopy and caused the support beam to deflect and damage the stone façade on the main building.

Image, middle: Truck damage to canopy beam and soffit at Park Street side.

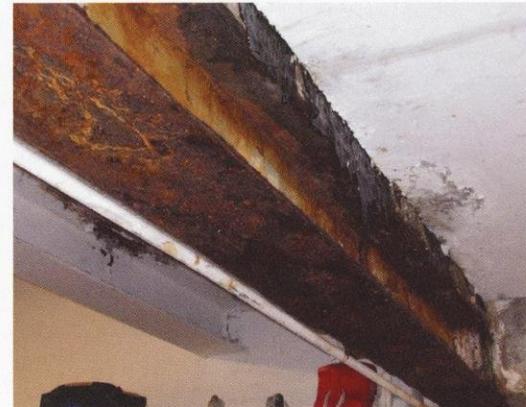
In the tunnel between the Hoofers Boat Repair Center and the rental office, the ceiling or roof of the tunnel has several continual leaks. These leaks are at various places throughout the tunnel and are causing severe deterioration. Each of the steel w-section beams spanning across the tunnel is corroded. A few of the beams have severe corrosion and at least one has a critical level of corrosion that has caused approximately 30% section loss on

Image, right: Critical corrosion and leaking on steel beam in Hoofers' tunnel.

the bottom flange and is losing section for its entire length and height. This beam needs to be closely monitored and replaced or shored if renovations to this area are not completed shortly. It is recommended that all of the beams be monitored and cleaned and painted until the renovations can be completed. A long term resolution must include the repair or replacement of the steel beams and the installation of new waterproofing over the tunnel.

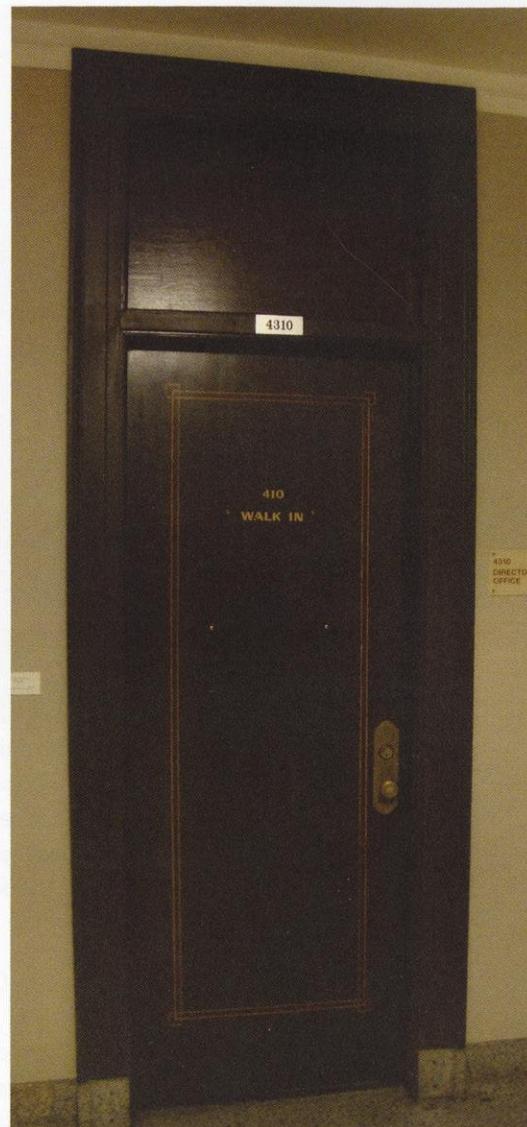
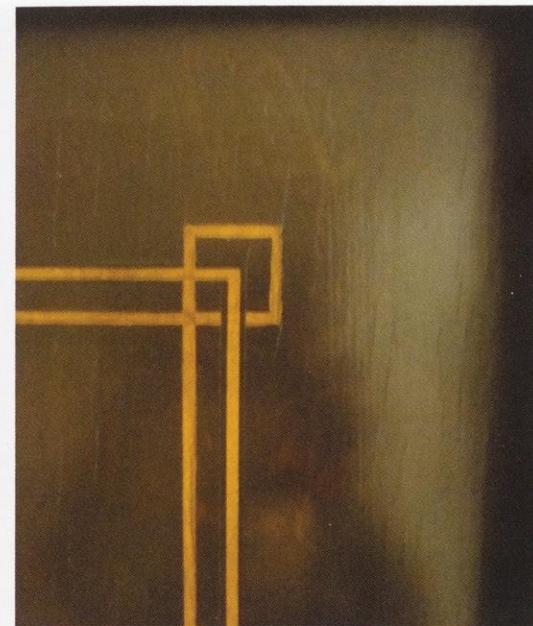
- Image, left: Typical door and casing found on the upper floors in the Commons Wing.  
Image, right: Detail of wood inlay found on doors of the upper floors.

Most of the historic wood doors and surrounds are in good condition with minor scratches, chips and gouges.

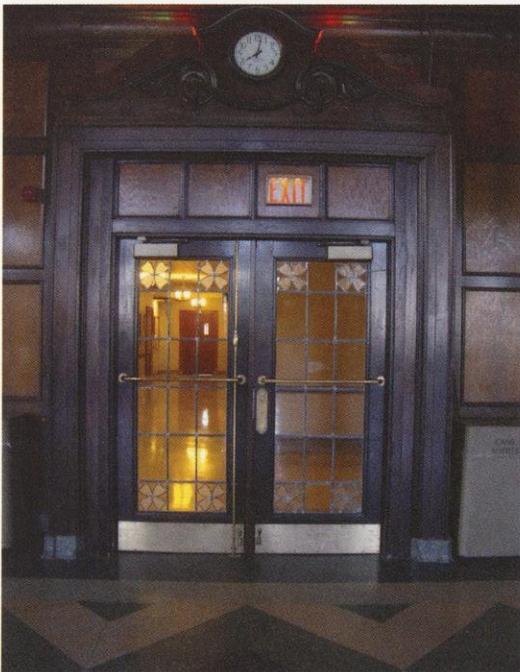
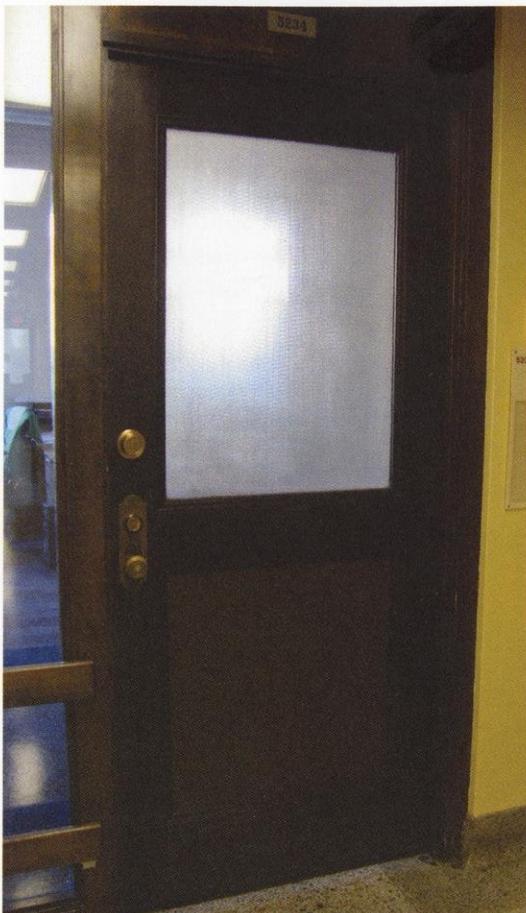
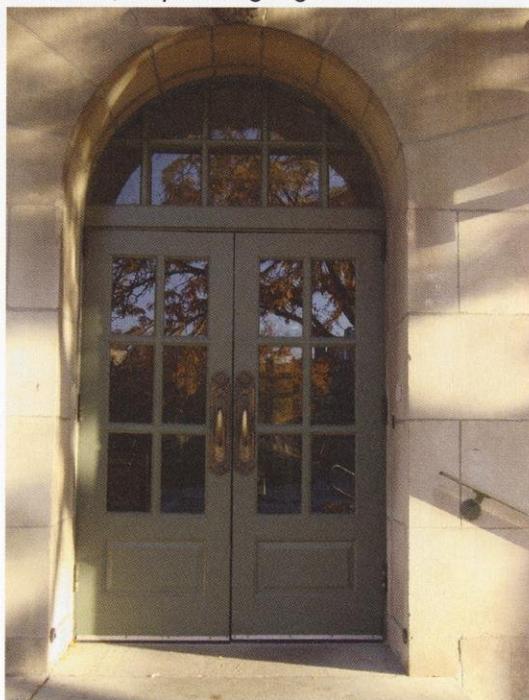
Image, left: Wood entry doors to Tripp Commons.

Image, middle: Typical wood door and casing at fifth floor Central core.

Image, right: Wood entry doors of the ground floor Commons Wing at Langdon Street.

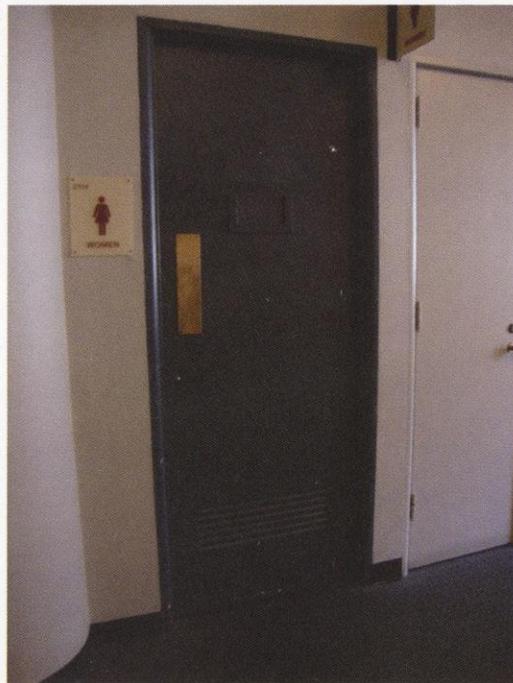
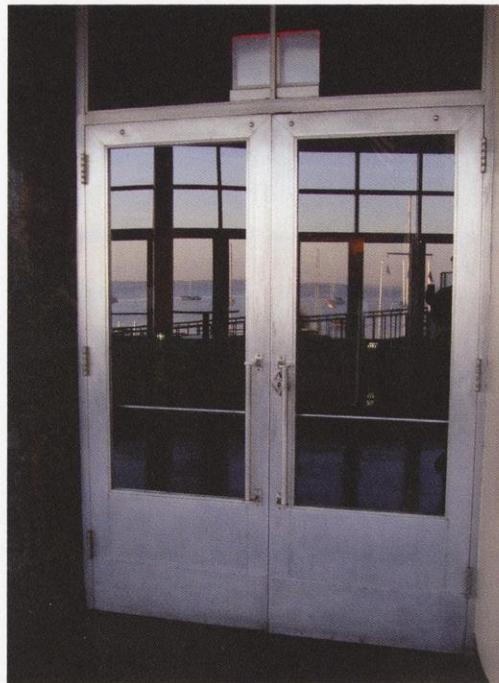
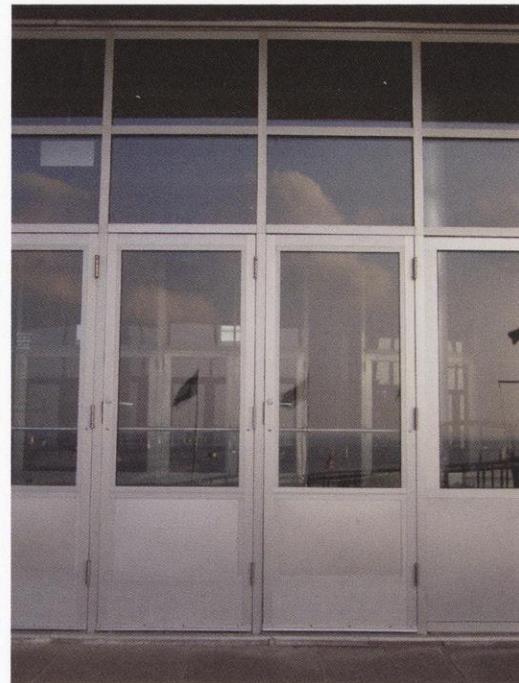
- Image, left: Typical flush hollow metal door of the Theater Wing.
- Image, middle: Aluminum and glass doors at the Union Theater lobby.
- Image, right: Exterior entry doors to the Union Theater lobby.

tem. On the north and west this glass wall is relatively and in very good condition, having been replaced in the late 1980s.

A detailed survey of doors will be required to determine those that have potential for reuse.

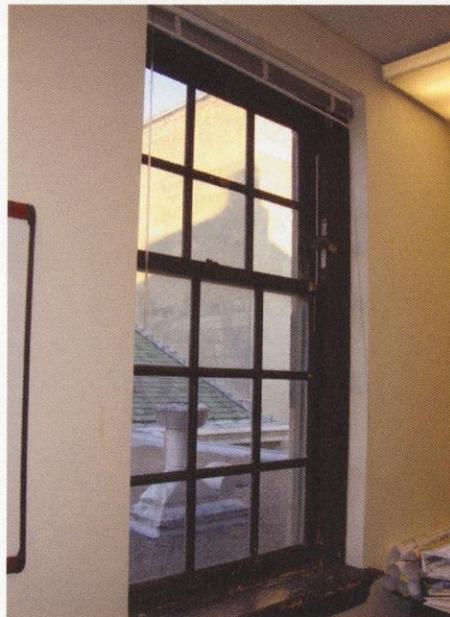
Image, left: Historic wood window of the Central Core protected by an aluminum storm window.

Image, top: Typical original aluminum window of the Theater Wing/Craftshop.

wood windows are in good condition. In general, rails, stiles and muntins are in good condition and structurally sound. Almost all historic wood windows remain operable.

The original aluminum double hung windows of the Union Theater Wing are in very good condition. Although approaching 75 years in service, these windows remain generally intact and serviceable. The aluminum components are in very good condition with minor surface pitting evident. Sealant joints at the juncture of the aluminum frames and limestone surrounds are in need of replacement. Sills are in good condition. Glazing and glazing sealants remain serviceable.

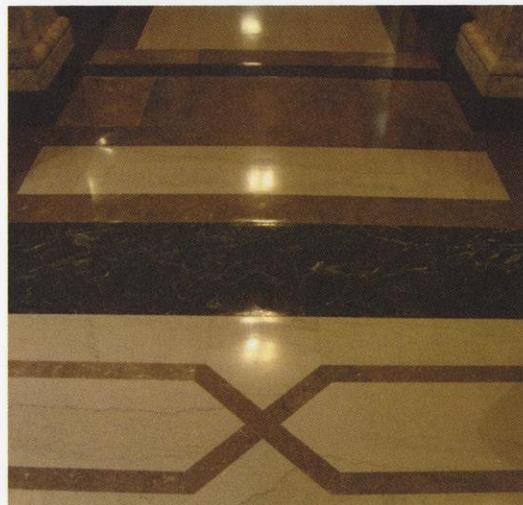
■ Image, left: Stone detailing at the floor in Memorial Hall.  
Image, right: Book matched stone panels in Memorial Hall.

Stone is used extensively in the Central Core portion of Memorial Union in the areas of Memorial Hall and the Main Lounge. Here we find marble for base, floor border and field, and for columns and wall panels. All of the stone is well maintained and little significant damage, beyond scratches and minor chips, is apparent.

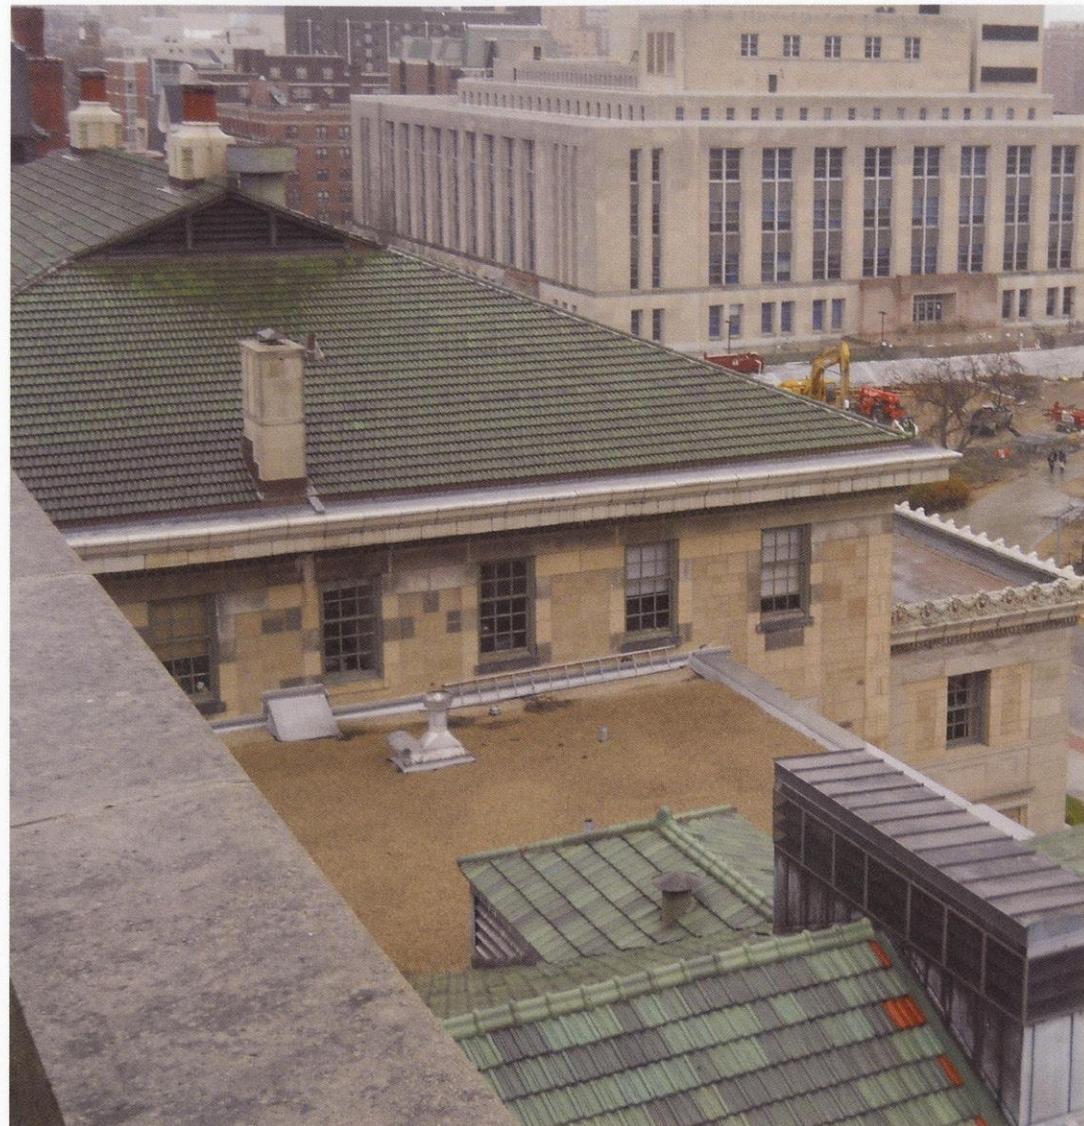
- Image: General view of the Theater Wing and Central Core south roof areas, photo courtesy of Specialty Engineering Group, LLC.

of the Theater Wing are reaching the end of their life expectancy, but the repair is considered a minor deficiency as no signs of current leaks were noticed. During a major remodel it is recommended that the roofing materials be replaced. This replacement will also allow for the installation of new insulation. The lower roof to the northeast of the Play Circle Theater and east of the Theater Stage Tower is in poor condition with standing water and heavy organic growth over the ballast. This roof is in critical condition and should be replaced with the Theater Wing renovation. The other membrane and ballasted roofs on the Theater Wing are in fair condition due to their life expectancy and signs of organic growth.

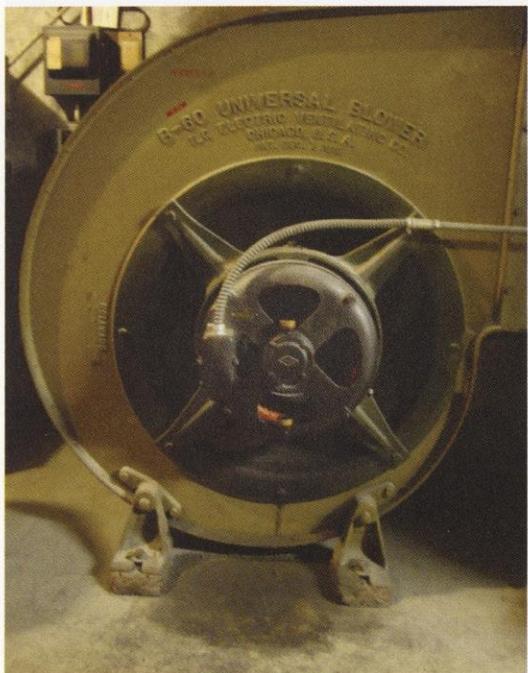
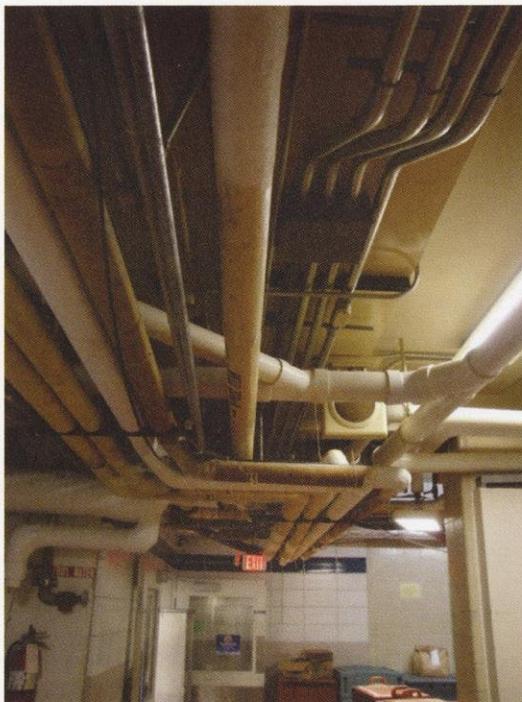
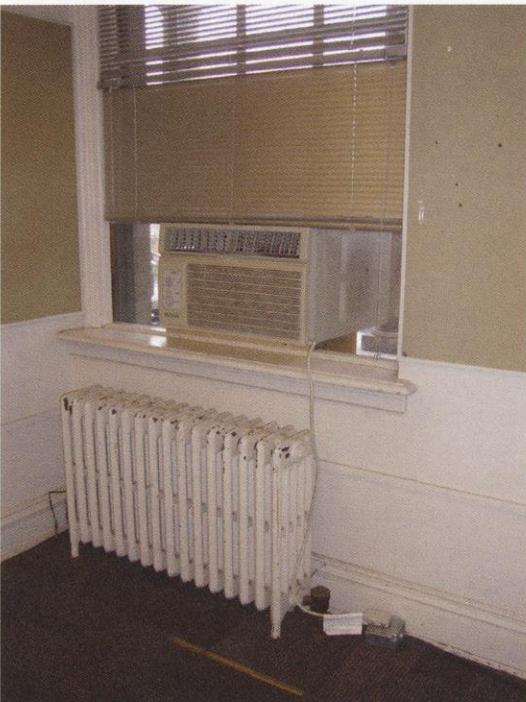
Image, left: Original Universal Blower still functioning in attic of Central Core.

Image, middle: Maze of mechanical and plumbing piping with electrical conduit in the basement kitchen area.

Image, right: Original steam radiator in a second floor office.

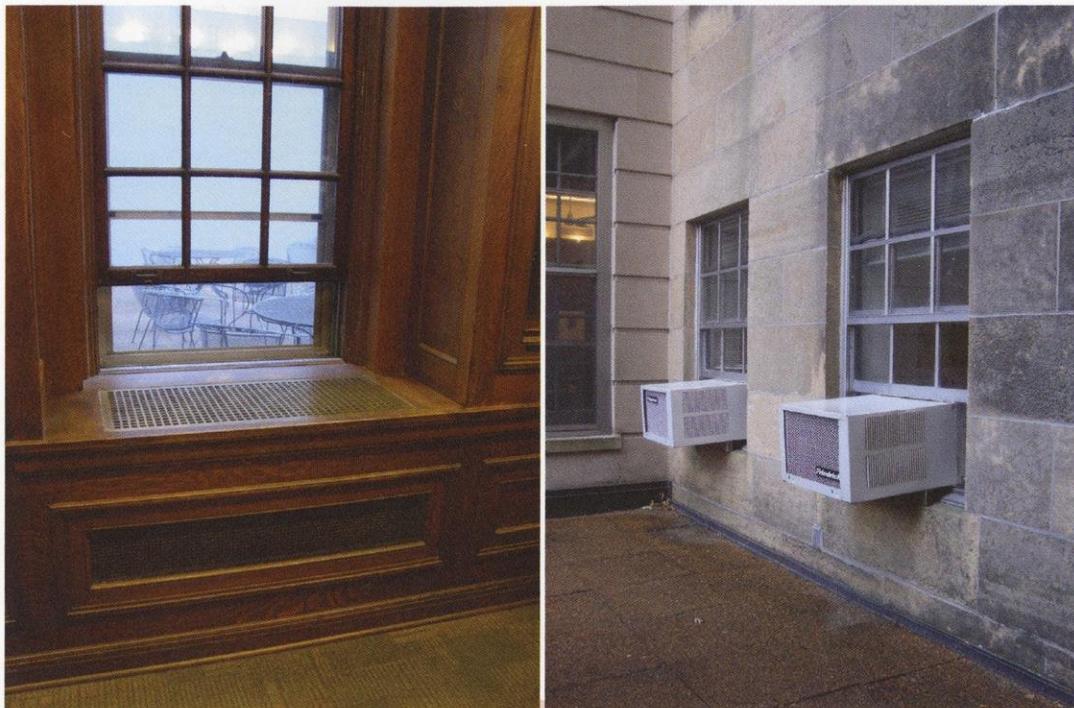
- Image, left: Wood radiator enclosure at the Hamel Family Browsing Library.  
Image, right: Window air conditioners at second floor Theater Wing offices. Typical of conditions for most offices.

Window air conditioning units are utilized in many spaces and city water cooled is also used (office spaces, meeting rooms and guest rooms). These spaces do not have any mechanical ventilation, which does not meet current code.

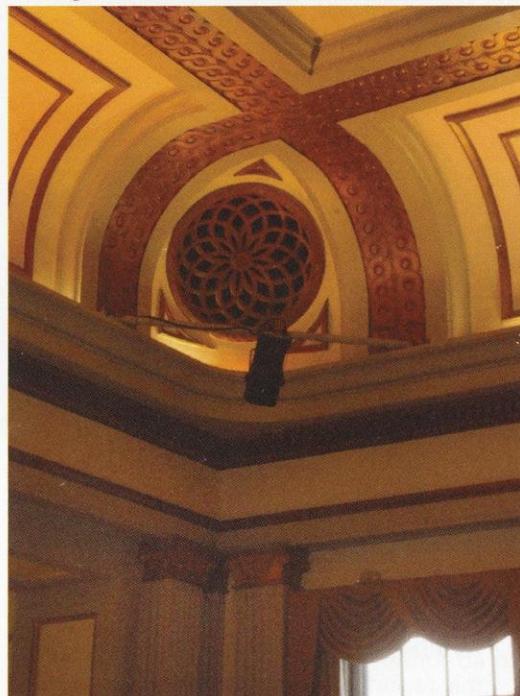
Image: Original air delivery grille still in use in the Great Hall ceiling area.

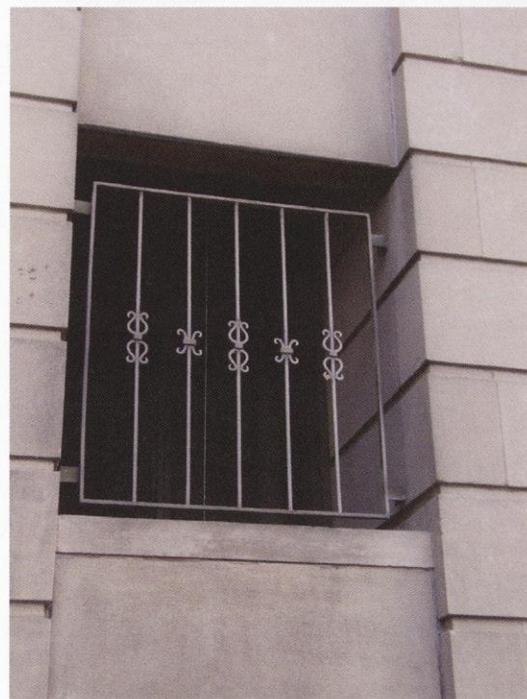
- Image: Building outdoor air intake within air shaft on the north wall of the Central Core.

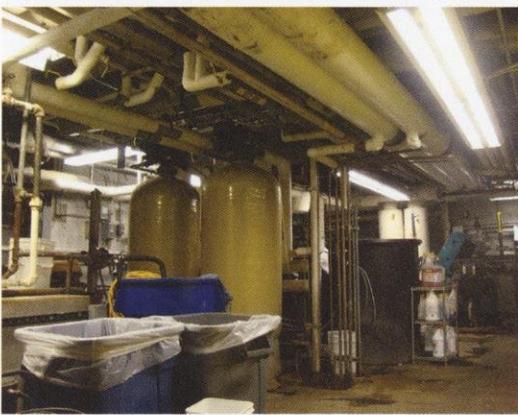
Image: Water softening system located in room B319.

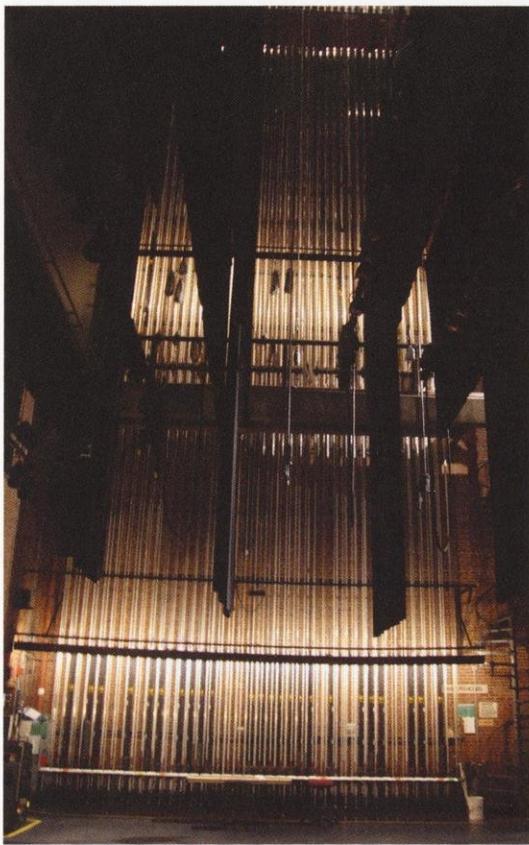
The stagehouse currently contains a manual counterweight rigging system in good condition. There are two line sets which need to be added to the lock rail and a motorized 1st electric is recommended for the heavy lighting load.

Image: View of the stage looking east with the manual counterweight rigging system visible in the background.

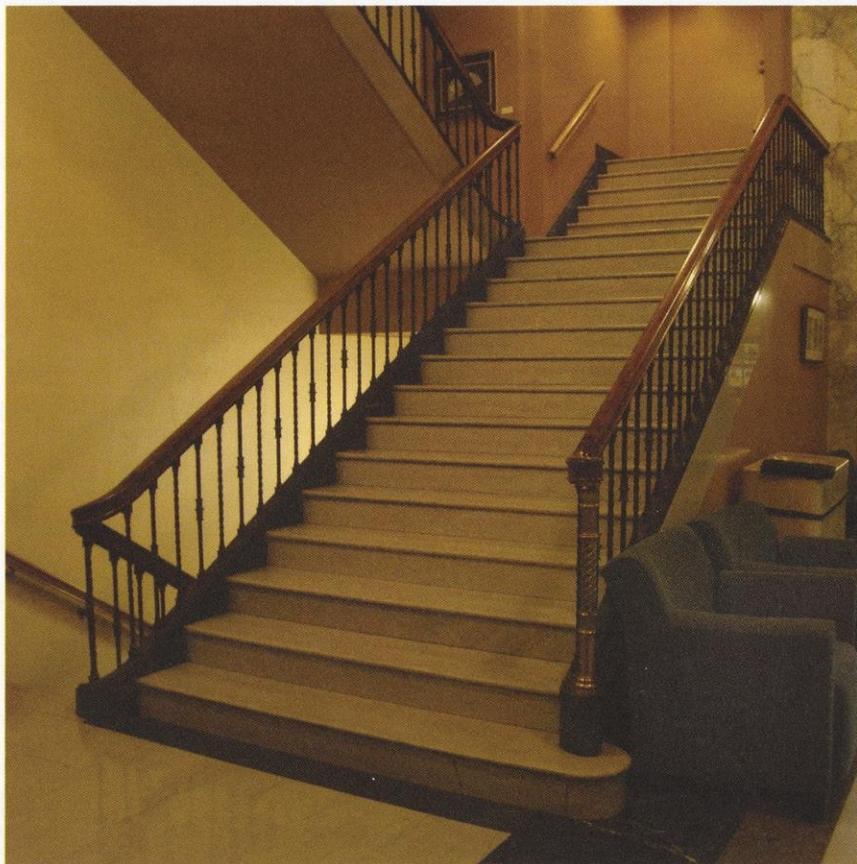
■ Image: View of the west grand stairs at the second floor level. The two main stairs are enclosed at first and fifth floors but open at second and fourth floors.

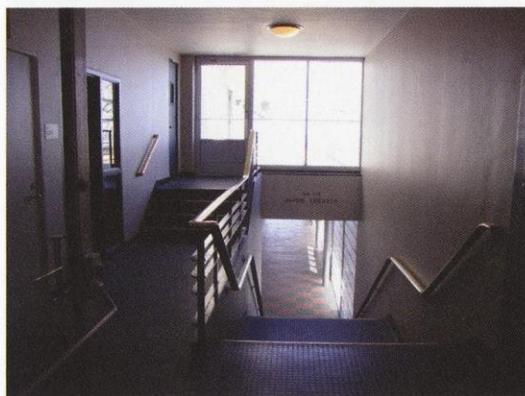
approximately equal, but the west entrance lacks a clear sense of arrival into the building and does not accommodate the disabled.

Providing a new west entry that is better connected to the activity areas of the Memorial Union is a clear design challenge, as are improvements to the east entry and preservation of the historic, formal second floor entrance.

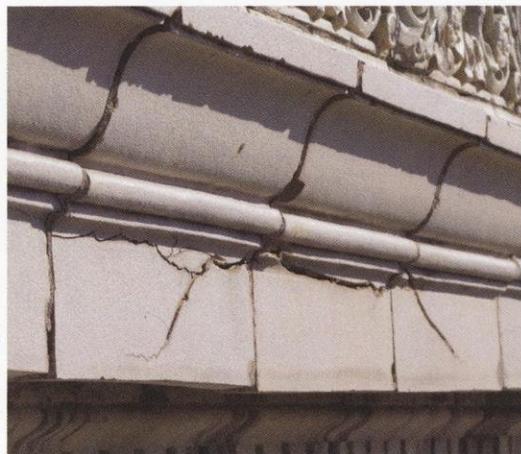
- Image: Detail of typical cracked and deteriorated Terra Cotta Cornice.

against the elements should also be a primary focus. This includes the roof, exterior walls, windows and doors. Roofs will be replaced, masonry exterior walls repointed and repaired, terra cotta cornices repaired or replaced and windows and doors rehabilitated and reused.
