WISCONSIN DEPARTMENT OF NATURAL RESOURCES

RESEARCH REPORT 167

Effects of Streambank Riprapping On Physical Features and Brown Trout Standing Stocks In Millville Creek

by Ed L. Avery

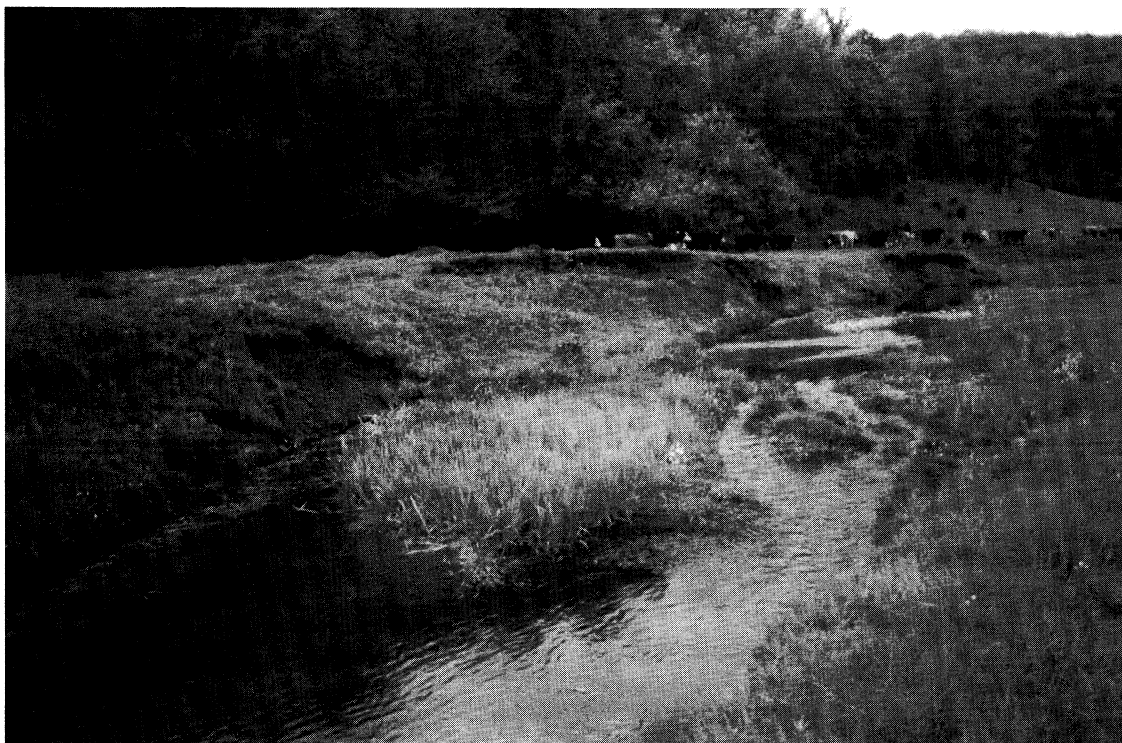
Figure 2. Excessive stream width, channel braiding, and filling of pools with sediment all result from heavy livestock grazing in the riparian zone—Millville Creek, May 1990.

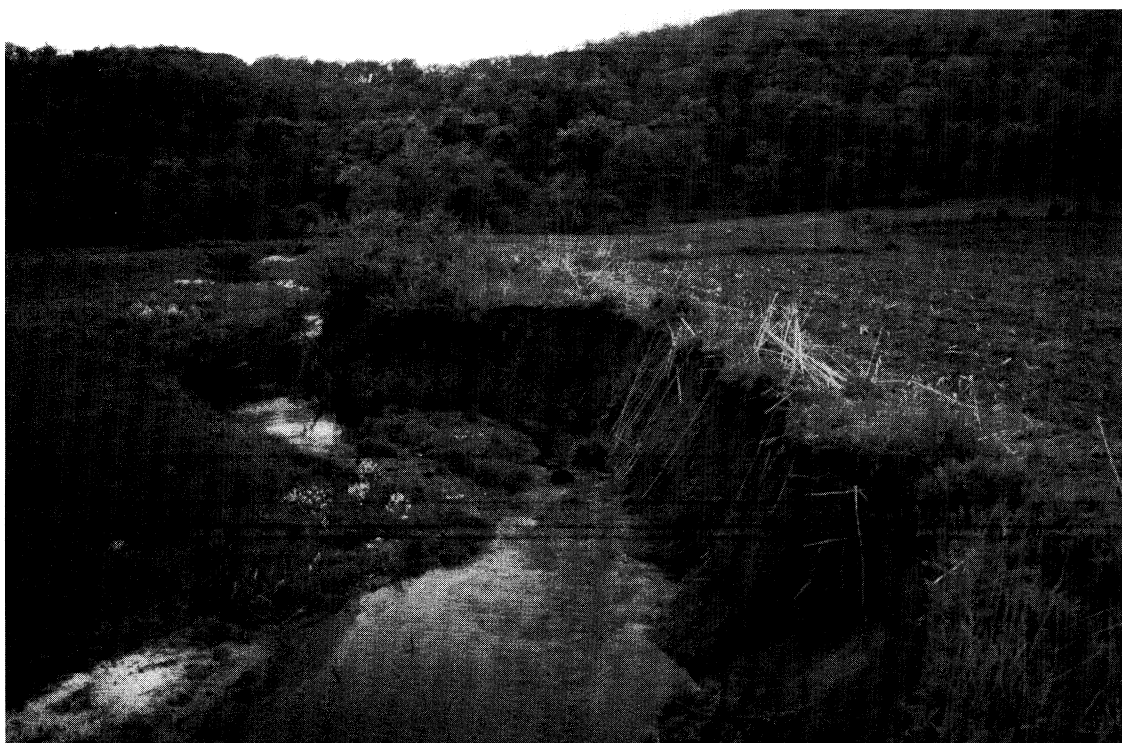
Figure 3. Unstable, vertical streambanks and massive soil loss following thunderstorms often result from over grazing and rowcropping in the riparian zone—Millville Creek, May 1990.

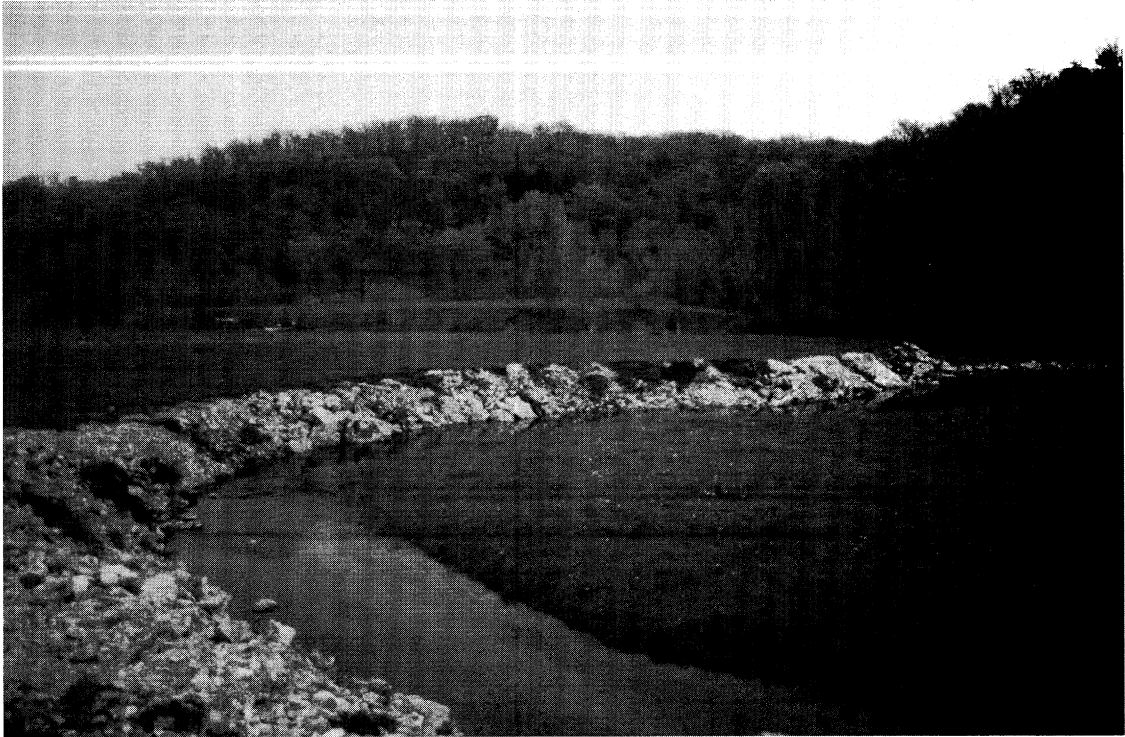
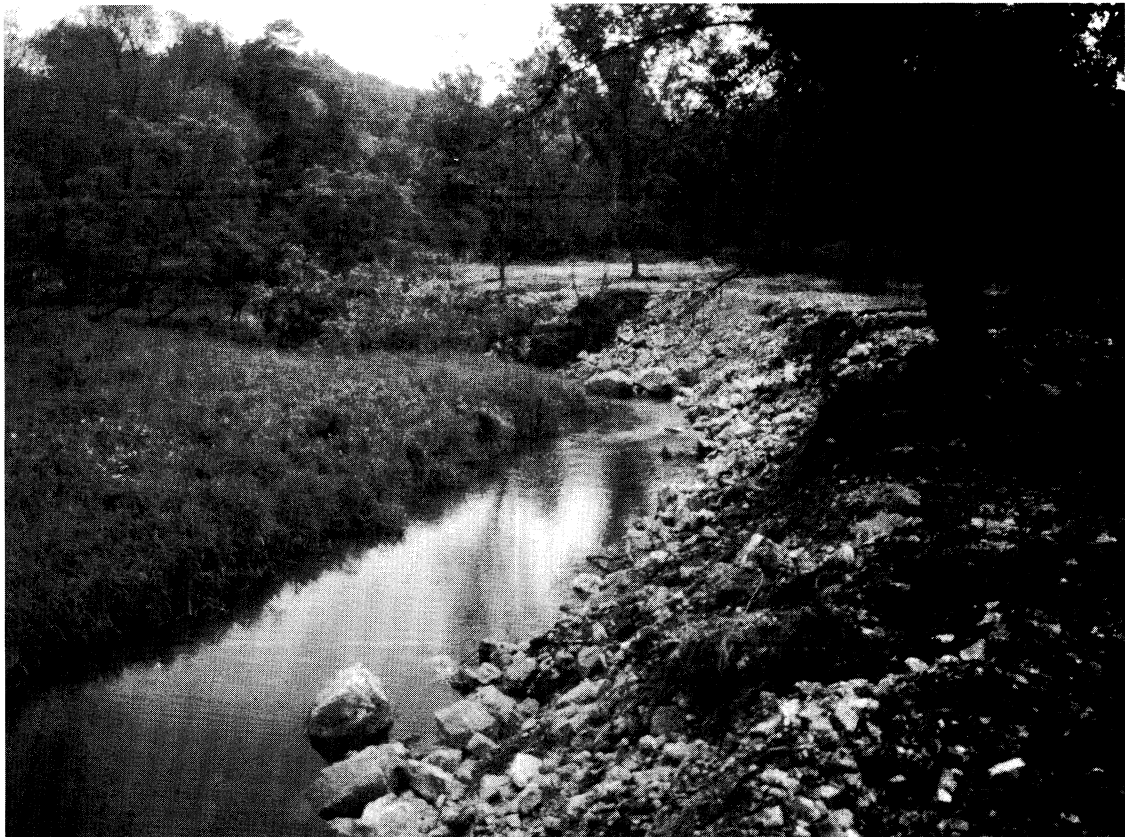
Figure 4. *Intensive streambank riprapping stabilizes eroding streambanks, encourages downward streambed scour, and ultimately creates a deeper stream—Millville Creek, May 1991 (upper), and August 1990 (lower).*

During July through mid-September 1990, approximately 14,780 ft of streambank were intensively riprapped throughout the 4-mile reach of lower Millville Creek (Fig. 4). All comparable trout water received some riprap work and therefore negated establishment of a "reference zone" and limited comparisons to "before" versus "after" in TZ1 and TZ2. All unstable, nonvegetated, and often vertical streambanks were riprapped. Riprap was trucked to the site, dumped, and pushed over the streambank; banks were not sloped prior to riprapping. Cost of the project, including time, labor, and materials, was \$75,000 (approximately \$5.00/ft or \$26,800/mile).
